Quadra Hill Wetland Restoration

Post Construction Report, October 6 - 19, 2025

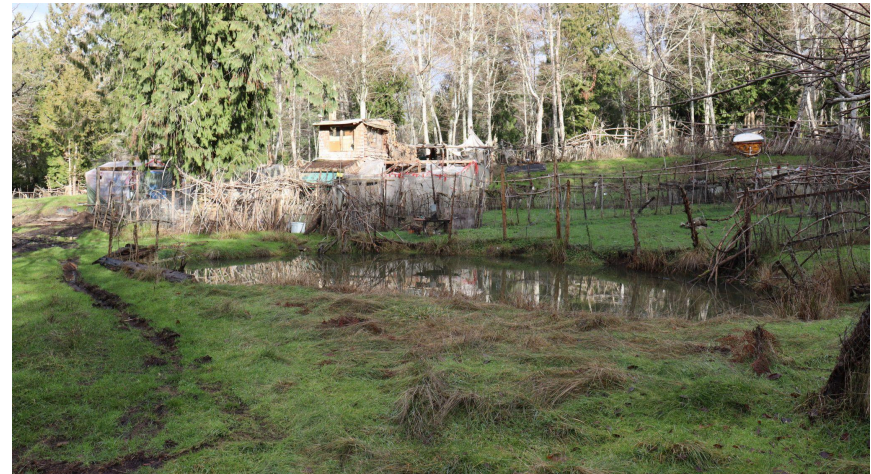
Before restoration - January 2022

Site 2 is situated in the southeast portion of the field and was one of three existing dugout ponds on the site. The pond held water prior to restoration but had very steep banks. The banks were regraded to create a more gradual slope down to the water. Additionally, the low edge of the pond was raised 30 cm to prevent the formation of a headwall. All ditches surrounding the restored pool were removed. Additional materials from the regrading of the margins were used to recontour the southern portion of the ridge that runs along the eastern edge of the field. A vegetated spillway was retained through the stand of cedars on the southeastern corner of the pool. Prior to restoration a rutted road that provided access into the field ran directly beside Site 2. This road was decommissioned back to the primary access road and left rough and loose. This feature was constructed on days 5-6 of restoration, October 10 & 13, 2025.

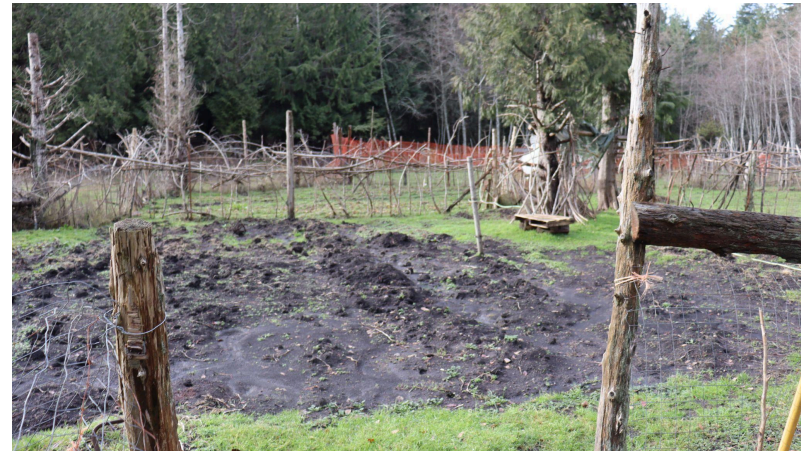
Before Restoration - January 2022

Site 3 is located in the center of the field, upslope of Sites 4 and 5. The slope on this portion of the field was gradual, so the low edge of the pool was not raised. The pool was excavated to approximately 50 cm deep. Excavated soil was used to help recontour the ridge along the eastern edge of the site. There were several live and standing dead cedars in this area that were all retained. One standing dead cedar was transplanted into the center of the wetland. A vegetated spillway was established through the cluster of live cedars on the western side of the pool. Several ditches surrounding the pool were removed and filled. This feature was constructed on day 5 of restoration, October 10, 2025.

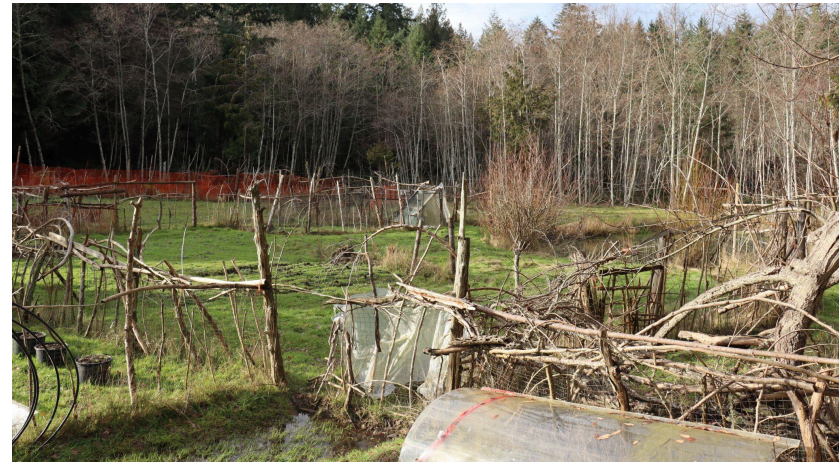
Before Restoration - January 2022

Site 4 is found in the lower western portion of the field, upslope of Site 6. Because this portion of the field has a more significant slope and coarser soils, a core trench was installed beneath the bottom edge of the pool. The trench was dug 1 m deep and 80 cm wide. The available fines at this site were dry. Moisture was added from the nearby ponds to produce a more suitable material for filling the core trench. The trench was built to ground level and then covered with 20 cm of topsoil to raise the lower edge of the pool slightly, accommodating for the slope. The hole from mining materials for the core trench was converted into a pool. A large stump was salvaged from the margin of the treated area and added to the pool. This feature was constructed on days 3-4 of restoration, October 8-9, 2025.

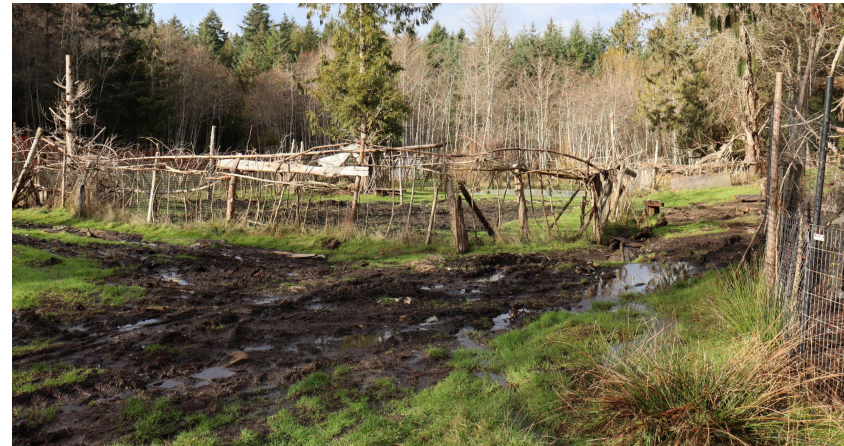
Before Restoration - January 2022

Site 5 is situated directly upslope of Site 7, to the south. Once the ditch connecting Site 7 to the upslope portion of the field was removed, a small pool was excavated. A core trench was not constructed for this pool because the mineral soil in this area was finer than other areas in the field. The lower edge of the pool was raised 30 cm to accommodate the slope of the site. The area surrounding the pool was decompacted and the excess material from excavating the pool was used to recontour the ridge along the eastern edge of the field. An additional wetland, located to the east of wetland 5, was removed from the design as it was determined that it would result in significant disruption to the root systems of mature western cedar and sitka willow (*Salix sitchensis*) on site. This feature was constructed on day 4 of restoration, October 9, 2025.

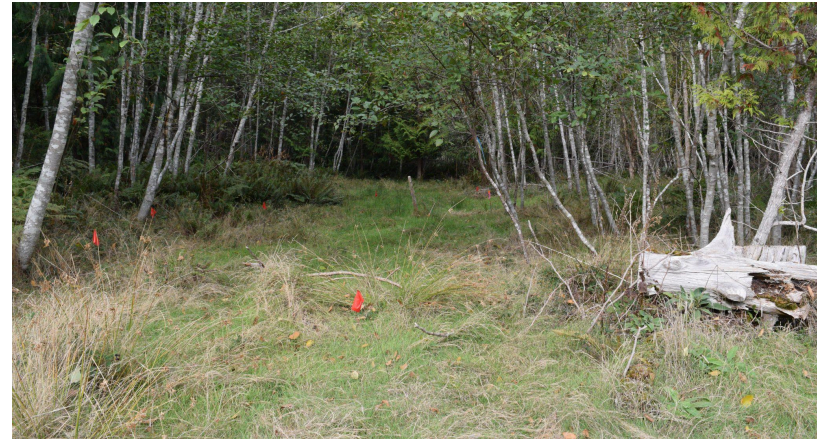
Before Restoration - October 2025

Site 5 is located just within the fenceline, at the edge of the field on the upslope end of a bulldozer track that captured and drained surface flows into the lower alder stand. The end of the roadway was decompacted and left rough and loose. A small pool was created with a final depth of 20 cm. A ditch leading down towards the roadway was cleaned and filled. This feature was constructed on day 3 of restoration, October 8, 2025.

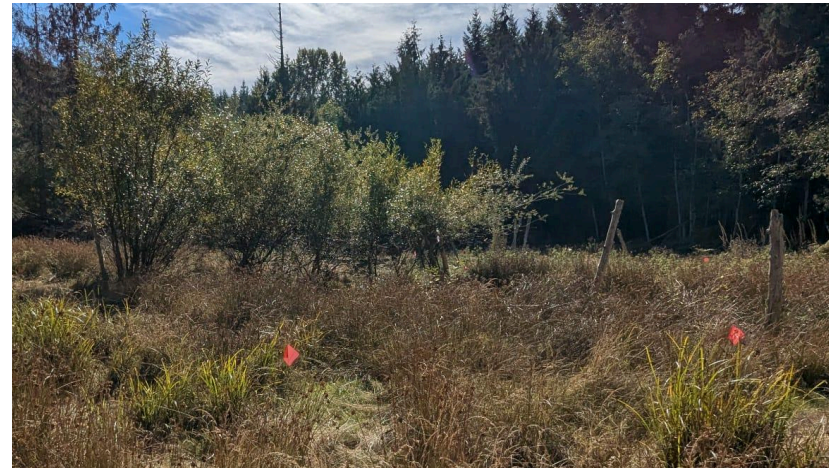
Before Restoration - October 2025

Situated on the northern, lower edge of the open field, Site 7 featured one of the existing dugout ponds. When surveyed prior to excavation on 6 October, 2025, this pond held 1 m of water at its deepest point. Plastic pipe had been installed to drain the pond into the disturbed marsh. Plastic pipe was also installed upslope within a ditch to drain the upper portions of the site into the pond. Both the outlet and the input pipes were removed and the ditches were cleaned and filled. The pond was improved by making the slope of the banks more gradual and excavating small 'bays'. The existing Sitka and Pacific willows were preserved, as they will provide valuable live-stake material for the site. Because the bank surrounding the willows could not be excavated backwards without disturbing the willows, it was re-graded by backfilling towards the pond. A vegetated spillway was retained draining down towards the sedge marsh. The field surrounding the pond was decompacted and left rough and loose, and woody debris was incorporated throughout the area. The unhealthy alder stand below the pool was also made rough and loose, dead alders were removed, and a pocket pool was added. This feature was constructed on days 1, 2, & 3 of restoration, October 6, 7, & 8, 2025.

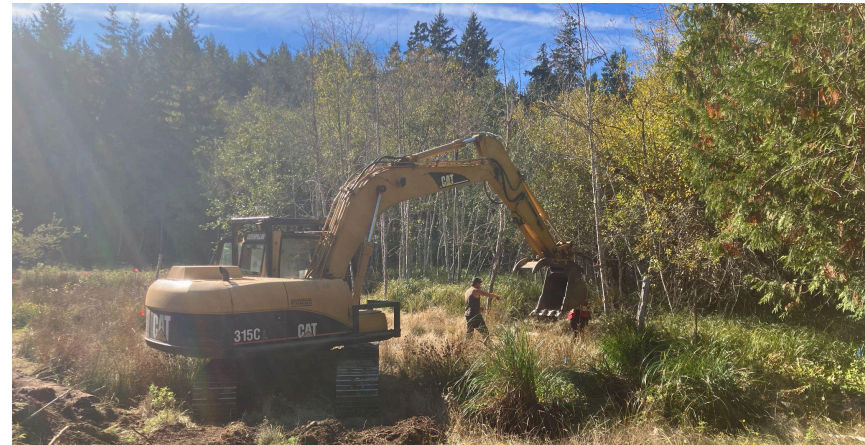
Before Restoration - October 2025

Site 8 is found on the southern edge of the disturbed swamp and marsh complex, to the east of Site 7. The legacy of grazing and the use of heavy machinery on the landscape had left a stark border between the sedge marsh and the open field. Site 8 was designed to extend the sedge marsh into the field and disrupt the linear border between the features. A 20 cm deep pool was dug into the field, extending back into the marsh. In the surrounding area, the slope down to the marsh was regraded to make the transition between features more gradual. The sedge wetland was made rough and loose wherever it was possible to reach through the line of cedar and alder on the southern edge of the marsh with the excavator, and a small pool was created. Several dead alders were felled to facilitate access to the marsh, and these were incorporated into the pond as woody debris. The slough sedge (*Carex obnupta*) removed during decompaction was salvaged and incorporated into Site 8 to facilitate the regeneration of wetland species within the open field. Fallen alders and woody debris from forest thinning activities were incorporated into the pool. These features were constructed on day 1 of restoration, October 6, 2025.

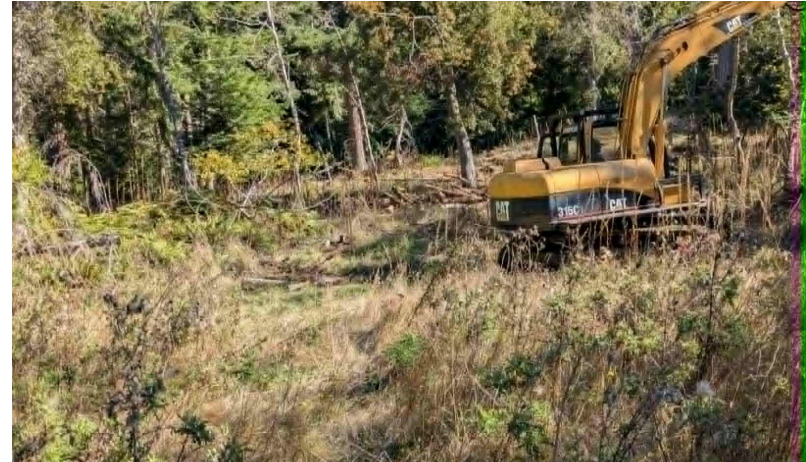
Before Restoration - October 2025

Site 9 is located upslope and to the south of the sedge swamp and marsh complex, in the northeast corner of the field. A 45-cm deep pool was created at this site. Because this pool is located on a slope, the lower edge was raised approximately 15 cm. All open field areas surrounding the pool were decompacted and given a rough and loose treatment by the excavator. Sweet-briar and Scotch broom were removed by the excavator and significant woody debris was added to the site. A large spoil pile covered in thistles near the pool was recontoured. This feature was constructed on day 1 of restoration, October 6, 2025.

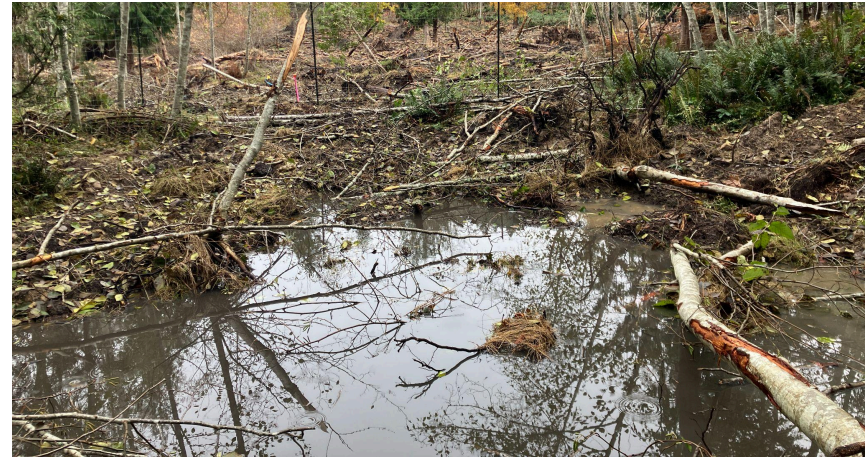
After Restoration - November 2025

Site 10 includes a series of small, pocket pools along the former bulldozer track connecting Site 12 to the open field. The track, and additional machine tracks branching off from it, were decommissioned. Soil was made rough and loose and two pocket-pools were added along the roadway, both approximately 20 cm in depth. Two sets of machine tracks were decommissioned and pocket pools were added at the terminus. Common holly, Himalayan blackberry and cutleaf blackberry were removed. These features were constructed on day 3 of restoration, October 8, 2025.

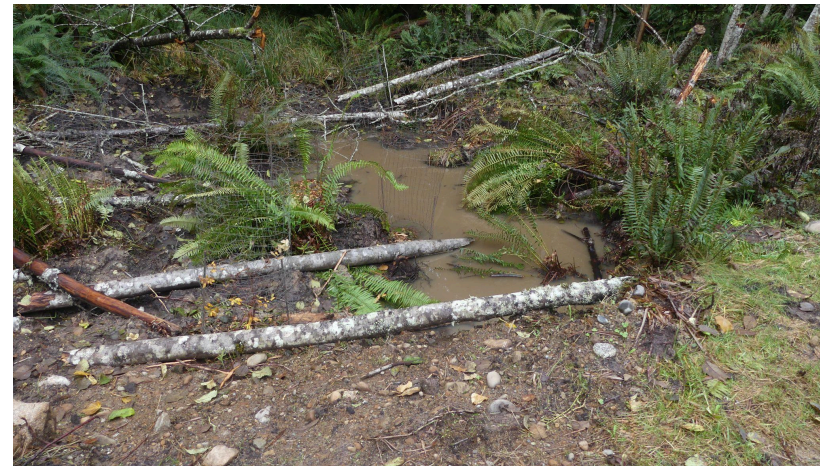
After Restoration - November 2025

Site 11 is situated on the west side of the primary access road at the outlet of a culvert that drains a roadside ditch below Site 12. The area below that road had clearly been disturbed by historic road building activity, and material had been piled on the side of the ditch draining the culvert. The outlet of the culvert had been accidentally blocked and buried during road improvements made in May of 2025. The culvert opening was cleared, excess material was moved out of the riparian zone, and a small pool was established on day 9 of restoration, October 17, 2025.

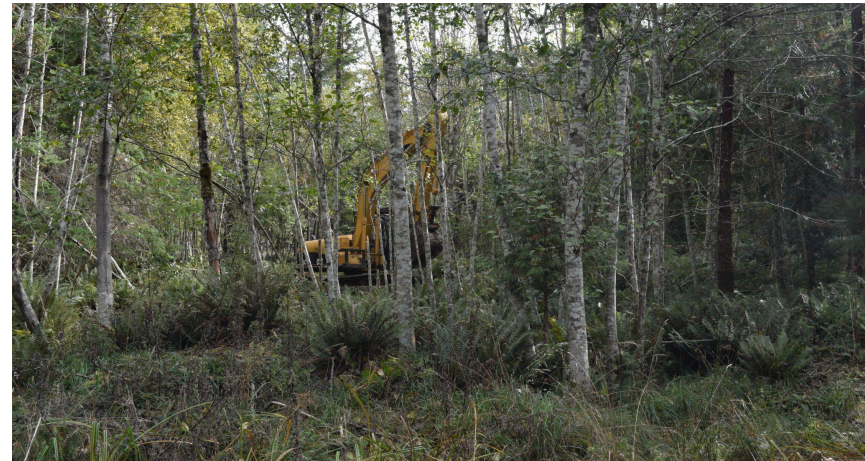
Before Restoration - October 2025

Site 15 is found directly beside the access road to the east, in the northwest corner of the project area. This area was crisscrossed by tractor and bulldozer tracks, with one predominant track leading down from the field to the access road. Prior to restoration, the roadways and machine tracks were acting as ditches, draining water from the field across a red alder stand and through the culvert to Site 11, before continuing on to the Retreat Cove Farms property to the west.

As with all other sites, the area was surveyed for wildlife prior to excavation and one northern red-legged frog was flushed from the site. A pile of material forming a ridge beside the access road, likely a remnant of the construction of the road, was redistributed and roughened to decrease the severity and homogeneity of the slope. A core trench was installed just upslope of the roadside ditch. The core trench was excavated approximately 1 m deep and 1.5m in width. The fine sediments available for the core trench were drier and had a lower clay content than is generally optimal for core trench builds. The final elevation of the core trench was 20 cm above the undisturbed ground height. The pit used to mine sediment for the core trench was converted into a pool with a final depth of approximately 1.2 m. A vegetated spillway was established. There was no rock available to embed into the spillway for erosion control. As such, this spillway should be monitored on an ongoing basis for erosion. To access the site the excavator removed several dead and live alders. These alders were incorporated into the wetland as woody debris along with an impressive log and stump salvaged from the nearby forest. Several English holly plants and a grey birch tree (*Betula populifolia*) were removed from the area. Fruits were removed from the grey birch but the tree was left on site. Young trees growing on the bank of the access road were removed during this process to improve the longevity of the road. Care was taken to avoid damaging the roots of a mature black cottonwood tree (*Populus balsamifera ssp. trichocarpa*) bordering the pool. This feature was constructed on days 2-3 of restoration, October 7-8, 2025.

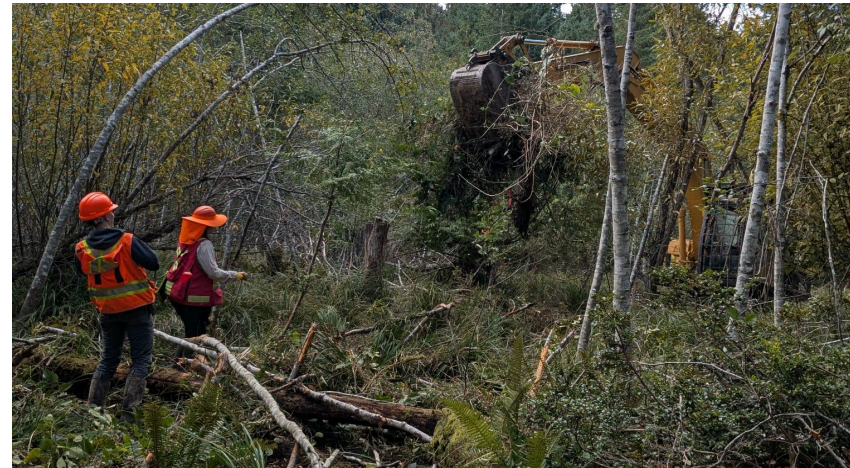
Before Restoration - October 2025

Site 13 is located in the southwest portion of the sedge marsh at the outlet of the plastic pipe that drained Site 7. This pool was expanded from the original design to further restore the microtopography of the site. Prior to restoration, a small lean-to structure was disassembled at this site. All garbage was removed but the untreated wood used in the structure was left on site and buried below the surface by the excavator. Himalayan and cutleaf blackberry on the site were removed. The final depth of the pool created at this site was 30-45 cm. Care was taken to avoid damaging the roots of a mature black cottonwood tree bordering the pool. This feature was constructed on day 3 of restoration, October 8, 2025.

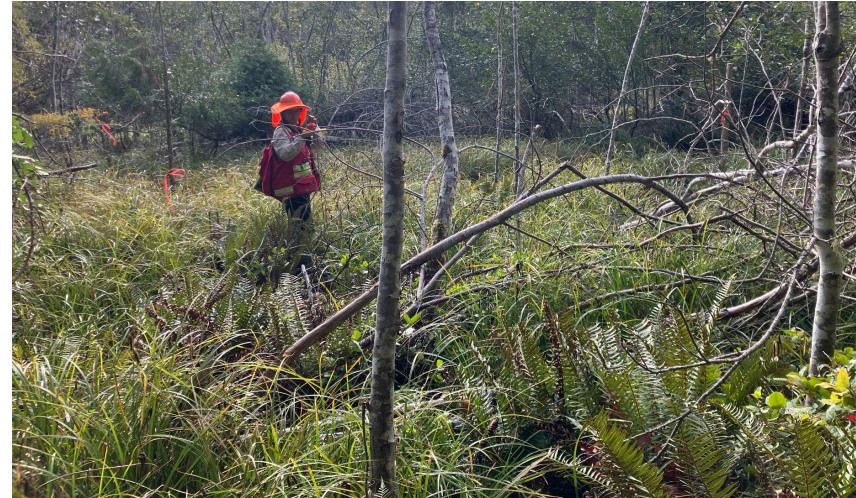
Before Restoration - October 2025

Site 14 is situated in the northeast portion of the sedge marsh. This area consisted of almost entirely slough sedge with one skunk cabbage (*Lysichiton americanus*) and a patch of inflated sedge (*Carex exsiccata*). This site was added to the wetland plan because access to this portion of the marsh was easier than anticipated and additional topographical diversity was desired. Prior to excavation the site was swept for wildlife, surveyed, and the boundaries were marked. Wetland boundaries were placed intentionally to preserve the skunk cabbage, inflated sedge, evergreen huckleberry (*Vaccinium ovatum*), western redcedar, and Pacific willows (*Salix lucida*) on site. Given the homogenous species composition of the marsh an emphasis was placed on preserving existing biodiversity. A compromised branch was removed from a Pacific willow bordering the pond and was placed in the wetland as a source of propagules. This feature was constructed on day 3 of restoration, October 8, 2025.

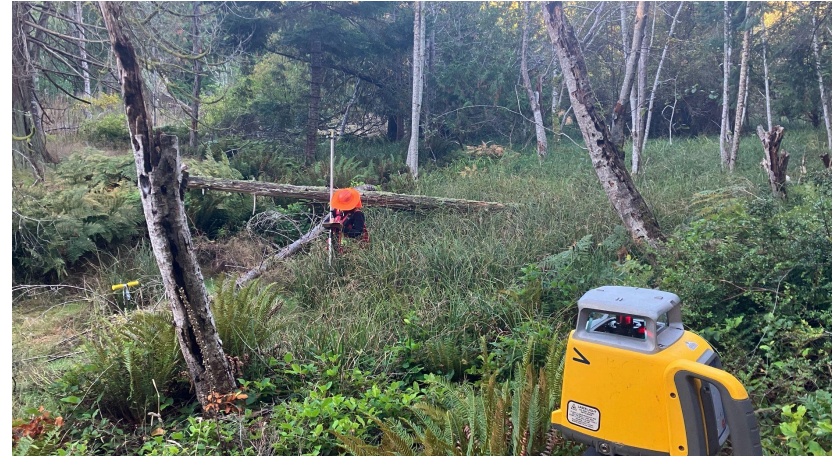
Before Restoration - October 2022

Site 15 is located north of the field, at the bottom edge of the sedge marsh. An old logging road at this location was channelizing outflow from the marsh towards the Great Beaver Swamp Nature Reserve road network. To spread the flow and help the marsh to retain more water, a core trench was constructed at the lowest extent of the sedge wetland. The core trench was raised 40 cm above base ground level to slow the flow of water and promote infiltration. A pool was established on the upslope side of the core trench to create some topographical diversity within the fairly homogenous and flat sedge wetland. The final depth of the pool was 30 cm. Cobbles and small boulders were embedded into a depression on the north edge of the core trench to establish a spillway leading into Site 16. This feature was constructed on day 1 of restoration, October 6, 2025.

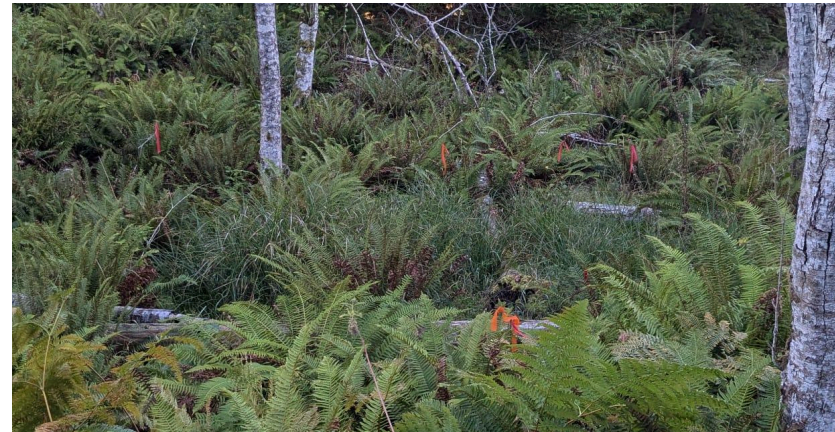
Before Restoration - October 2025

Site 16, found just downslope of Site 15, is located on top of the same road segment at the base of a shallow valley. A soil mining pit and material piles from the construction of the road were present on the southern edge of the site. This site was used to source fine sediments for the core trench at Site 15. The pit created by mining for fine sediments was converted into a small pool, 25 cm in depth. Several dead alders were pushed down and were integrated into the wetland as coarse woody debris. The road was decompacted and given a rough and loose soil treatment by the excavator and the pits and piles created by the original road build were dispersed and filled. Road removal is intended to slow the drainage of the sedge marsh, promoting longer seasonal retention of water and preventing channelization of the flow of water down to the Great Beaver Swamp. English holly and sweet-briar rose in this area were removed by the excavator and disposed of. This feature was constructed on day 1 of restoration, October 6, 2025.

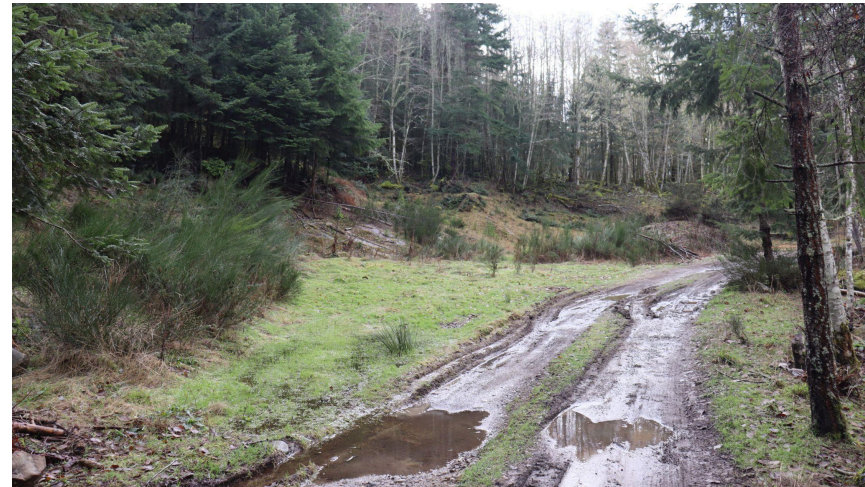
Before Restoration - January 2022

Site 17 is a former gravel pit located on the intersection of the primary access roads for the property. Several piles of topsoil removed prior to gravel excavation were identified along the rim of the pit; a large soil pile covered with Scotch broom and teasel had been left beside the access road. The topsoil piles were redistributed on the site and the slope was recontoured and left rough and loose to create more natural and diverse topography. Stretches of slope with significant vegetation (ferns and conifer saplings) and less severe slopes were retained, creating a series of vegetated strips along the slope. Approximately a quarter of the existing flattened area was retained to be used as parking or gathering space for events. This work was completed on

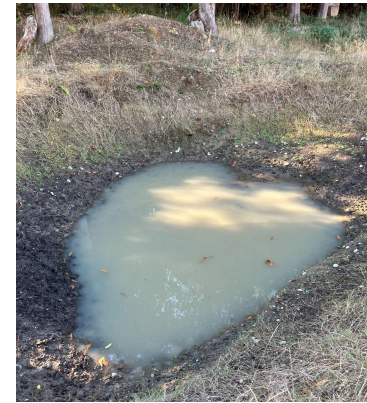
Before Restoration - November 2022

Site 18, located just upslope of site 4, was one of the 3 existing ponds on site. This pond was very steep and deep, and did not retain water into the summer months, likely due to underlayment by coarse sediments. The material from pond excavation had been piled on the margin. Given that this pond was not retaining water, the depression was backfilled with wood from the structures on site and additional soil from the creation of other pools throughout the field. Ditches leading into and out of Site 18 were removed. This feature was constructed on day 4 of restoration, October 9, 2025.

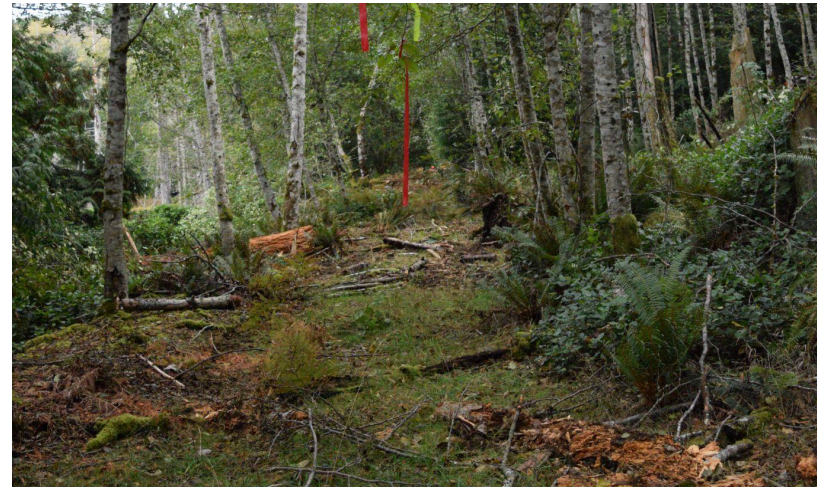
Before Restoration - October 2025

Site 19 consisted of an old logging road running parallel to the margin of the Great Beaver Swamp wetland east of the intersection with the branch road from the Quadra Hill Nature Reserve. This road segment once crossed the swamp, but the crossing has since been flooded and reclaimed by the wetland. The remaining road area was swept for wildlife prior to excavation. A small disturbed clearing was present at the road terminus, and signs of significant recent beaver activity (felled red alder trees) were noted in this area.

The road surface was made rough and loose, with small ridges and pools added across the road to disrupt the previous grading. Wherever possible, the surface was blended back into the existing slope. Approximately ten small and five large pocket pools were roughed in. A large old growth log that crossed the roadway was retained as an important habitat feature and left in place. Selected alders were felled along the roadway and incorporated as woody debris. Throughout this process, all English holly plants in the area were flagged and removed. The final work on all road segments was approved by the Cultural Monitors. This road segment was decommissioned on day 8 of restoration, October 16, 2025.

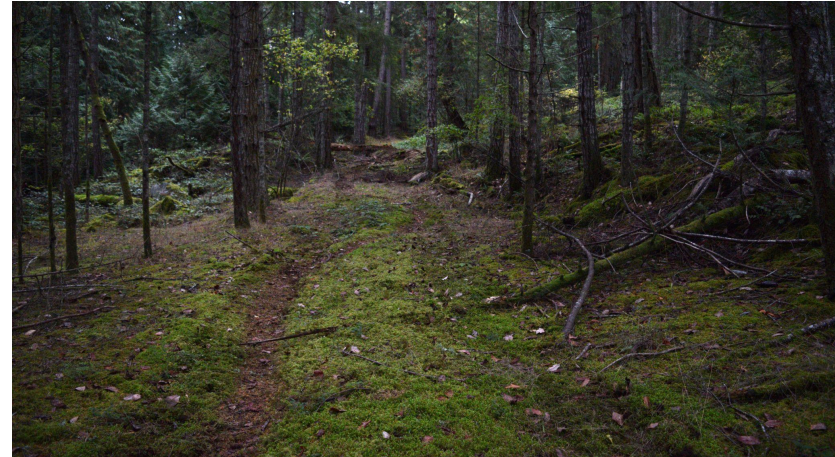
Image Before - October 2025

Site 20 consisted of an old logging road running parallel to the margin of the Great Beaver Swamp wetland west of the intersection with the branch road from the Quadra Hill Nature Reserve. The western branch of the road was rockier and bordered in places by mature trees. As such, the regrading of the road was less extensive. The area was made rough and loose within the bounds of the existing roadway to avoid causing damage to the root systems of the trees. The pits and mounds in this area were shallower as a result of the rocky soil. Two pocket pools were added to this branch of the roadway as well as several large rock features. A live northern red-legged frog was found on the roadway while recording data the day after excavation. The road segment continued onto the neighbour's property; the restored area stops just short of the property line. This road segment was decommissioned on day 8 of restoration, October 16, 2025.

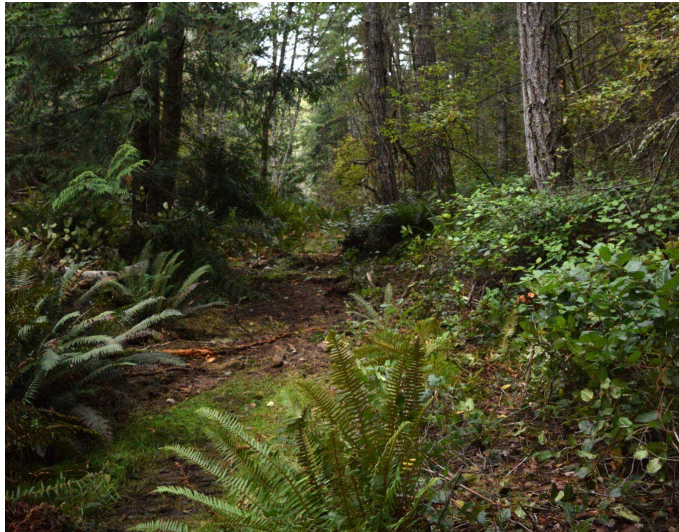
Before Restoration - October 2025

The branch road from the Quadra Hill Nature Reserve was significantly steeper. The focus in this area was to prevent channelization of the seasonal flow that was being funneled down the roadway. A ditch on the west side of the road was removed and pocket pools, soil mounds, woody debris, and rock features were added to the roadway and surrounding area as it was made rough and loose. These features will disrupt flow and encourage the water to meander as it descends towards the Great Beaver Swamp. Two short lateral branches off of this roadway were also decommissioned, as well as several small upland road segments elsewhere on the Quadra Hill Nature Reserve property. This road segment was decommissioned on days 8-9 of restoration, October 16-17, 2025.
