Coastal Douglas-fir Forest Restoration and Liner Wetland Construction

At the Millard Learning Centre on Galiano Island

UNIVERSITY OF VICTORIA RESTORATION OF NATURAL SYSTEMS
GALIANO CONSERVANCY ASSOCIATION

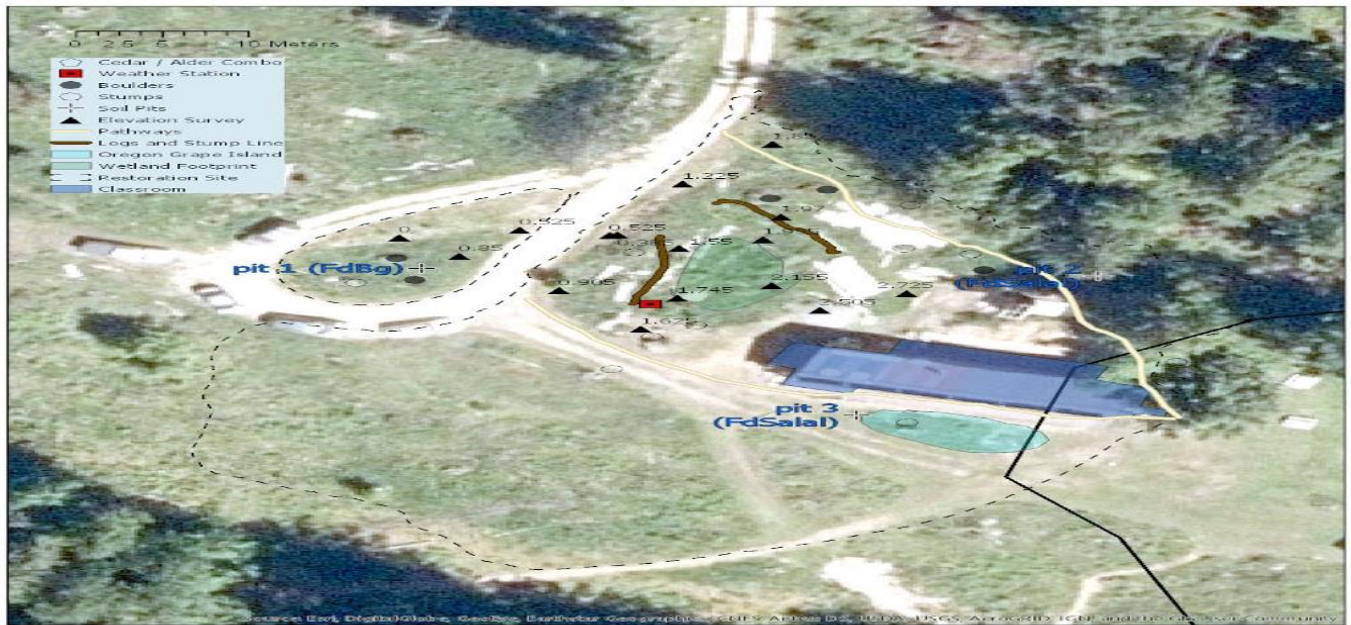
Figure 4: GIS image of the project site. 2 more soil pits were dug in the bottom left area. GIS data collected by Adam Dewar, image prepared by Adam Huggins

In reference to my site (Figure 4), specifically, there is not much of a plant community present at all. This area was logged in the early 2000s, and the effects of the removal of trees, the associated destruction of the understory, and ground compaction caused by the use of heavy machinery is still evident today. This paired with the ungulate browsing

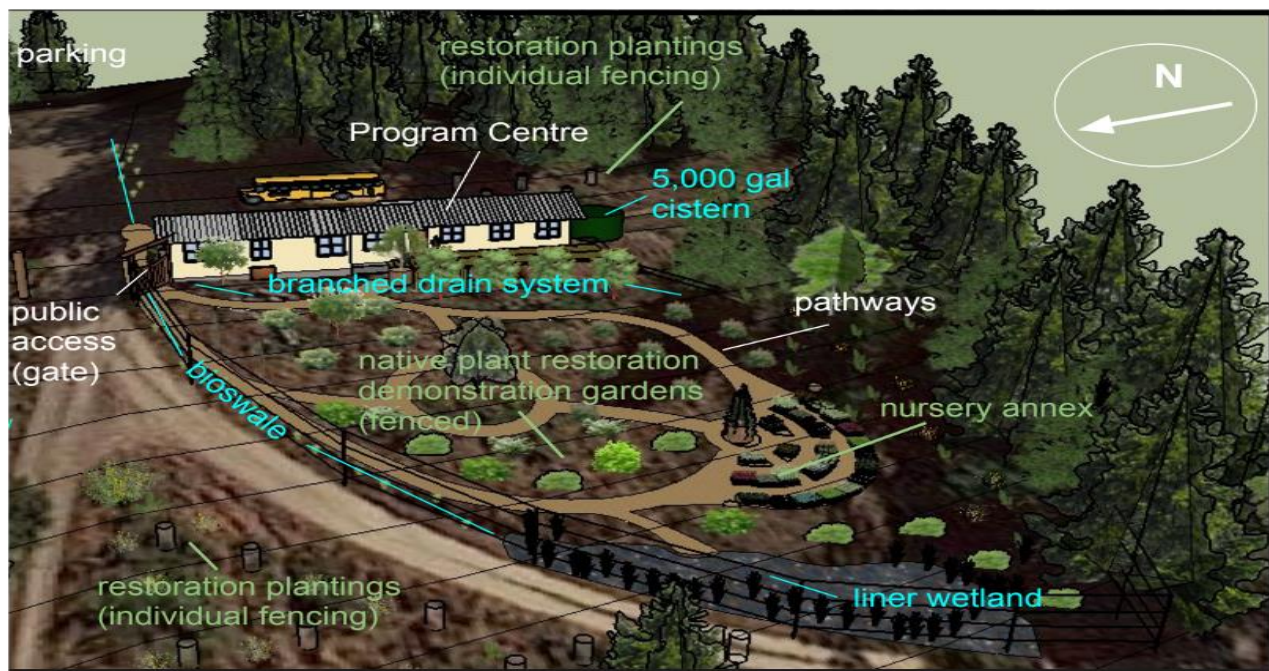
Figure 5: Illustrated schematic of the Program Centre project. This included the construction of the building itself, as well as the restoration of the areas around it with demonstration gardens, a nursery annex, a bioswale, and liner wetland. Photo: GCA

The wetland build aspect was initially intended to be a part of the construction of the Program Centre building. Figure 5 is an illustrated schematic of the initial plan for the surrounding landscape around this building. Included in this project was the implementation of a bioswale to help direct,

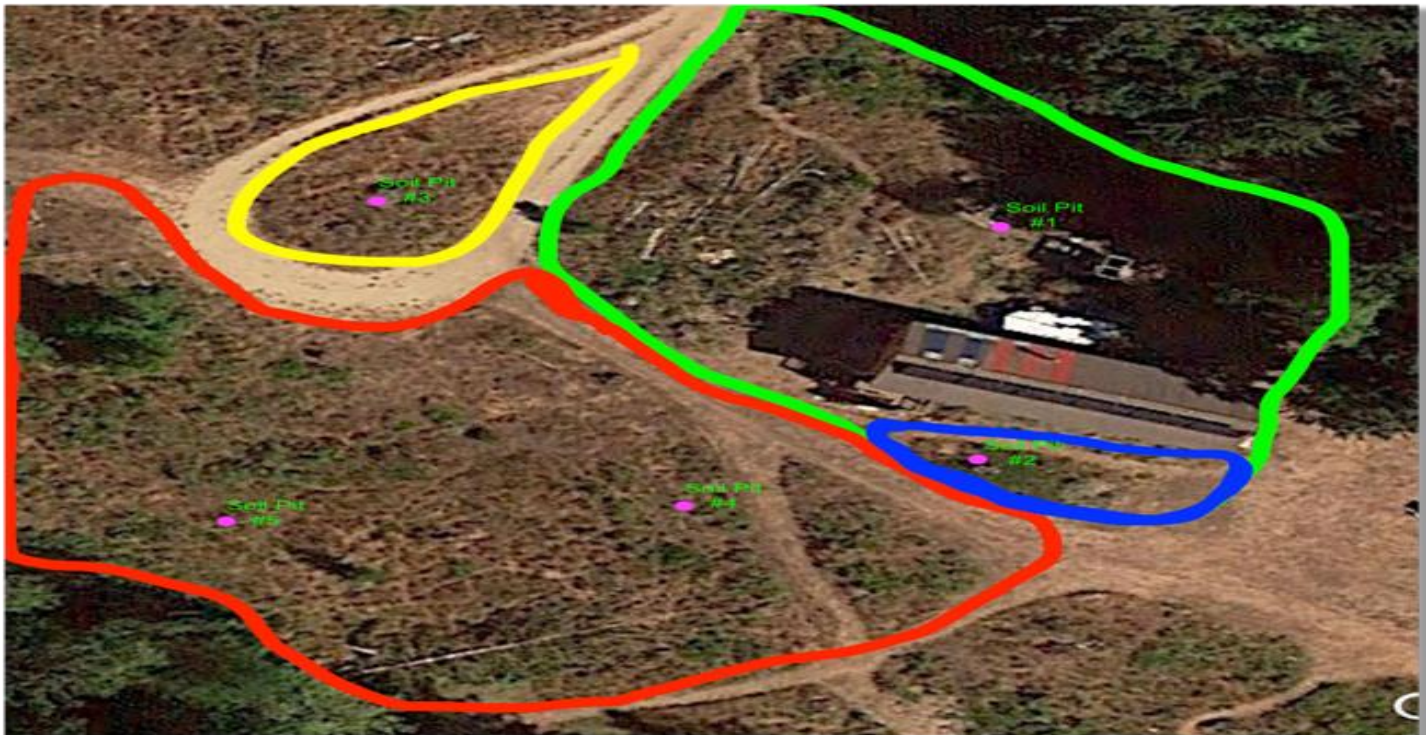
Figure 7: The results of the TEM mapping. Each pink dot represents one soil pit tested. The coloured outlines each represent a different ecosystem polygon. GREEN: DSjdf2bLI BLUE: DSjdf3aLI YELLOW: DFjfy3aLI RED: RSjyd3bLI

Figure 9 outlines the different TEM polygons present at the classroom site. The results of the soil pit tests are shown below in Table 1. The results of the TEM polygon code determination are presented in Table 2.

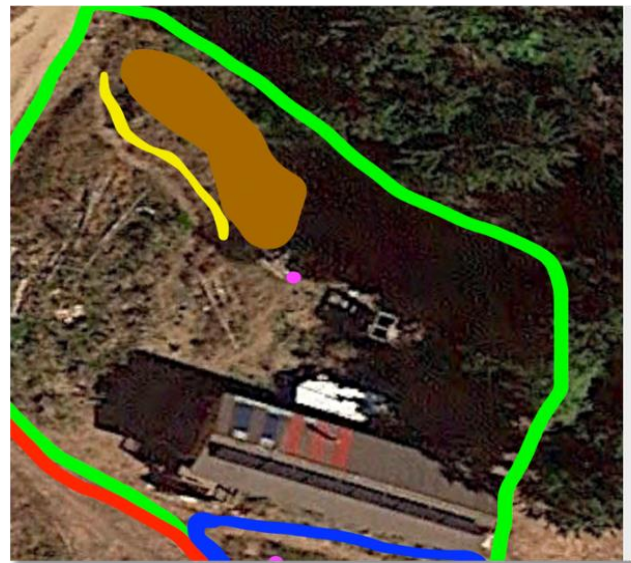
Figure 8: Green polygon, the brown area represents the septic leach field, and the yellow line indicates the location of the buried powerline

The main challenges presented in this polygon were the close proximity it has to the classroom building and other infrastructure (Figure 10). Primarily, this area had to be planned and planted conforming to the Firesmart Canada regulations. This includes but is not limited to: no planting of large woody plants within 10m of the building and no use of flammable material within that distance. The plan for this polygon includes a marked pathway with wheelchair access to the building, discussed below. There are two other main infrastructure considerations. First, part of the grassy area is a septic leach

field that is attached to the washroom. Thus, even though this area is far from the building, it could not be planted with deep-rooted woody plants. Second, there is a powerline running underground along the stump line (Figure 10). All earthworks and deep rooting species had to be planned around these two features.

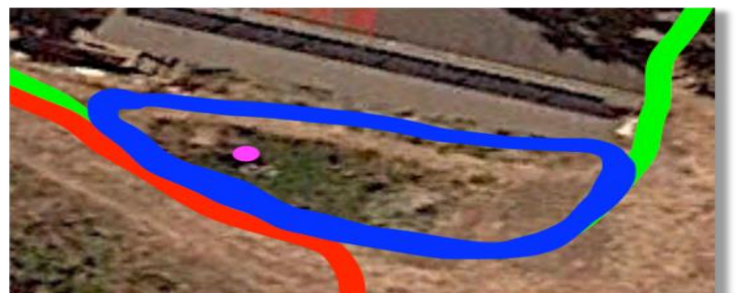
Figure 9: Blue polygon. The solar array atop the classroom roof is seen clearly in this photo

thin that pathway, while maintaining a thoroughfare for foot traffic. The only contention to be had with infrastructure in this area was the fact that large trees were prohibited due to the solar array present on the south side of the roof of the classroom building.

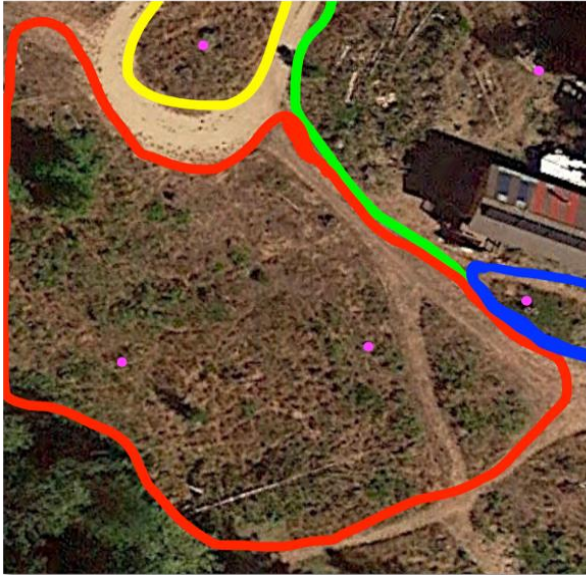
Figure 10: Red polygon. The natural forest that we are trying to expand is seen in the bottom-left corner of the image

It can be seen in the bottom left part of Figure 12 that this area is bordered on

that edge by a fairly healthy and natural mature redcedar forest. The goal in this polygon was to advance that line as much as possible, reclaiming this area to the forest it should be. This area was mechanically decompacted with an excavator, the operator being careful not to uproot the existing saplings and planted with the trees mentioned above. These trees were all caged after planting to help ensure establishment without the stresses and pressures of ungulates. The establishment and growth of these planted and already-present trees will help control the invasive species as well, as they will serve to shade them out.

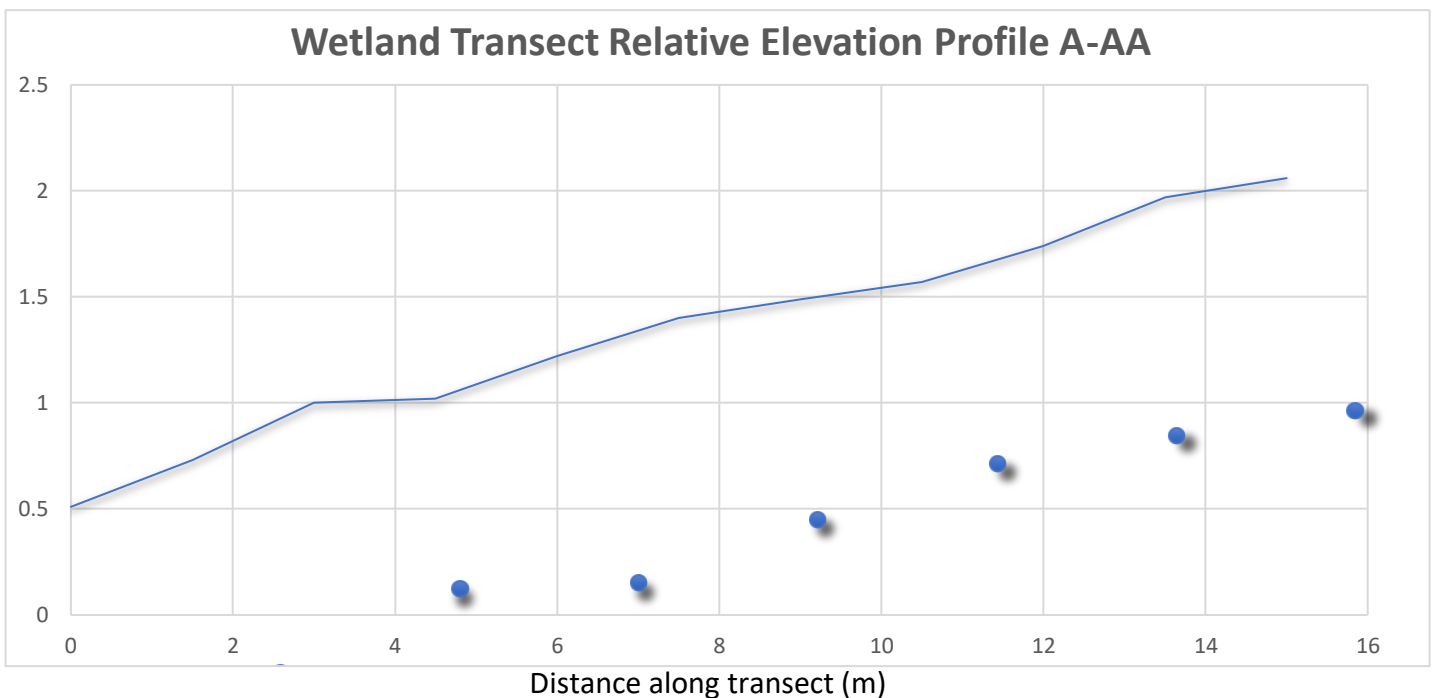
Graph 1: Relative Elevation Profile of Transect Line A-AA

Transect line A-AA is a fairly consistent slope but shows little to no “bowl-ing”. Transect line B-BB is more or less a flat line and not something that would work as a pond.

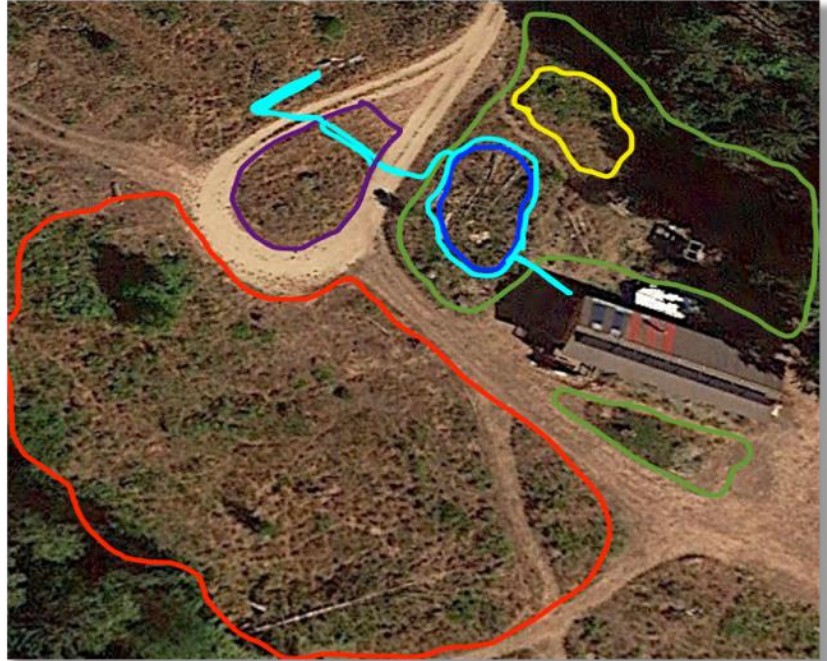
Figure 12: The flowpath of water as it moves through the system. Right to left from this perspective: off of the roof, through the primary swale, into the wetland, through the first culvert, through the secondary swale, through the second culvert

There were two possible locations for the wetland at the classroom site. Separate designs were created for each possible site and a decision was made collectively for which site was ultimately selected. Each site would have the same flow path (Figure 15) and same primary water source, the roof of the classroom. This path begins with the water flowing off of the classroom roof and ending on the far side of the roundabout, flowing into the Nuts’a’maat Forage Forest, a previous restoration project completed in 2017. Figure 15 also shows the first possible location of the wetland in blue with the second possible wetland location outlined in purple. Each location had several benefits and drawbacks.

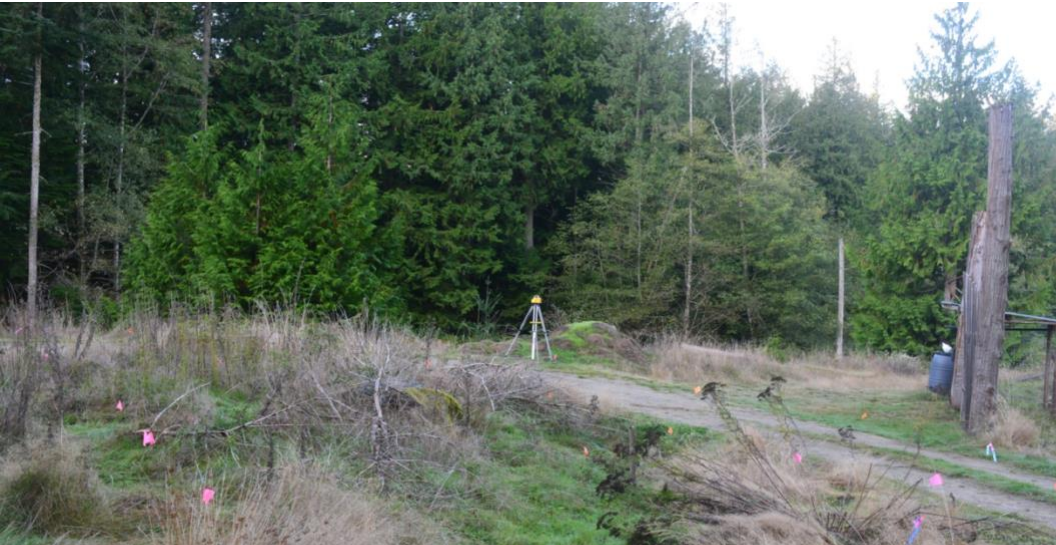
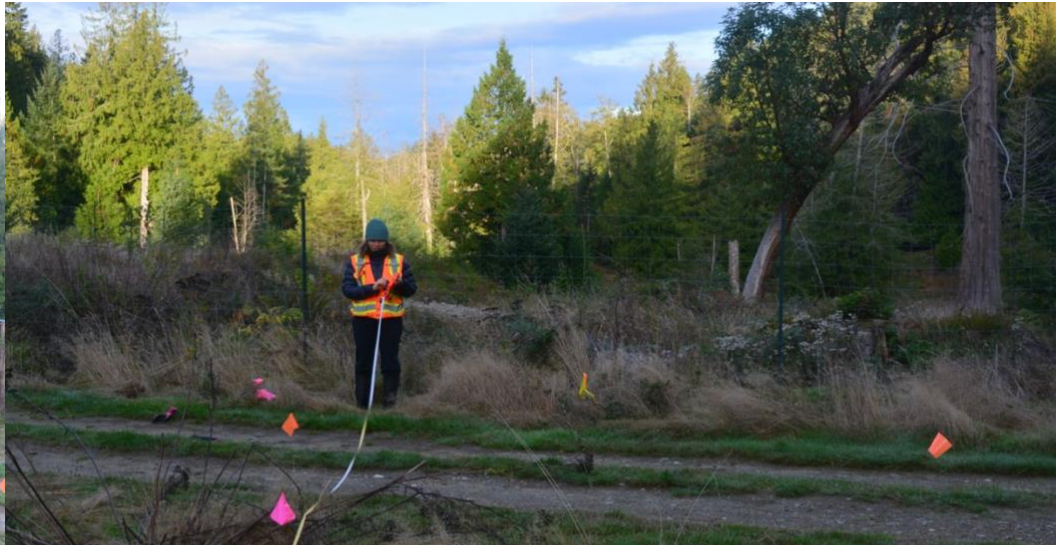
Upper left: laser level and marking flags.
Lower left: excavator preparing wetland area.

Upper right: measuring distances from wetland centre to edge.
Lower right: dig, measure, dig, measure, dig

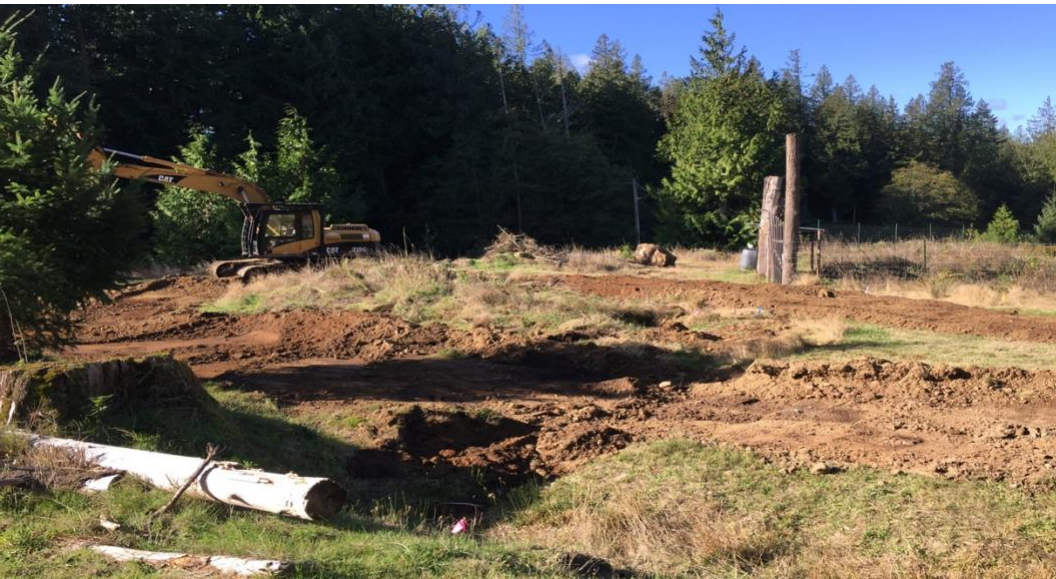
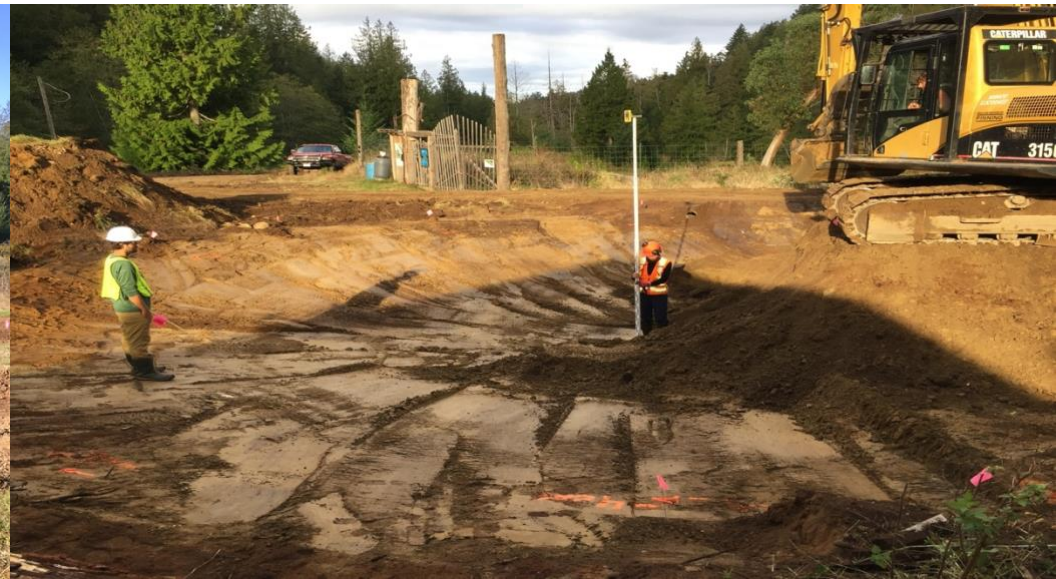
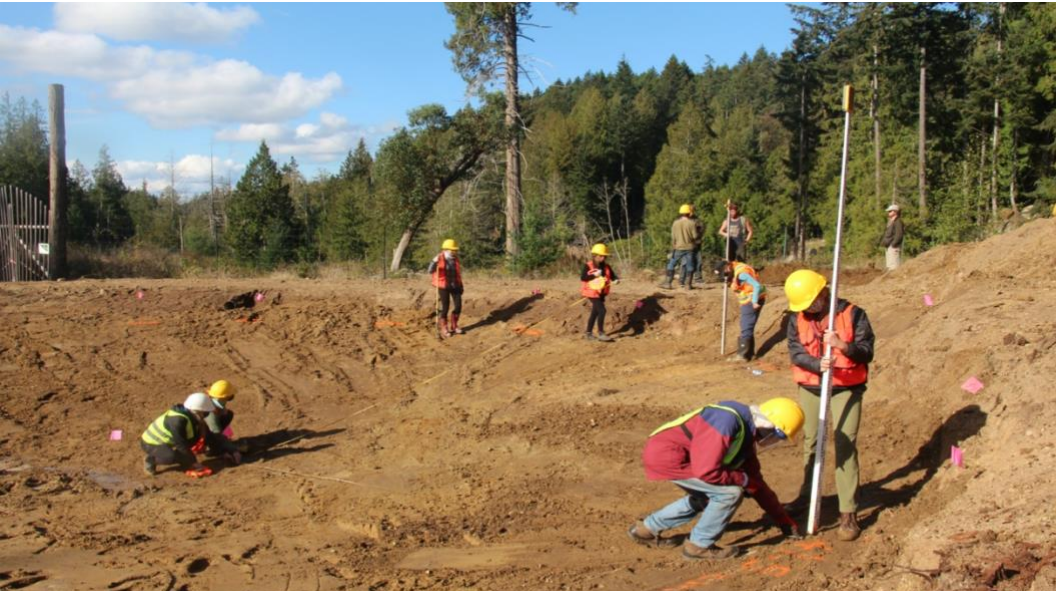
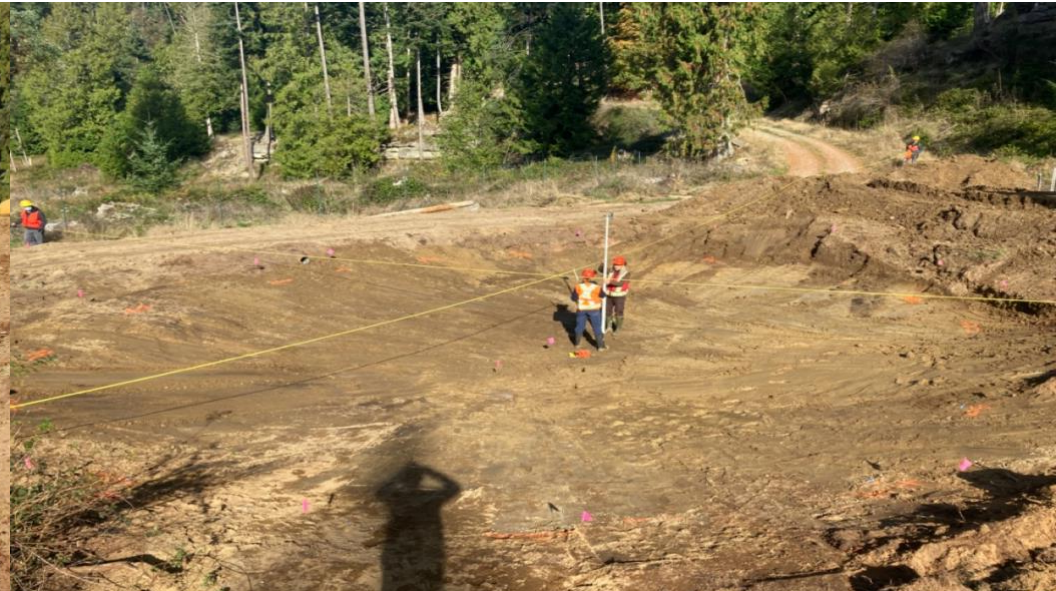
Upper left: volunteers raking out the wetland rim to ensure consistent elevations.
Lower left: extending the classroom's perimeter drainpipe into the wetland

Upper right: basin complete, one last centre depth check
Lower right: Volunteers unravel and install the three layers of geotextile and pond liner

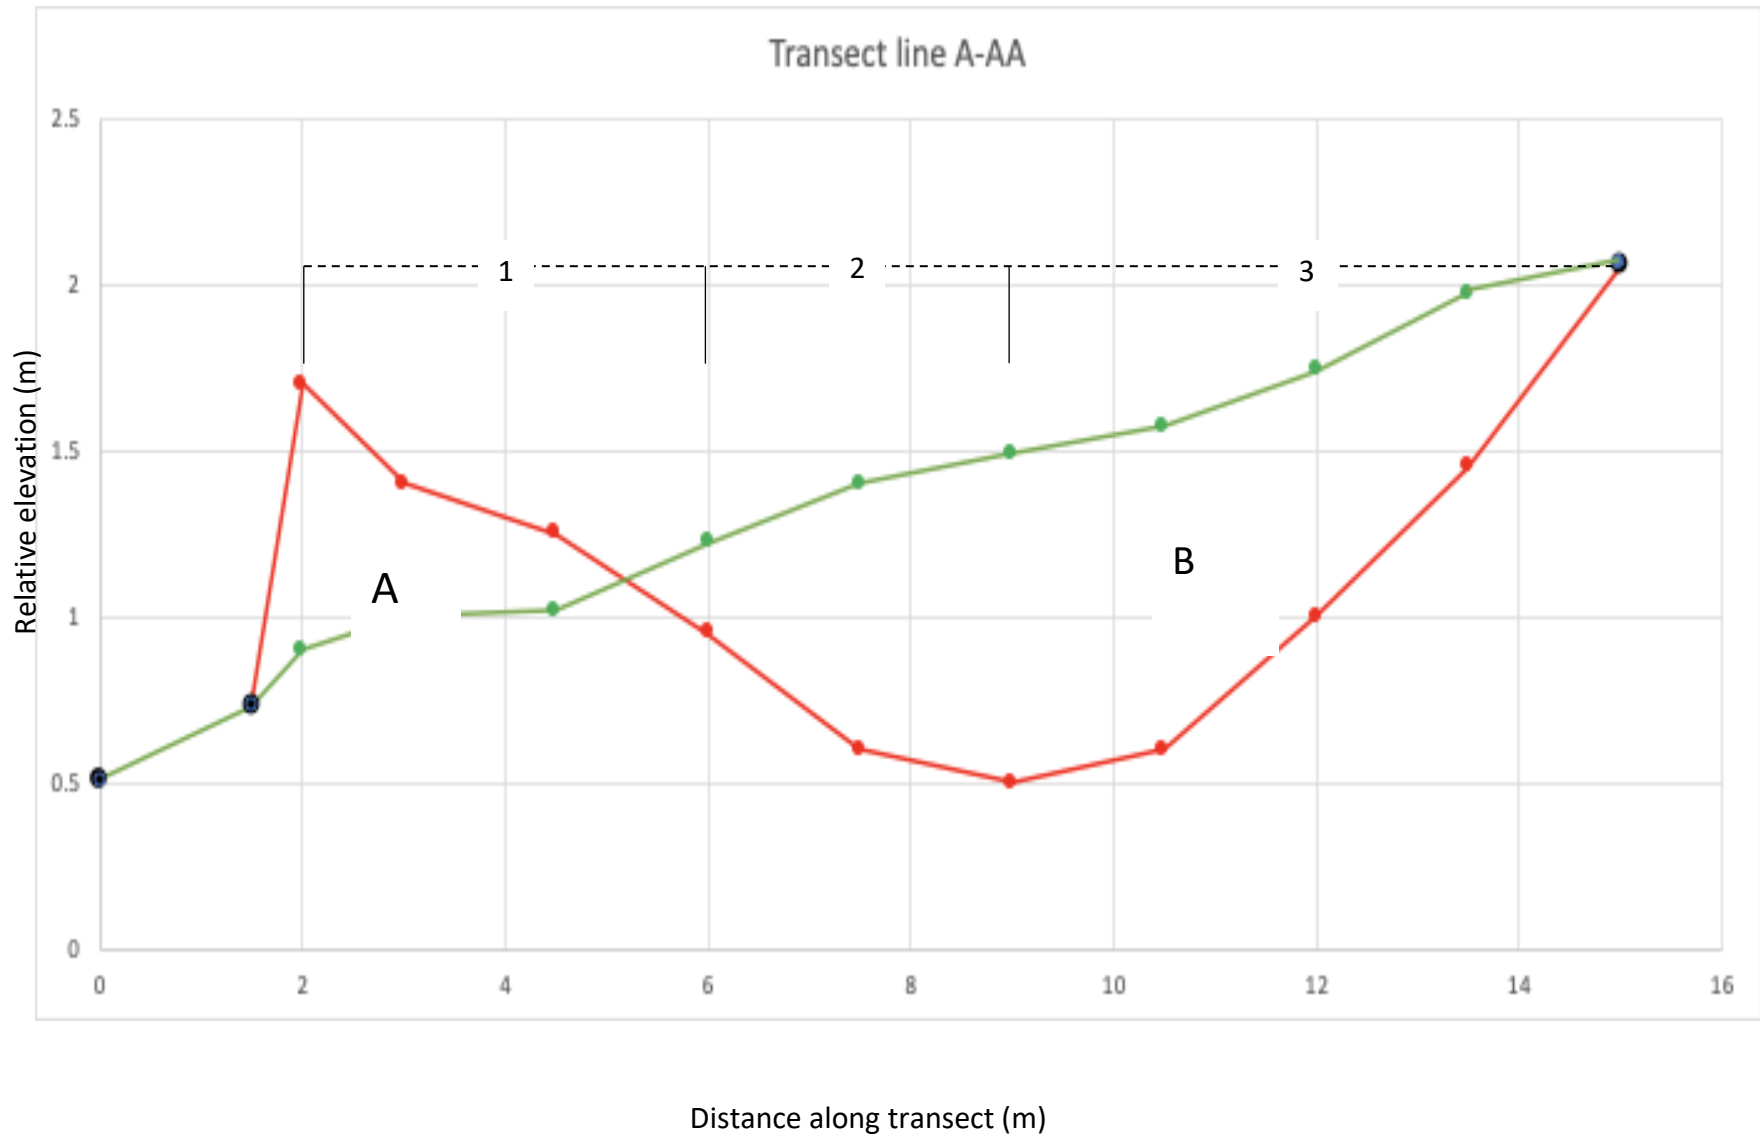
Graph 2: Overlay of current and desired relative elevation profiles along transect line A-AA

In the graph below, we see on the left side that there needs to be material deposited to create a “dam” of sorts in order to hold water. It was important to consider the strength and structure of this dam because it is on the road ward side of the wetland, meaning any breaches in this dam would be potentially catastrophic for the road. Calculations were performed to ensure that enough material was going to be excavated to be able to make this dam a reality. The simple calculation was to take the area between each of the curves in graph 3 and compare.

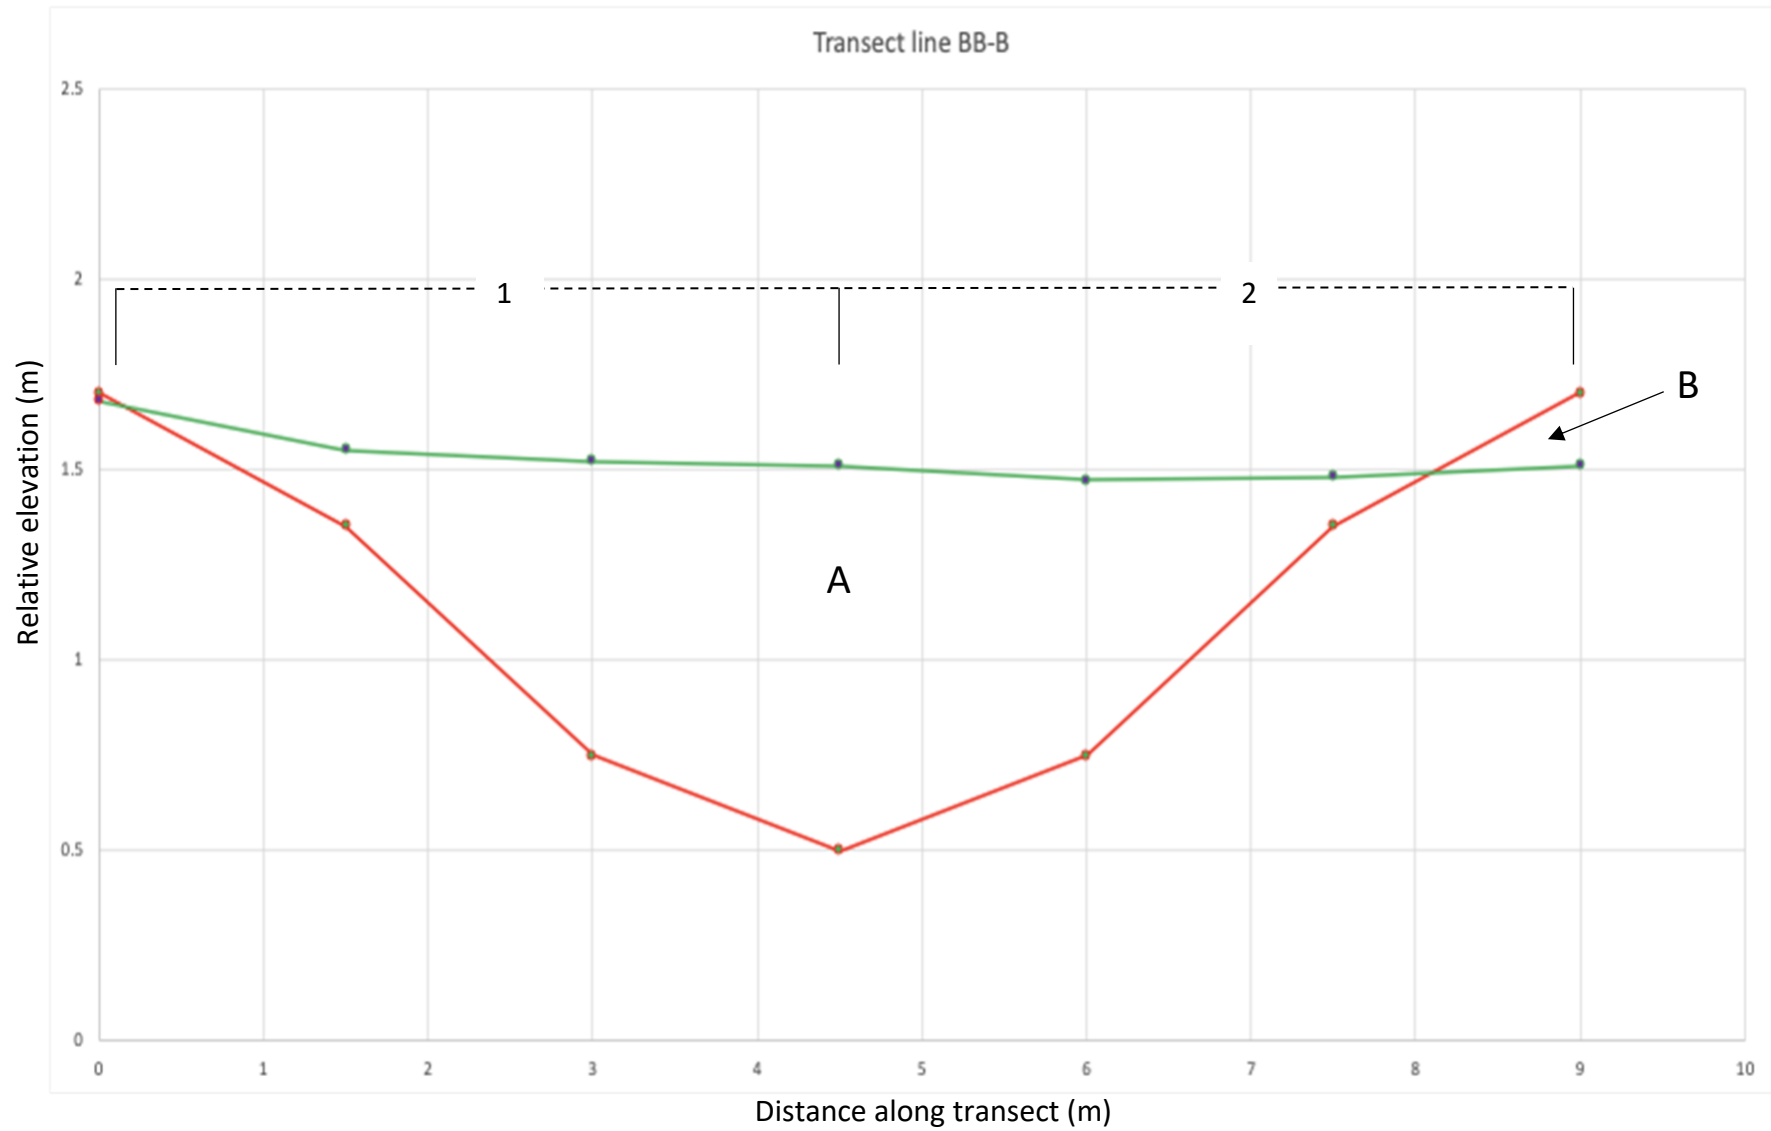
Graph 4: Overlay of current and desired relative elevation profiles along transect line B-B

- Current profile highlighted in purple
- Desired profile highlighted in green
