# DEMONSTRATION NATIVE GARDEN and FOREST RESTORATION

Prepared by Fern Yip on April 19<sup>th</sup>, 2020 for the University of Victoria and the Galiano Conservancy Association

ER 390

Restoration of Natural Systems

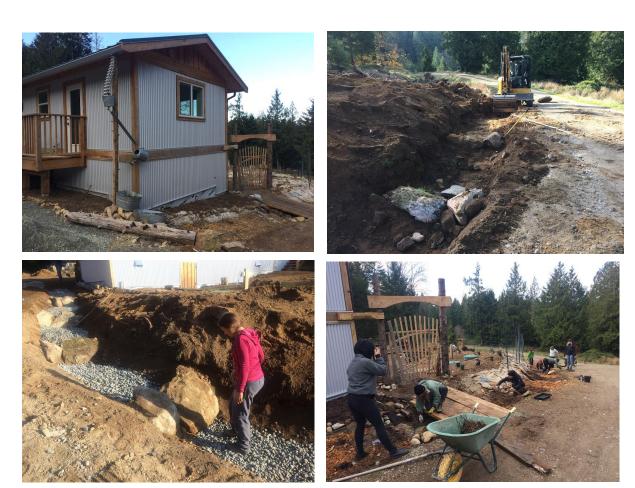
Figure 7.3.3: Creation of the bioswale from recontouring to planting. Water is collected from part of the roof and run-off from the above parking lot (top left). Excavator recontours bioswale by digging out a trench and placing large stones to create bioswale tiers (top right). GCA intern Sadie checks out the gravel filled bioswale (bottom left). Volunteers plant willow to stabilize the bioswale bank and place burlap sacks over planted areas (bottom right).

Adam Huggins coordinated the design and implementation of all of the water conservation systems on Site A, which include a demonstration bioswale, rooftop water collection system, and greywater system. The bioswale was designed by University of Victoria students Adam Dewar and Liam Baron-Preston for their ER 412 project, which outlined hydrologic design recommendations. Dewar and Baron-Preston's planting recommendations were considered in the recommended planting scheme for the bioswale area (Appendix A). Installation of the bioswale involved surveying and marking the bioswale dimensions, digging out the trough, lining the bioswale with gravel fill, and re-vegetating the site (Figure 7.3.3). The rooftop water collection system was installed by directing rainwater gathered on the rooftop into a cistern and placing a pipe system that transferred overflow into the garden. The greywater system collects laundry and shower water from the Project Centre and directs it through a branched piping system to a garden bed in Site A (Figure 7.3.4).
