Eelgrass Restoration on Galiano:

*A Zostera Marina* Restoration Project Design in Whaler Bay, Galiano Island, B.C.

David Goldman, Zoe Martin & Chelsea Power

University of Victoria

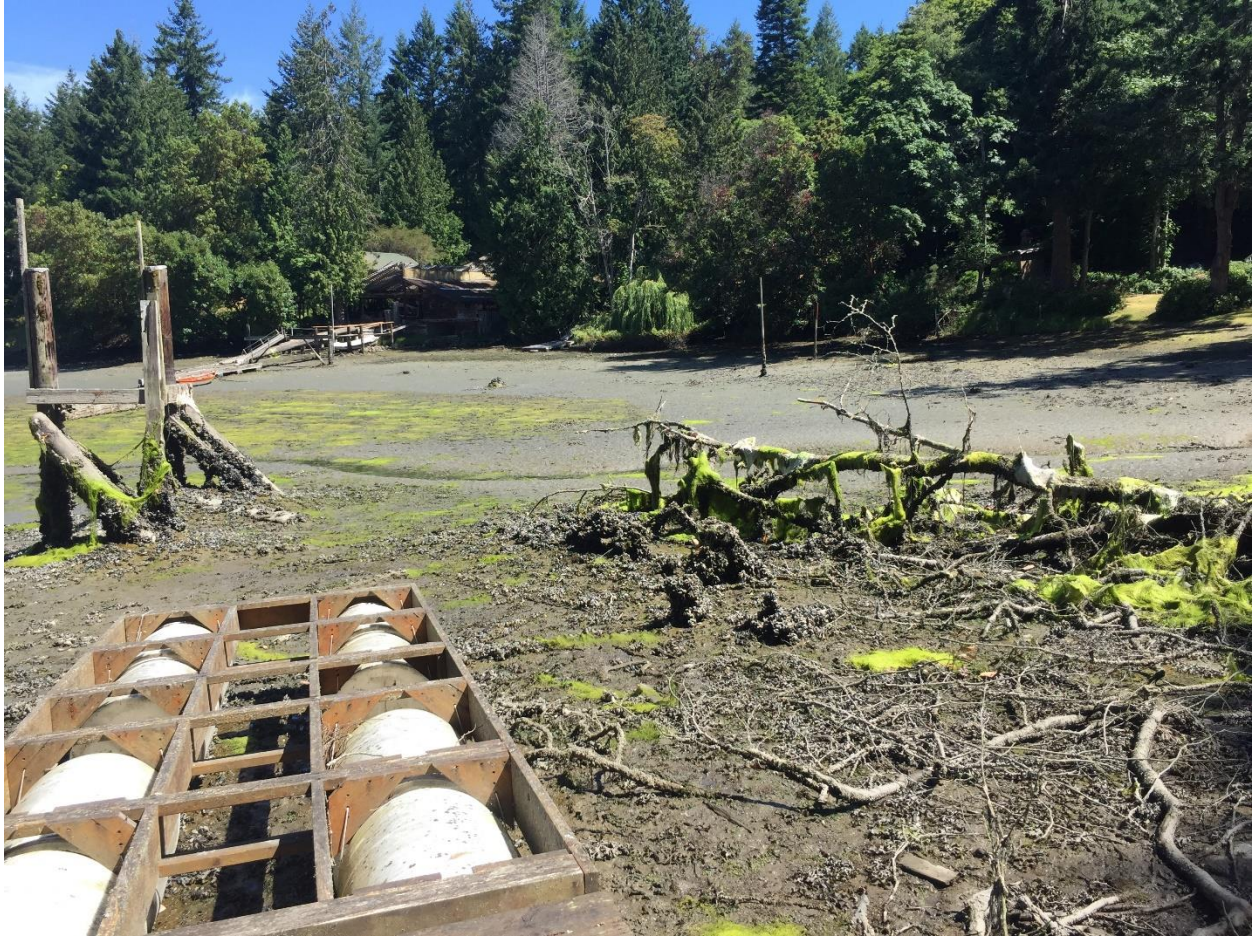
*Figure 5 Whaler Bay at low tide, note the marine debris and lifeless mudflats in place of a healthy intertidal ecosystem.*

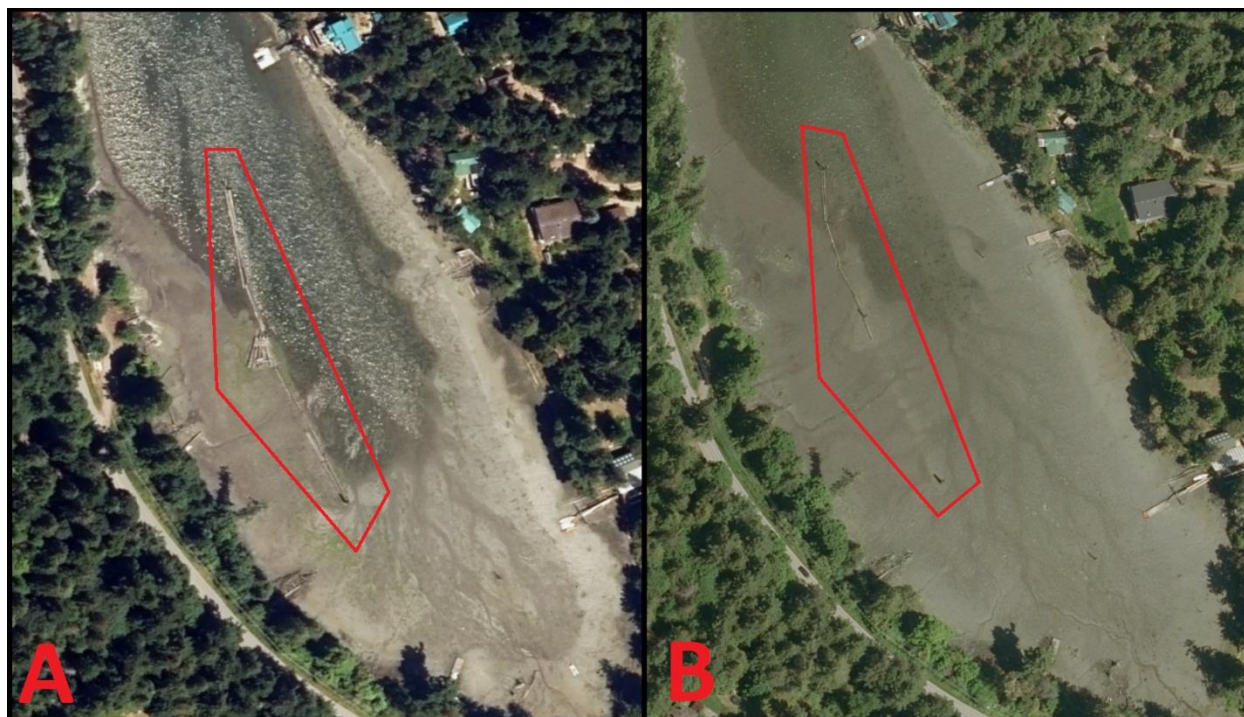
Figure 7 The site of the log storage lease in Whaler Bay, A is a photo from 2013 and B is a photo from 2017. Note that in 2013 the lease seems active.

We recommend that the GCA contact Galiano Timber Limited to ensure that no more activity will be taking place in the old log handling and storage lease before it expires on June 2022.

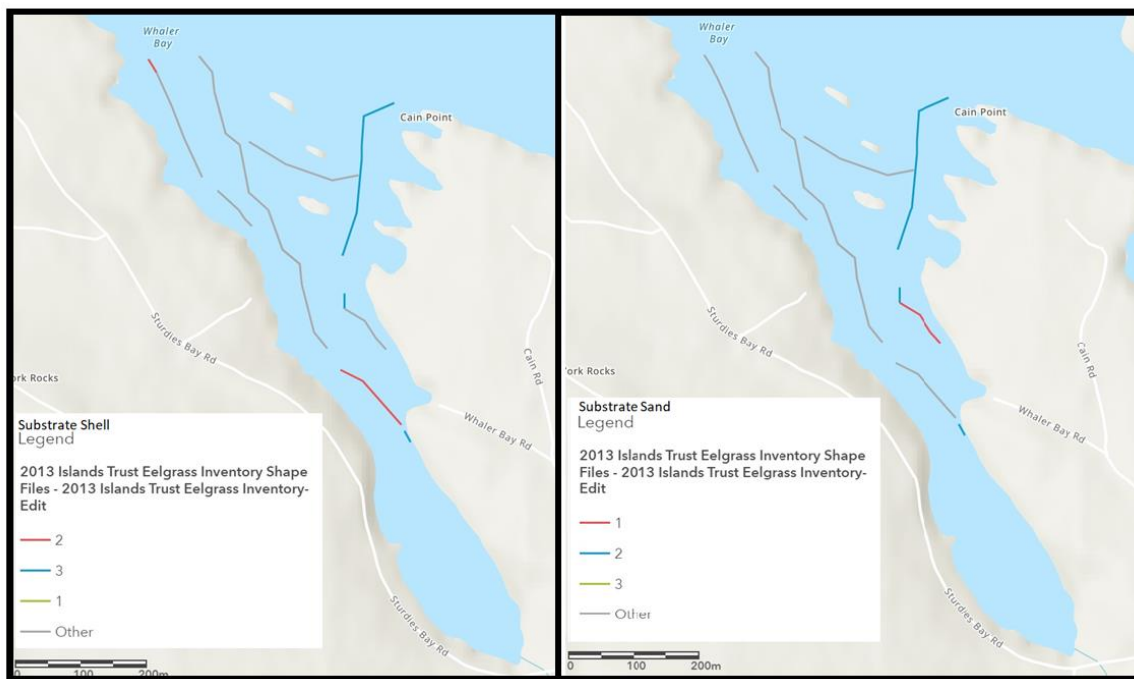
The substrate in the Whaler Bay area is primarily mud (Figure 8), while the secondary and tertiary substrate in the Bay is a mix of shell and sand (Figure 9). This substrate composition is conducive for *Z. marina*; however, it is likely that the substrate contained within the old logging lease was dredged and may need further restorative action. The majority of the bay has very low visibility, with a small section in the mid-bay at medium visibility (Figure 10). The low visibility in the Bay is likely due to silt content in the water. With little vegetation to stabilize the substrate, silt is easily turned up via recreational and commercial bay use. Heavy silt content does not allow sunlight to penetrate into the water and inhibits photosynthesis. Although this is not ideal for eelgrass health, once eelgrass is restored it will work to filter silt and debris from the ocean water. Thus, it is likely that the substrate is a viable habitat for *Z. marina*.

Figure 9 Substrate mapping of shell (left) and sand (right) in Whaler Bay. Primary ( 1), secondary (2), and tertiary (3).

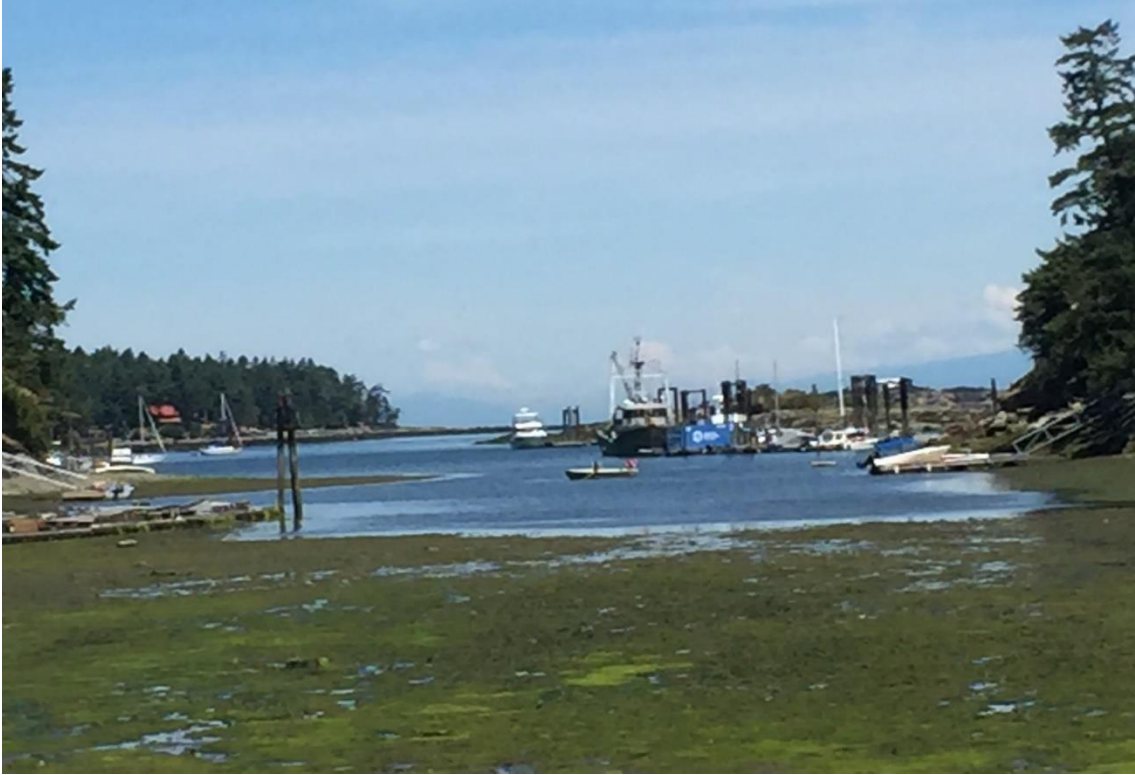
*Figure 11 The South arm of Whaler Bay at low tide, note the muddy bottom that is revealed.*

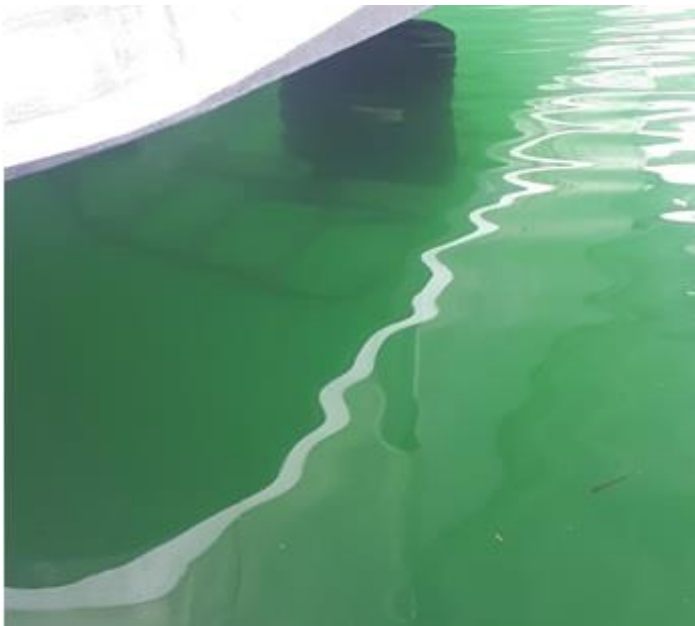
*Figure 12 Note the low visibility in the murky water under a large vessel at the Whaler Bay public dock, evidence of high silt content in the water.*

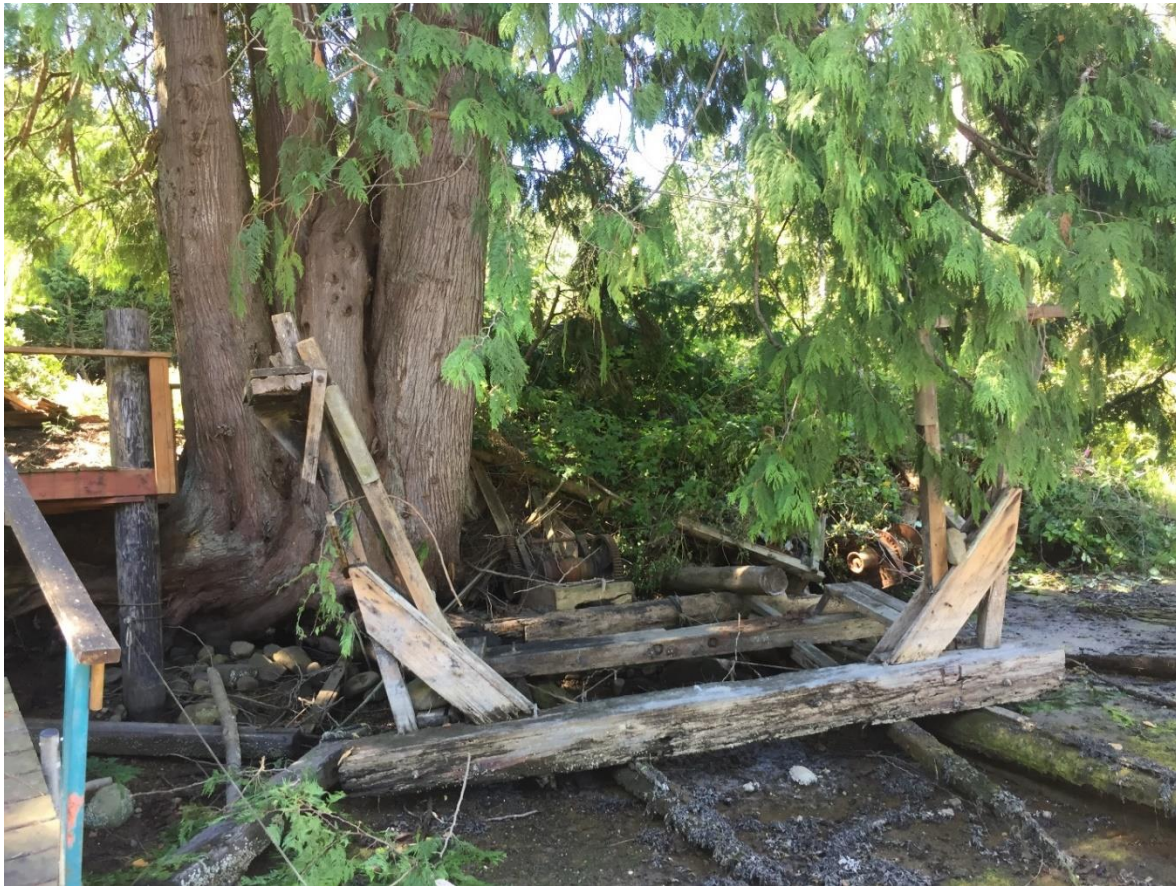
The southern arm of Whaler Bay is littered with evidence of past human activity: logging and marine debris are present throughout the Bay from the old log dump and storage lease. The debris inhibits vegetation from thriving by taking up space, changing water flow and thus increasing scour, erosion, and sediment deposition, which can bury SAV, and continue to leach contaminants into the water and substrate.

*Figure 13 Marine debris at Whaler Bay.*

We recommend cleaning up the logging and marine debris from the Bay, and testing the substrate and seawater for forest industry contaminants from fertilizers, pesticides, and nutrient loading before the transplanting process takes place.

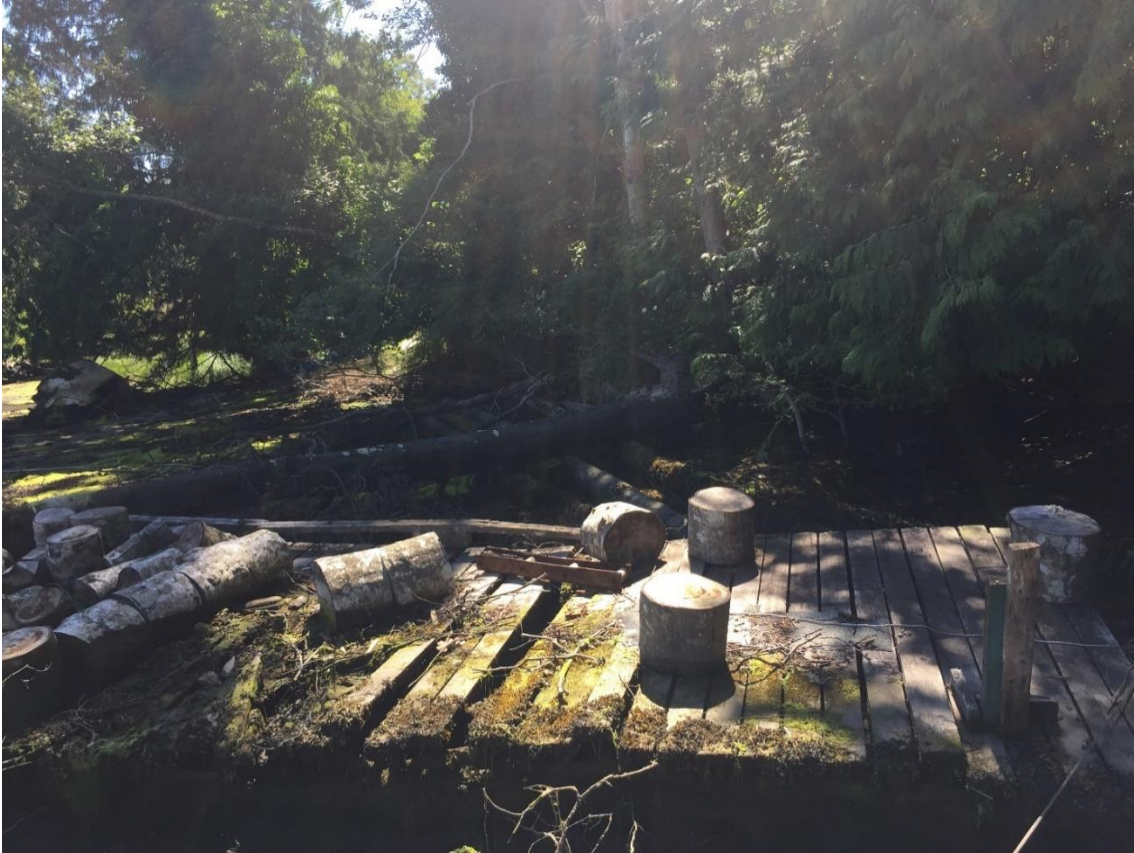
Figure 14 Debris from the old logging lease revealed at low tide in Whaler Bay.

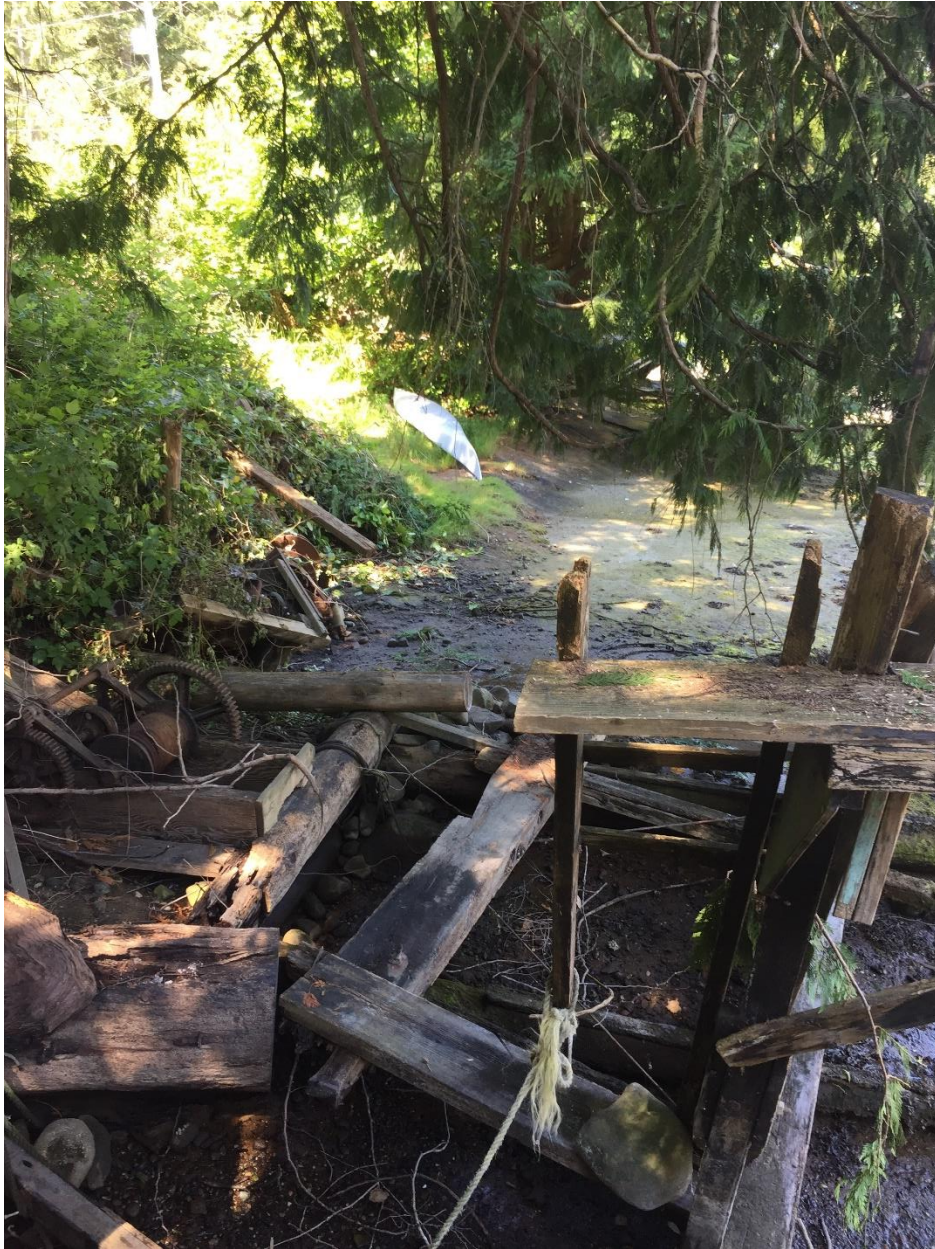
*Figure 15 Abandoned docks, machinery, and timber at the site of the old logging lease in Whaler Bay.*

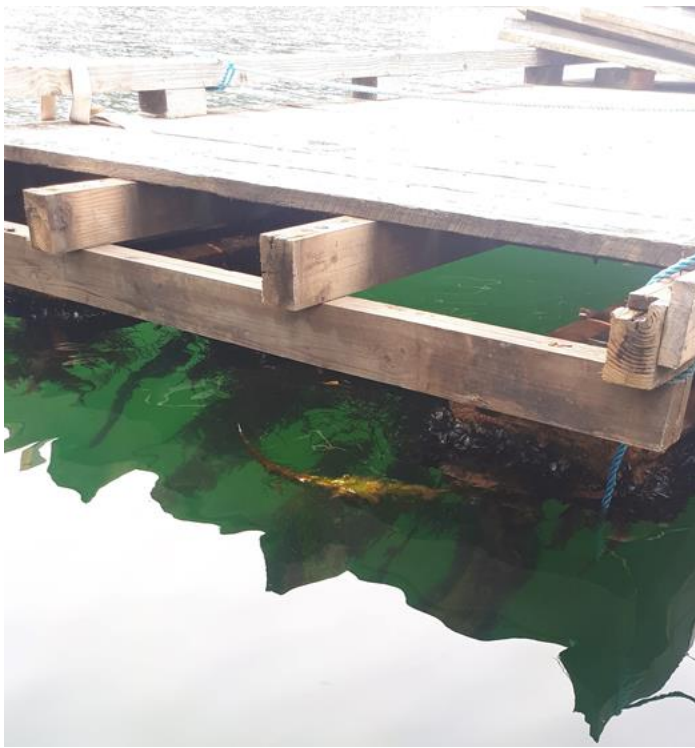
SAV (FLNRORD, 2018). Furthermore, eelgrass is rarely found thriving under docks (Burdick and Short, 1999; FLNRORD, 2018). The biomass of seagrass is reduced under

docks, and the seagrass that is present is inefficient as it compensates for the lack of sunlight by increasing blade chlorophyll content and length compared to unshaded areas (Shafer, 1999; FLNRORD, 2018). Dock piling and dock structures also change water flow which can cause scour, erosion, and sediment deposition which can have extremely negative effects on eelgrass

*Figure 16 A dock in Whaler Bay, casting a dark shadow unto the water.*

There are 13 active residential dock permissions in Whaler Bay; however, it is not uncommon for docks to be constructed without gaining crown permissions. With the ever-increasing value of ocean-front housing it is likely that dock construction will continue to persist. We recommend education for the community on less harmful docks, anchorage, moorage, and approaches to construction.

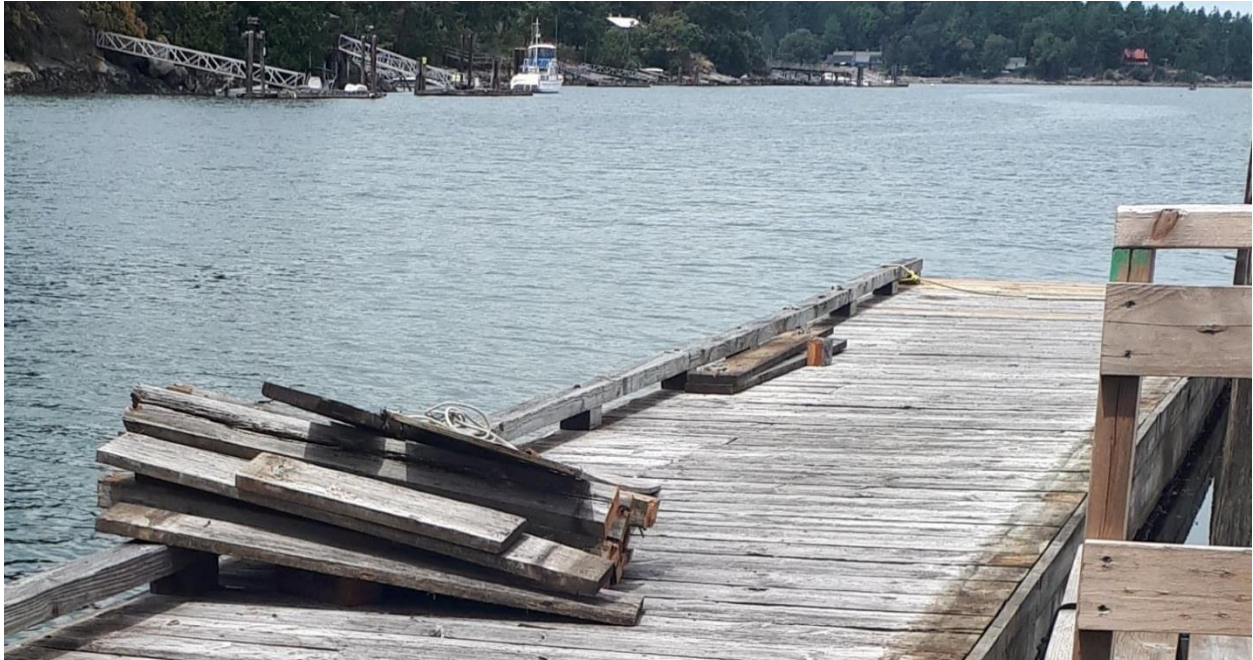
*Figure 17 A public dock piled with treated wood is evident in the foreground of this picture of Whaler Bay, while various residential docks and vessels rest in the background.*

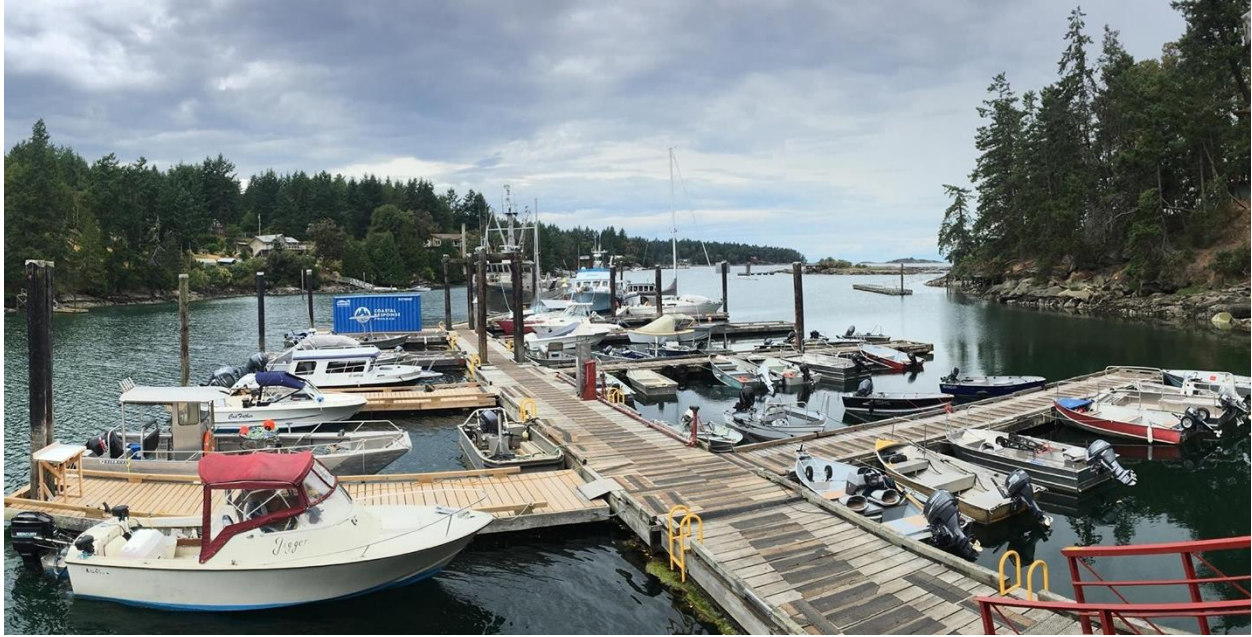
Whaler Bay is a popular recreational site, with motorized boats being particularly common in the area. Boat propellers, traditional anchorage traditional moorage can cause direct damage to *Z. marina* resulting in the loss of vegetation cover and consequentially substrate instability. Substrate instability then increases silt content and decreases visibility in the water, which in turn diminishes the likelihood of recovery for damaged SAV and the reduces the ability for existing eelgrass to photosynthesize (FLRNORD, 2018).

*Figure 18 The public dock in Whaler Bay, showing a diversity of commercial and personal boats.*

We recommend the educational sessions on sustainable boating practices and conservation anchorage and moorage be provided to the community. Conservation mooring reduces the habitat impact mostly by reducing the contact between the mooring components (chains, anchors, etc) and the seafloor.

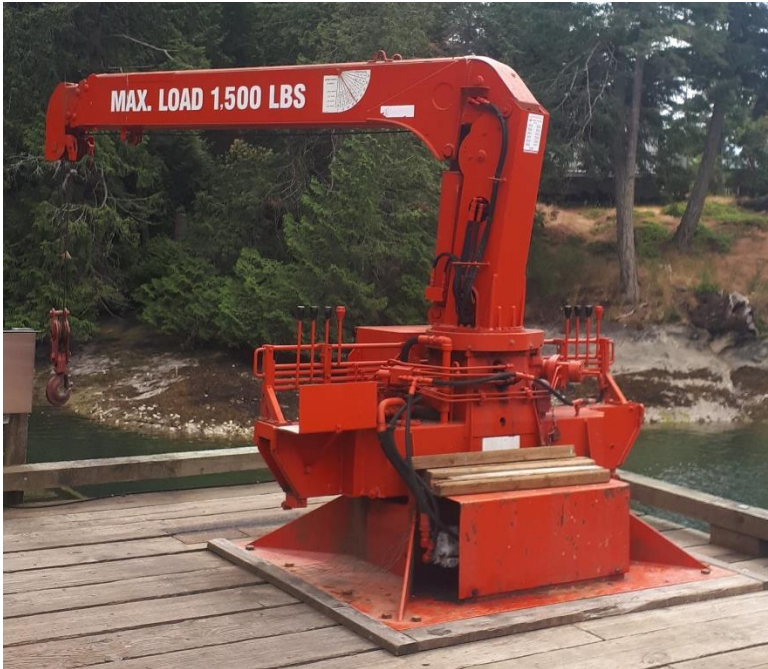
*Figure 19 An industrial lift located on the Whaler Bay Public dock, indicative of heavy commercial and federal dock use.*

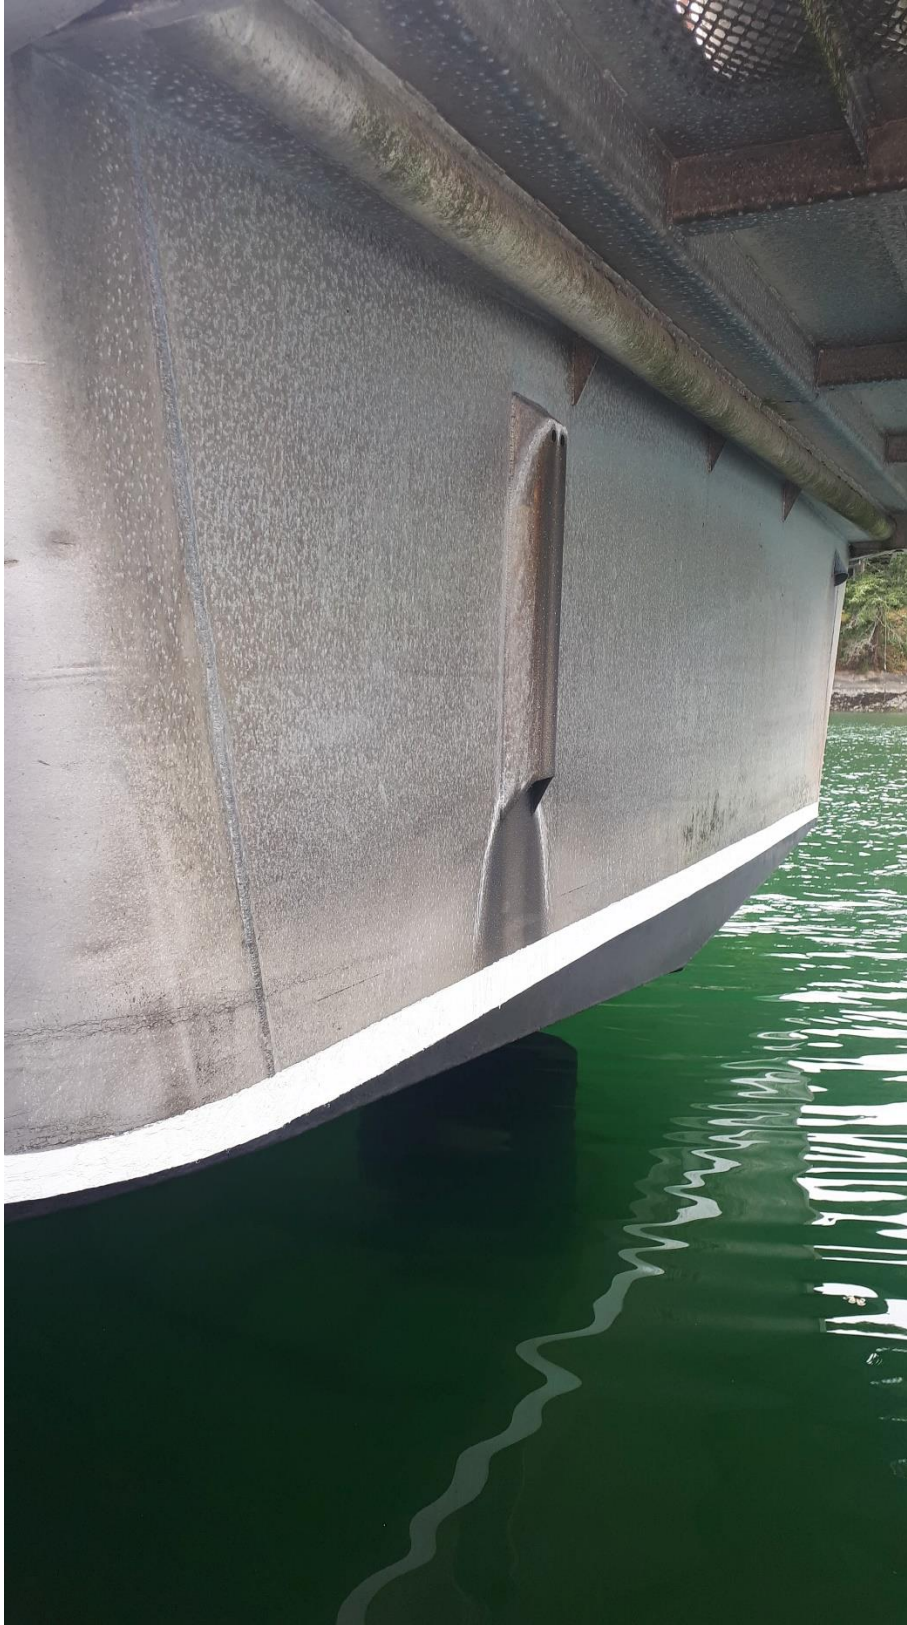
*Figure 20 Note the large shadow cast by a commercial fishing boat at the Whaler Bay public dock, inhibiting photosynthesis.*

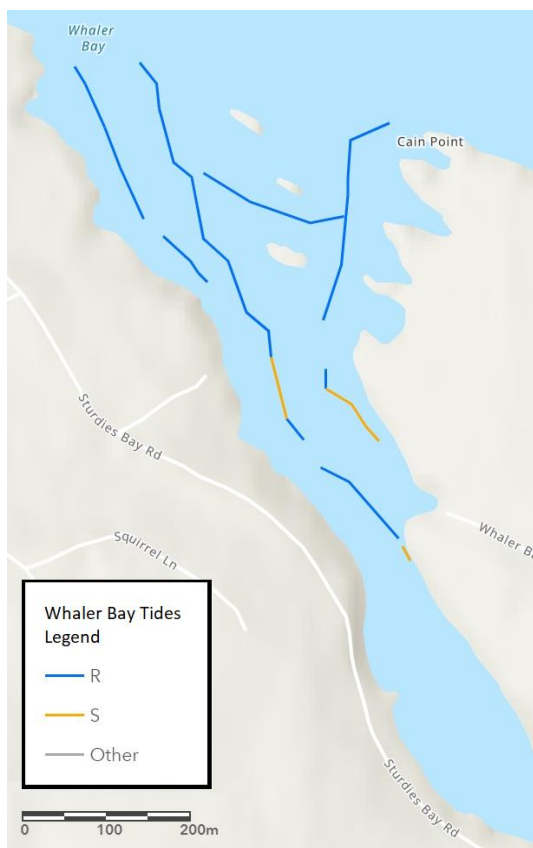
It is important to consider the wave energy, currents, and tides of a transplant site when planning eelgrass restoration. High wave energy and strong currents can dislodge *Z. marina* shoots and creates an environment in which eelgrass may not be able to establish itself (Paulo et al., 2019). Tides are also a necessary consideration as *Z. marina* in the intertidal zone vary compared to *Z. marina* in the subtidal zone: the donor site must match the tidal zone of the transplant site (Paulo et al., 2019). Whaler Bay site does not have notably strong currents nor wave energy; however, the majority of the tides in Whaler Bay are running (as opposed to slack), which can increase the likelihood of error of percent of eelgrass cover predictions and thus extra care is necessary in monitoring eelgrass beds in running tides (Figure 21). Low tide at Whaler Bay reveals a lifeless mudflat in the southern arm, however the two priority eelgrass restoration sites are farther up the bay in the subtidal zone.

Figure 21 Tide patterns of Whaler Bay, describes whether the tide is running (R) or slack (S).

We recommend that the wave energy and current in Whaler Bay be tested and recorded, and that the wave energy, current, and tides from the donor site match the wave energy, current, and tides in Whaler Bay priority restoration sites as closely as possible.

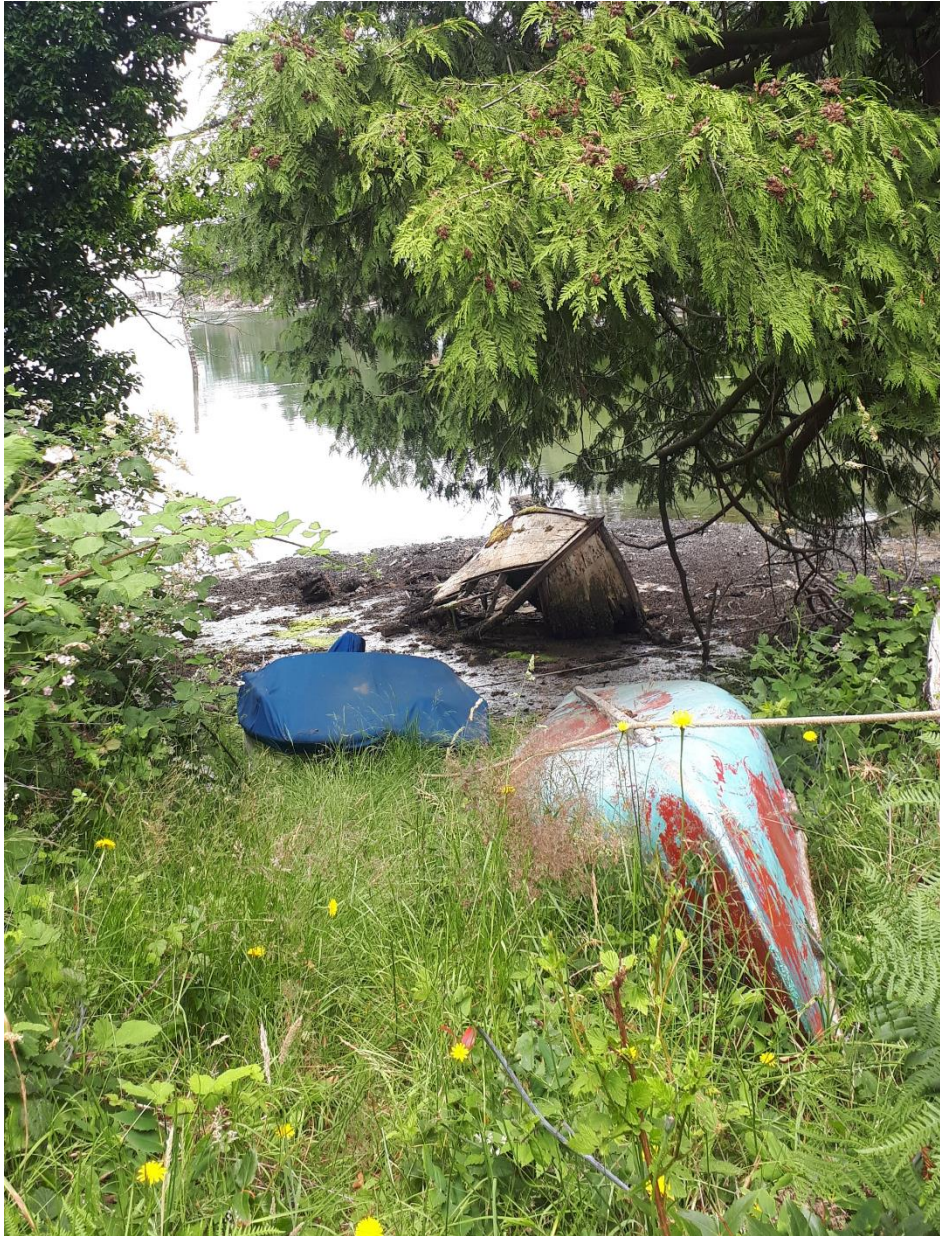
The riparian zone of the banks of infeeding creeks and other draining is important to consider at Whaler Bay as shoreline vegetation works to stabilize cliffs and shoreline sediment and filter road runoff. Without a healthy riparian zone silt and sediment will easily be carried into the water and slopes along the bay may collapse. Furthermore, riparian zone vegetation works to filter water and runoff from the road. A multitude of riparian zone vegetation can sequester heavy metals and other pollutants from runoff before it enters the bay, befittingly many of these heavy metals are leaked from automobiles in the form of oils and fuel (Evans, Ryswyk, Los Huertos & Srebotnjak, 2019). In comparison, constructed barriers, while they do work to stabilize the shore, can cause water flow to change and thus increase scour, erosion, and sediment deposition which inhibits photosynthesis and decreases the likelihood that *Z. marina* will thrive. Any coastal land alterations can inadvertently cause increased siltation and thus inhibit sunlight penetrating the water and photosynthesis.

*Figure 22 Riparian zone vegetation and marine debris at the south end of Whaler Bay.*

We recommend the riparian zone vegetation be analyzed for health, ability to stabilize the shoreline, and ability to filter runoff. If the riparian zone is in need of restoration, we suggest planting native vegetation that are known for their ability to absorb heavy metals from road runoff and that are known to be beneficial at stabilizing banks.

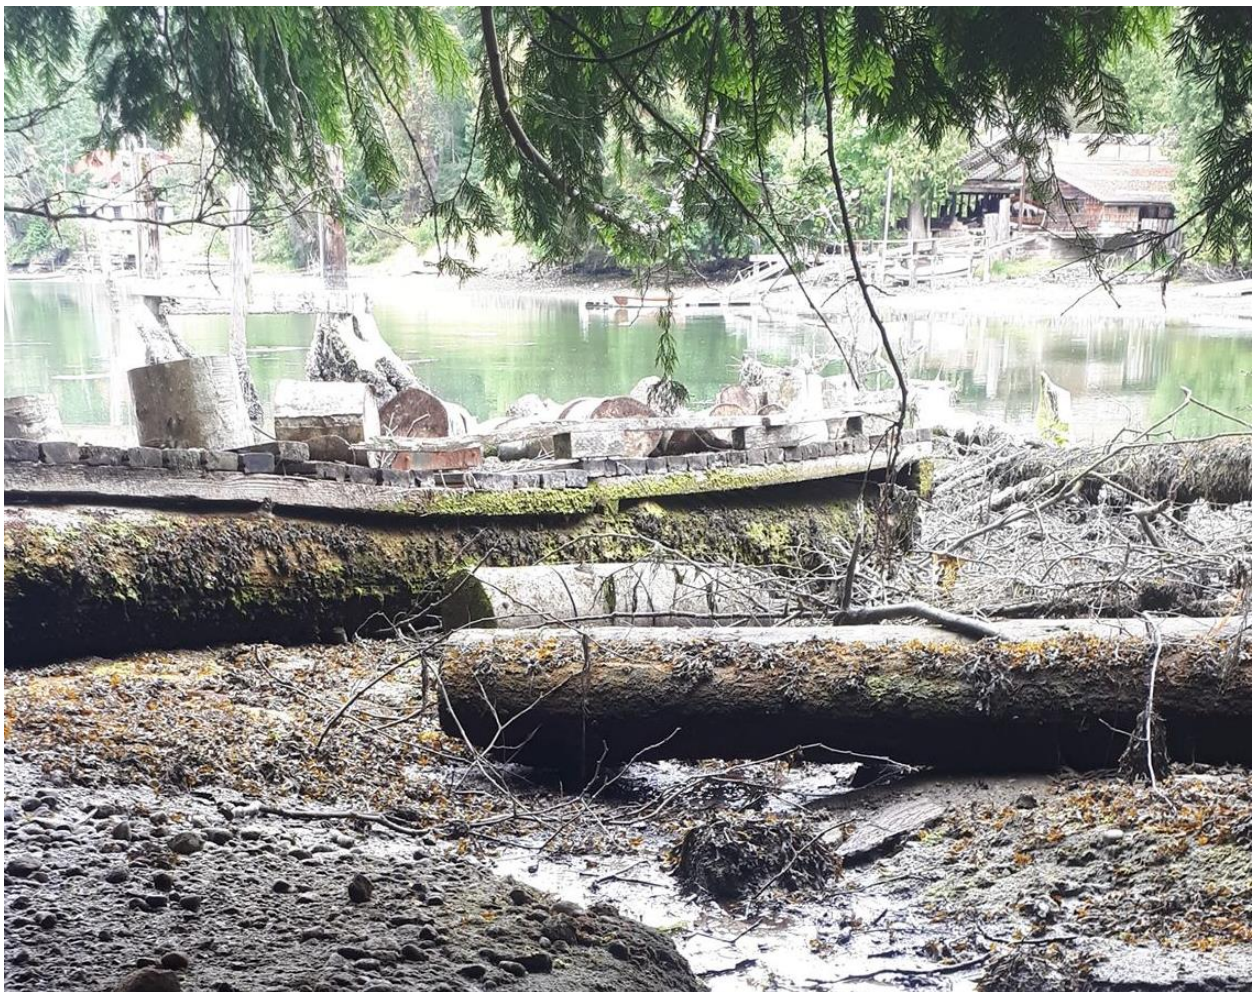
*Figure 23 Logging debris and abandoned infrastructure at the old log storage site in the Southern Arm of Whaler Bay.*

The inorganic fertilizers and chemical pesticides that are associated with the logging industry also likely have a negative effect on eelgrass habitat, we recommend testing the water in the bay for chemical pollutants (Campbell, 2017). Fertilizers promote the growth of aquatic algae and specific plants, which leads to lowered levels of oxygen as bacteria breaks down plant matter (Campbell, 2017). Additionally, chemical pollution from treated wood, dock and boom construction from the log storage site is likely taking place at Whaler Bay (see s4.4).

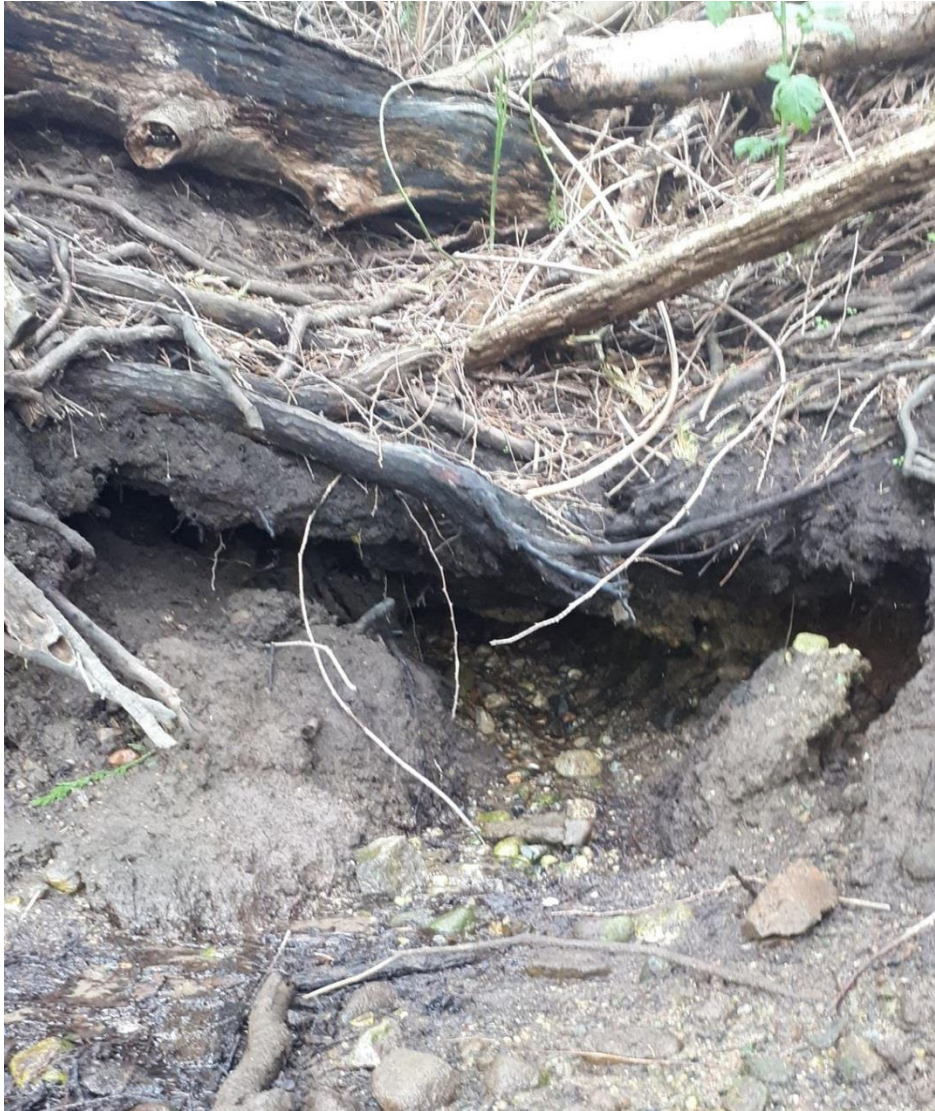
*Z. marina* often thrives in estuaries, where fresh water and salt water mix. Sites with freshwater creeks, rivers, or streams are ideal for eelgrass restoration; however, fresh water sources can also carry contaminants from land activity (agriculture, logging, urban use, automobile pollutants) into the bay. There is a small, seasonal creek running into Whaler Bay (Figure 24) which indicates that Whaler Bay may be an ideal restoration site for *Z. marina*, however, the creek runs through several watersheds, one which includes an agricultural land reserve (Figure 25) and others that house the heavily developed urban area of Whaler Bay.

*Figure 24 The creek that feeds in Whaler Bay, reappearing from where it was diverted under the road.*

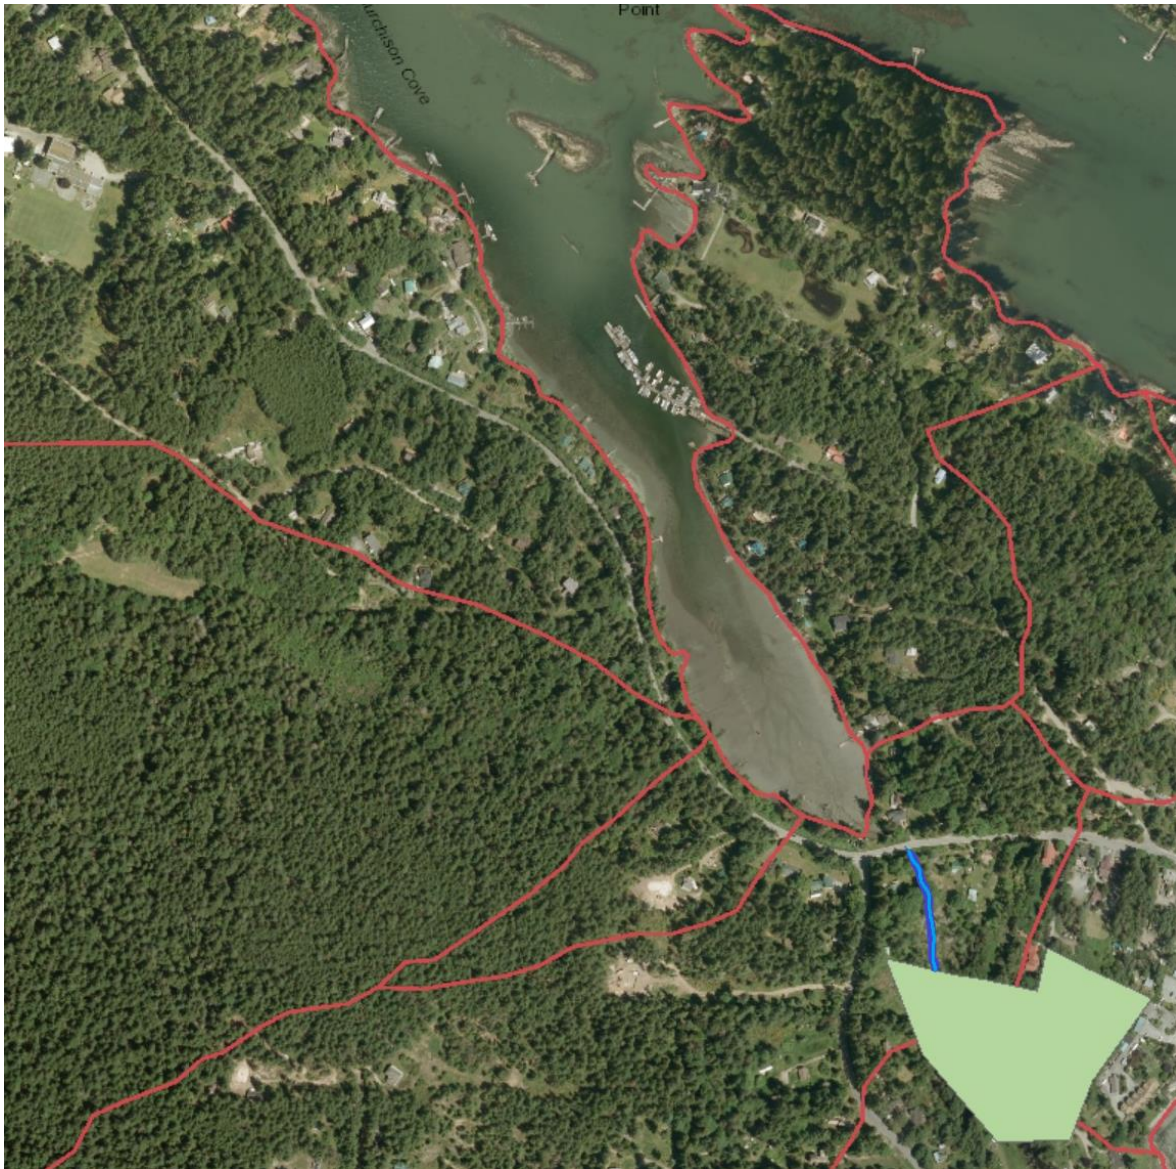
Figure 25 Watersheds (outlined in red), streams (blue lines), and agricultural land reserve (light green shape) in the Whaler Bay area.

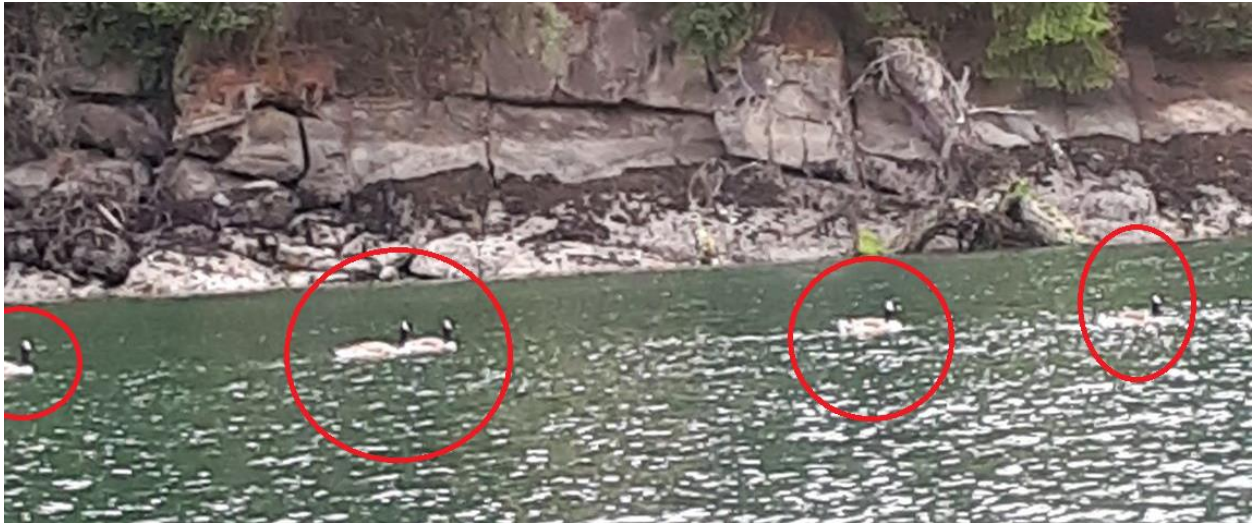
Figure 26 Canadian geese, a migratory bird species that grazes on *Z. marina*, in Whaler Bay.

We recommended that, due in part to the presence of migratory birds, eelgrass restoration in Whaler Bay concentrate on the subtidal zone. Furthermore, the community should be engaged in education on invasive species carried by boats, and how to prevent spreading them.
