Participatory Restoration of the Mill Site Galiano Learning Centre

Technical Report 2014

Restoration of Natural Systems
ER390

Prepared by: Vincent Hamann-Benoit
on behalf of the Galiano Conservancy Association

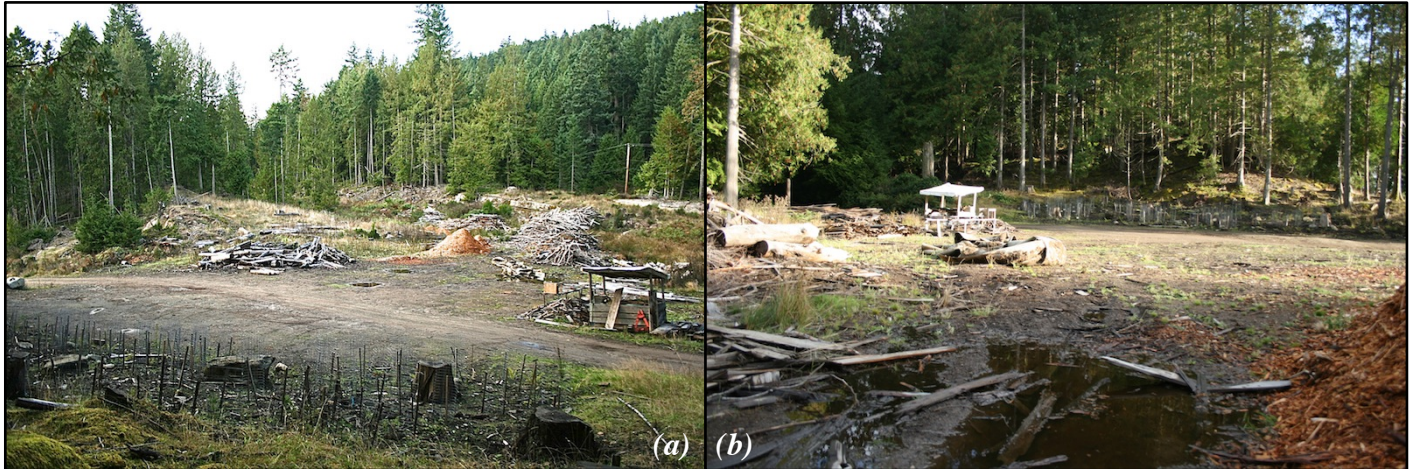
Figure 2. (a) Looking north at the Mill Site; (b) Surface pooling due to soil compaction (Photos taken on September 22nd, 2013)

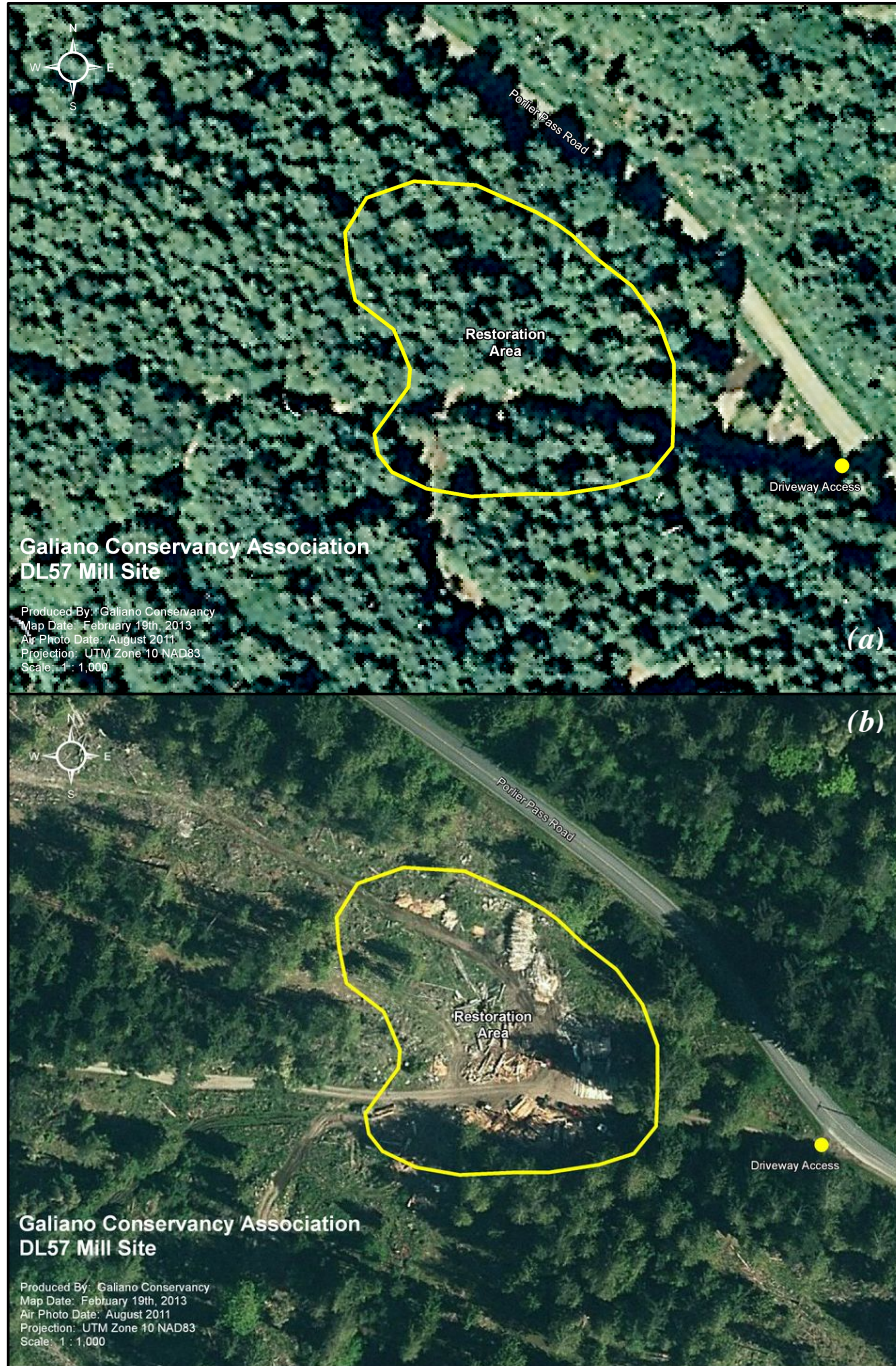
Figure 3. Aerial photographs of the Mill Site dating from (a) 1998 and (b) August 2011

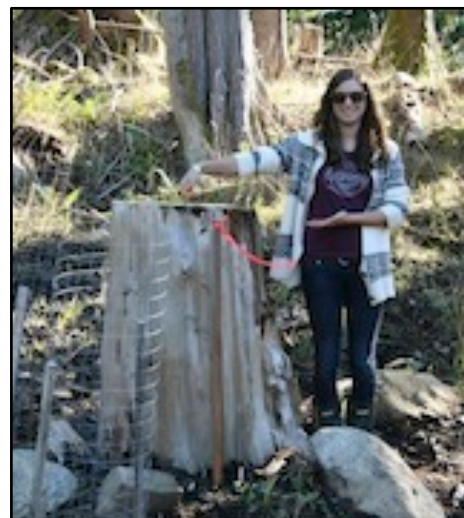
Figure 4. The benchmark of the Y-axis is the pith of this stump

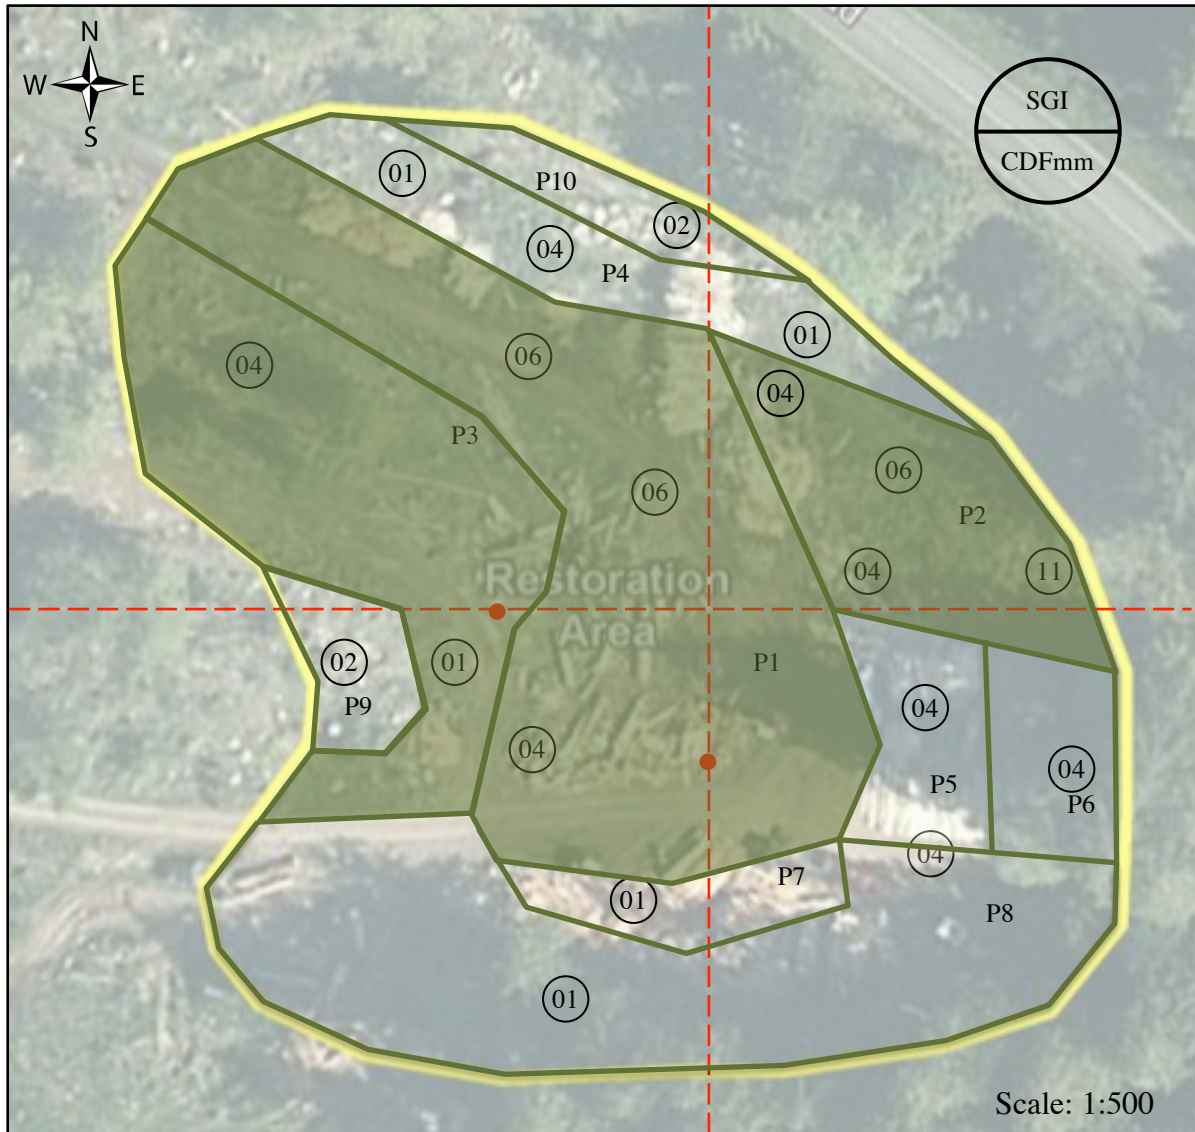
Using the geo-reference grid and my ground observations of soil and vegetation, I created a map including 10 ecological communities (polygons), as shown in Figure 5. The following table summarizes the key ecological characteristics of these 10 communities, as found when I conducted the baseline assessment in the fall of 2013. The table also includes the assumed site series and their relative proportion based on my observations of soil and vegetation characteristic

Figure 5. Ecological communities of the Mill Site. The shaded polygons represent the central area (P1), the wetland edge (P2), and the dry slope (P3). These are the three areas where detailed vegetation inventories were conducted. The circled numbers refer to the site series of the CDFmm BEC subzone. SGI refers to the Gulf Islands Ecosection. Many of these polygons encompass more than one site series. The dashed lines represent the X and Y-axes used to geo-reference the baseline assessment. The red dots mark the 0m mark on the axes. Note that the wetland extends to the right, beyond the boundary shown on the figure.

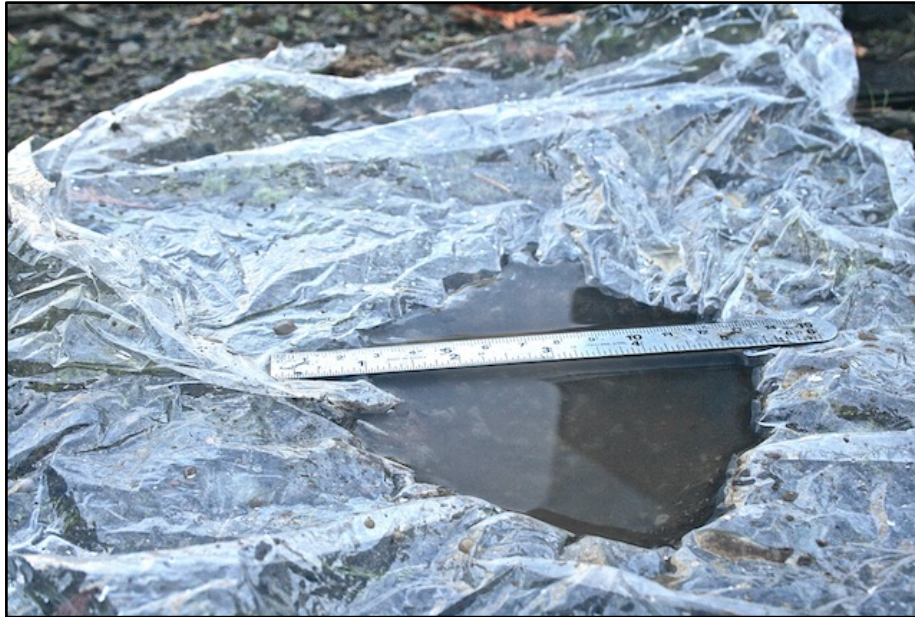
In order to quantify the degree of compaction, I used the soil excavation and replacement method described in Maynard & Curran (2007), using water instead of glass beads for measuring the volume of soil sampled, an alternative approach validated by Doug Maynard (D. Maynard, personal communication). I used a modified clod method to measure the bulk density of three soil clods sampled in the most compacted area of the site². However, the clods were not covered with paraffin, and the amount of water absorbed by the

Figure 6. Measuring bulk density using the soil excavation and water replacement method. I used a ruler to ensure that the cavity was completely filled with water. *Photo taken on October 29th, 2014*

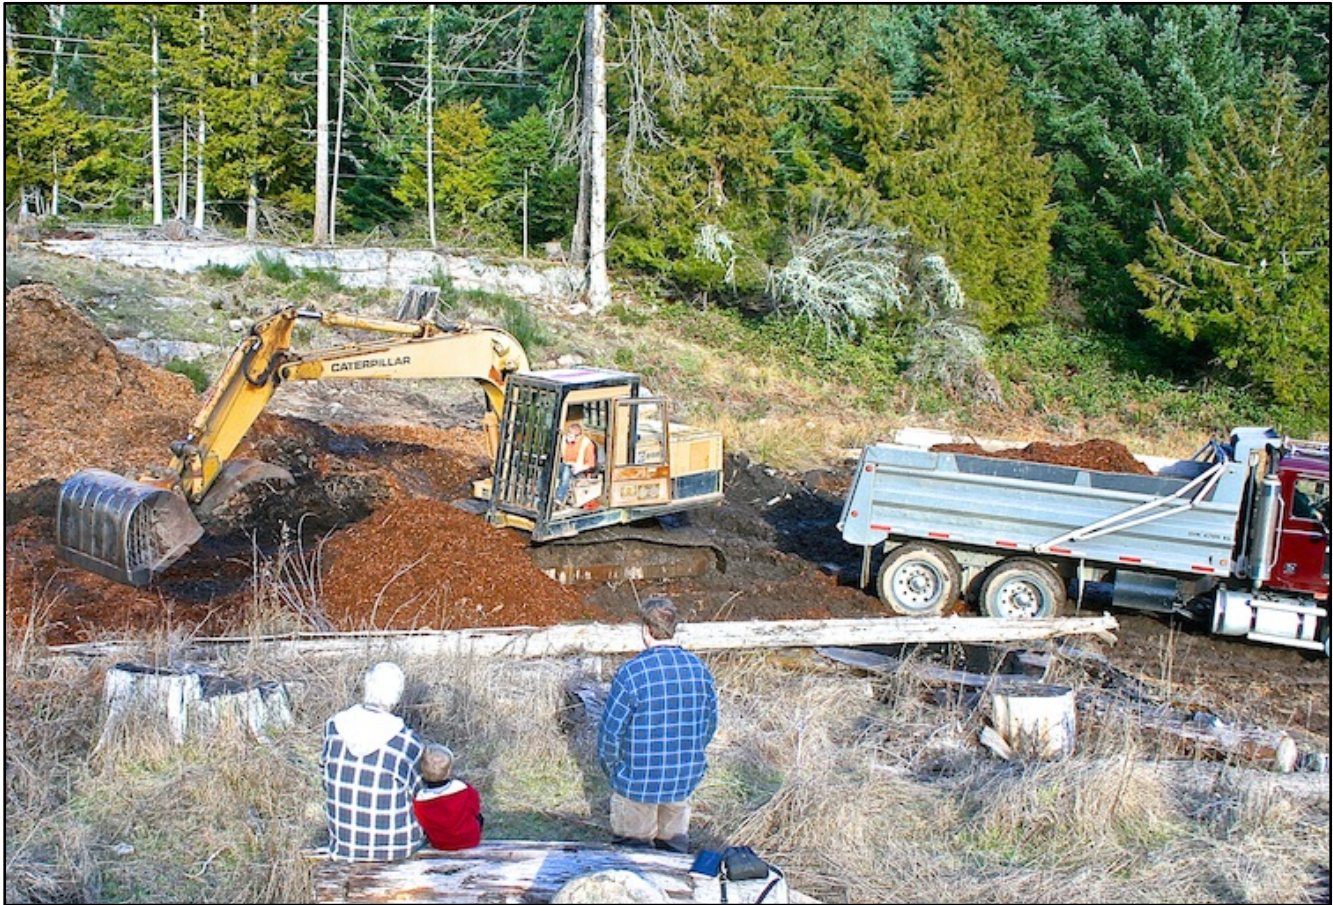
Figure 7. Restoring for posterity; excavator work never fails to impress, regardless of the generation (Photo taken on February 14th, 2014)

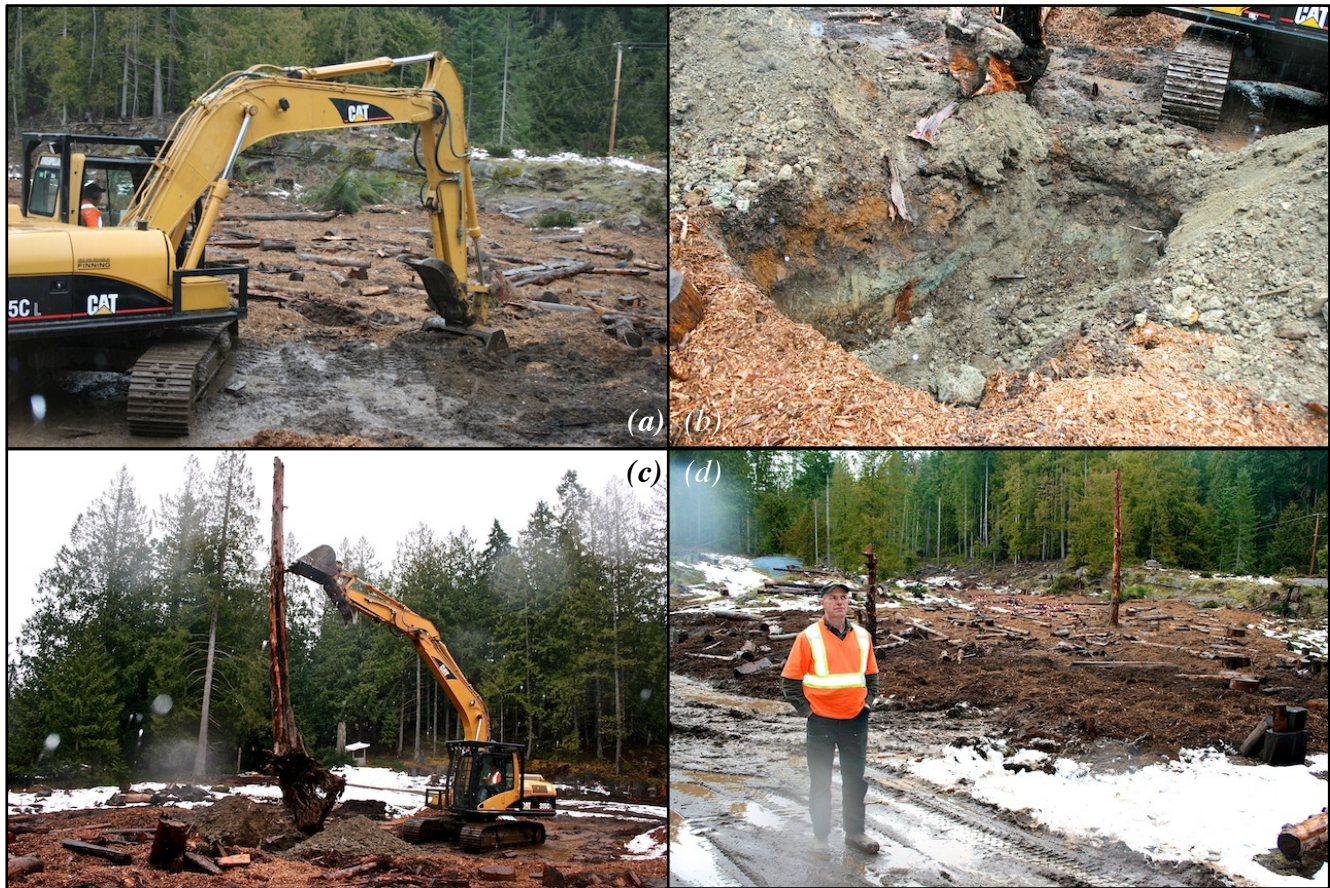
Figure 8. (a) Rough and loose de-compaction, with the excavator bucket reaching about 1m in depth; (b) 2m-deep pit dug for anchoring a snag in the ground. Considering that pools of water were covering the soil surface, the absence of water in the excavation confirms that there was very little subsurface percolation, probably due to a combination of anthropogenic surface compaction and the natural occurrence of a restricting layer, the blue clay horizon visible at mid depth; (c) a 15m-tall snag being installed in the ground; (d) proud excavator operator Fred Stevens, ‘hero’ of the day (photos taken on March 4th, 2014)

The compacted areas of the site, corresponding to the central area and a small section of the skid trail going north from the site, were de-compacted to a depth of 1m by Fred Stevens, using a Cat 315 excavator and following the ‘rough and loose’ method described in Polster (2013). He reached the edge of Polygon 3 to the west, and the edge of the established common rush population along the wetland edge. The ‘rough and loose’ approach has the advantage of increasing the topographic heterogeneity of a site, greatly improving infiltration and creating a multitude of microsites

that can support a diverse array of plant species (ibid). The method consisted in using the digging bucket of the excavator to open holes in the soil, releasing half the soil back in the holes, and half in between, spacing the excavations by half a bucket width. Also, care was taken when excavating the holes to shatter the material between them. The process of making the holes and releasing the soil was continued until the reasonable operating swing of the excavator was reached. Fred Stevens then backed up with the excavator by about the width of a hole, and repeated the process, making sure to line up the holes in the new row with the space between the holes and mounds on the previous row. This resulted in a ‘rough and loose’ configuration, or a mosaic of mounds and depressions throughout the surface of the site.

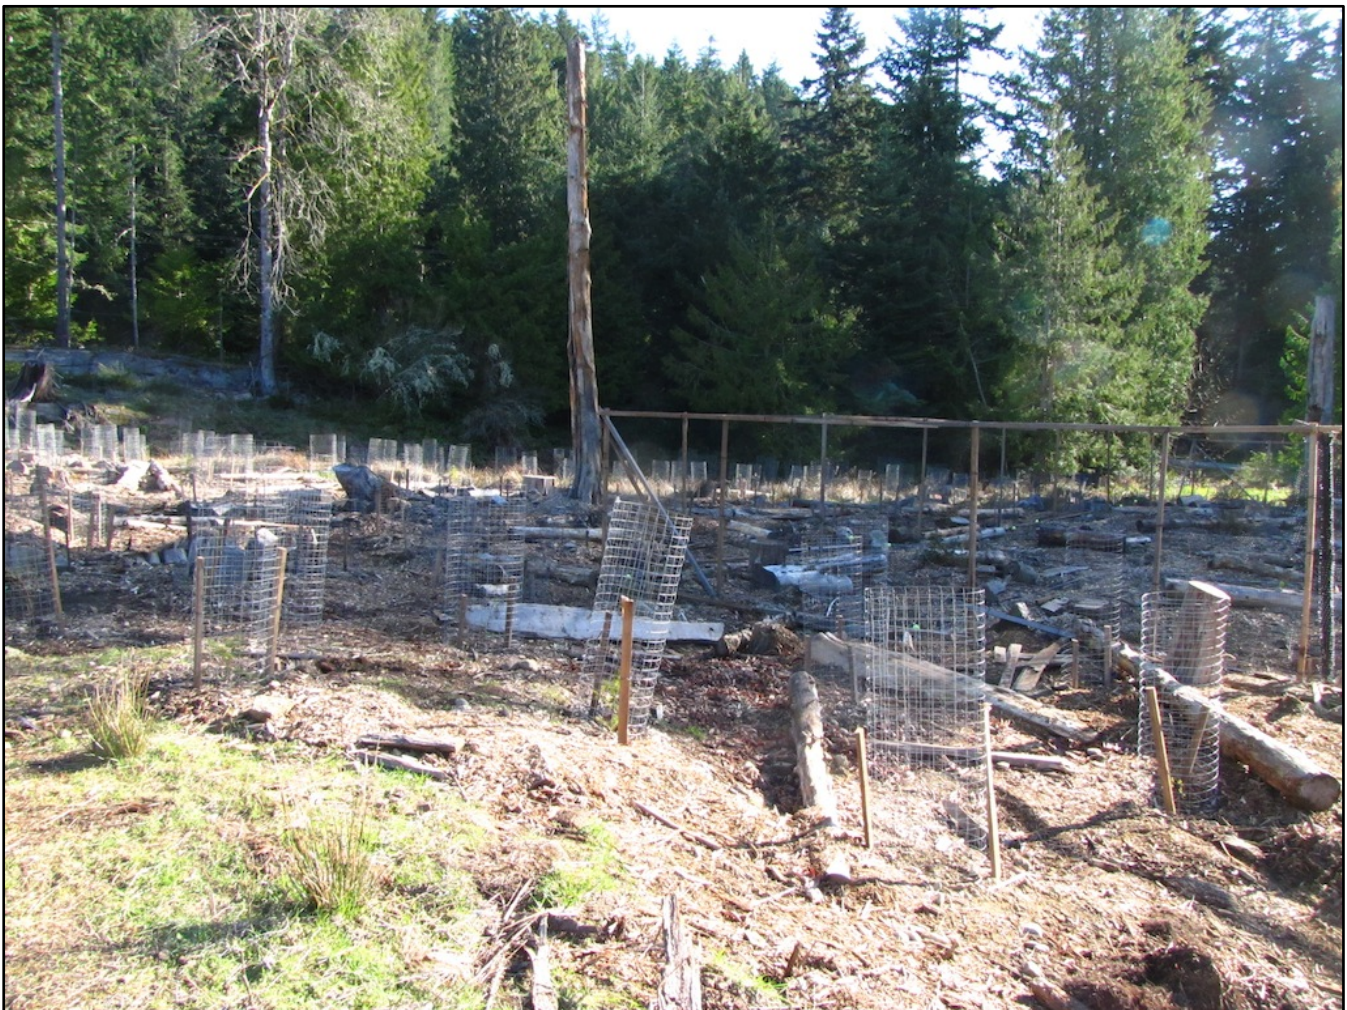
Figure 11. Foreground: individual 1.3m-high cages installed around the nursery plants; background: 7-feet tall deer enclosure installed around the experimental plot. Note that the black deer mesh is not visible on the photo.

A seven-foot black plastic mesh deer fence was installed around the perimeter of the experimental

area, with 2 x 2-inch cedar poles positioned every 10 feet. The corners were braced and the tops joined with 1 x 2-inch cedar poles. The installation was completed during the week of March 24th, 2014.

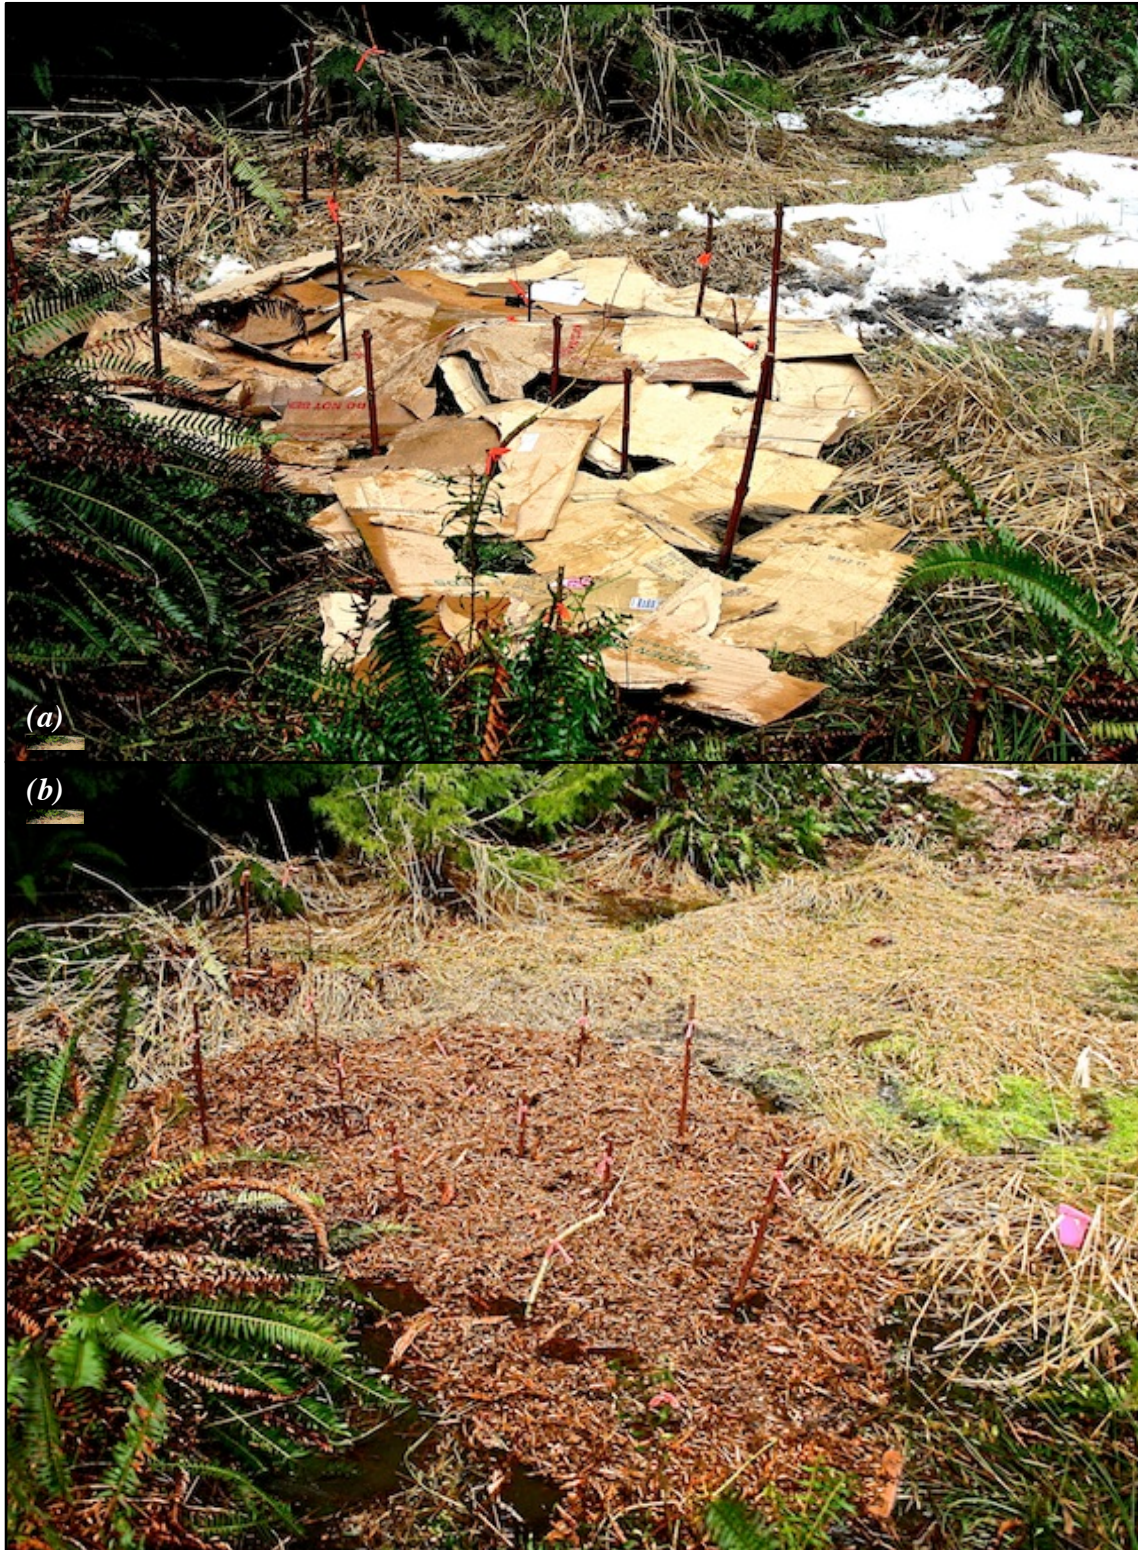
Figure 12. An attempt at controlling the spread of reed canarygrass by creating a shade barrier with live stakes and sheet mulching; reed canarygrass population in the background. (a) Corrugated cardboard layer; (b) 8-10cm-thick mixed woodchip layer laid on top of the cardboard. *Photos taken on March 4th and 5th, 2014*

Only a minority (< 20%) of the live stakes used in the project have thus far been protected from

deer browsing with the cylindrical cages, and it would certainly be advisable to increase this proportion. Also, incrementally extending the shade barrier into the reed canarygrass population by incorporating more live stakes (preferably including a higher proportion of willows in the future) would certainly contribute to controlling the spread of the species. It must be remembered however that reed canarygrass is wide spread on Galiano Island, and extensively present on DL57, especially along ditches near the Cove. Hence, the propagule pressure will remain strong, and continued efforts might be necessary to prevent it from dominating the wetland, at least until a well-developed canopy is established.

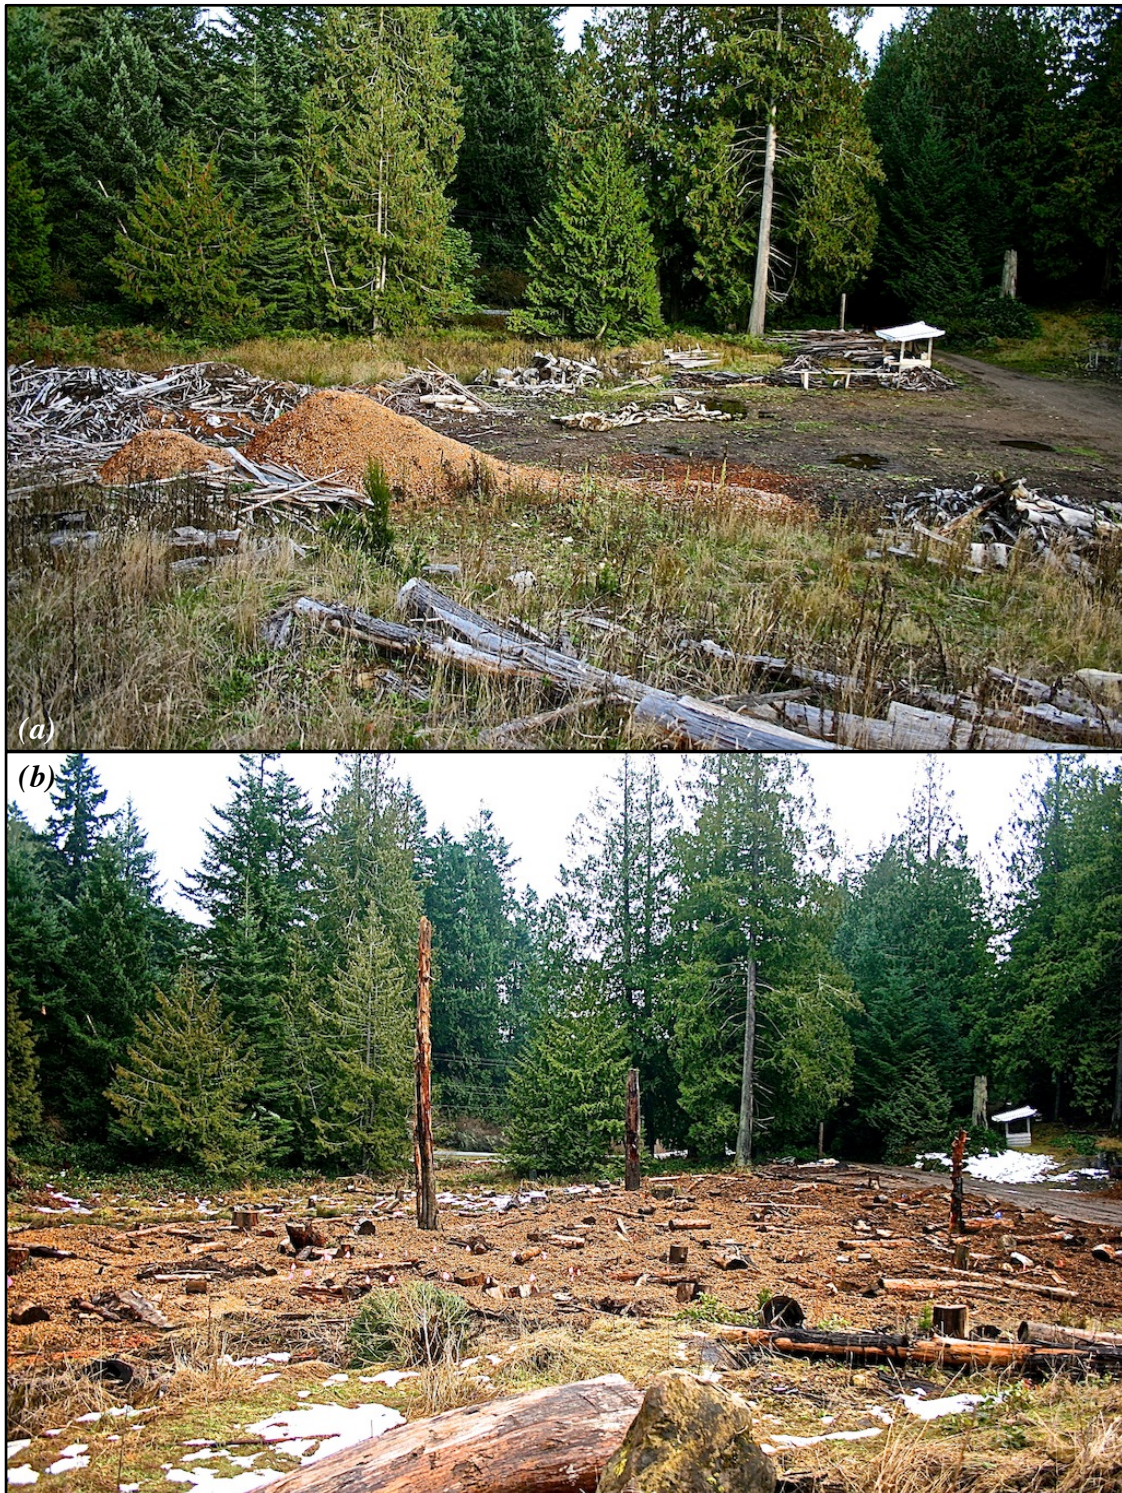
Figure 13. Approximate repeat photographs taken on (a) September 22nd, 2013 and (b) March 5th, 2014. The three snags are visible on the bottom photograph. Note that these photos are not the official photopoint monitoring ones, but personal picture I took during the project, explaining the slight deviation in angle.

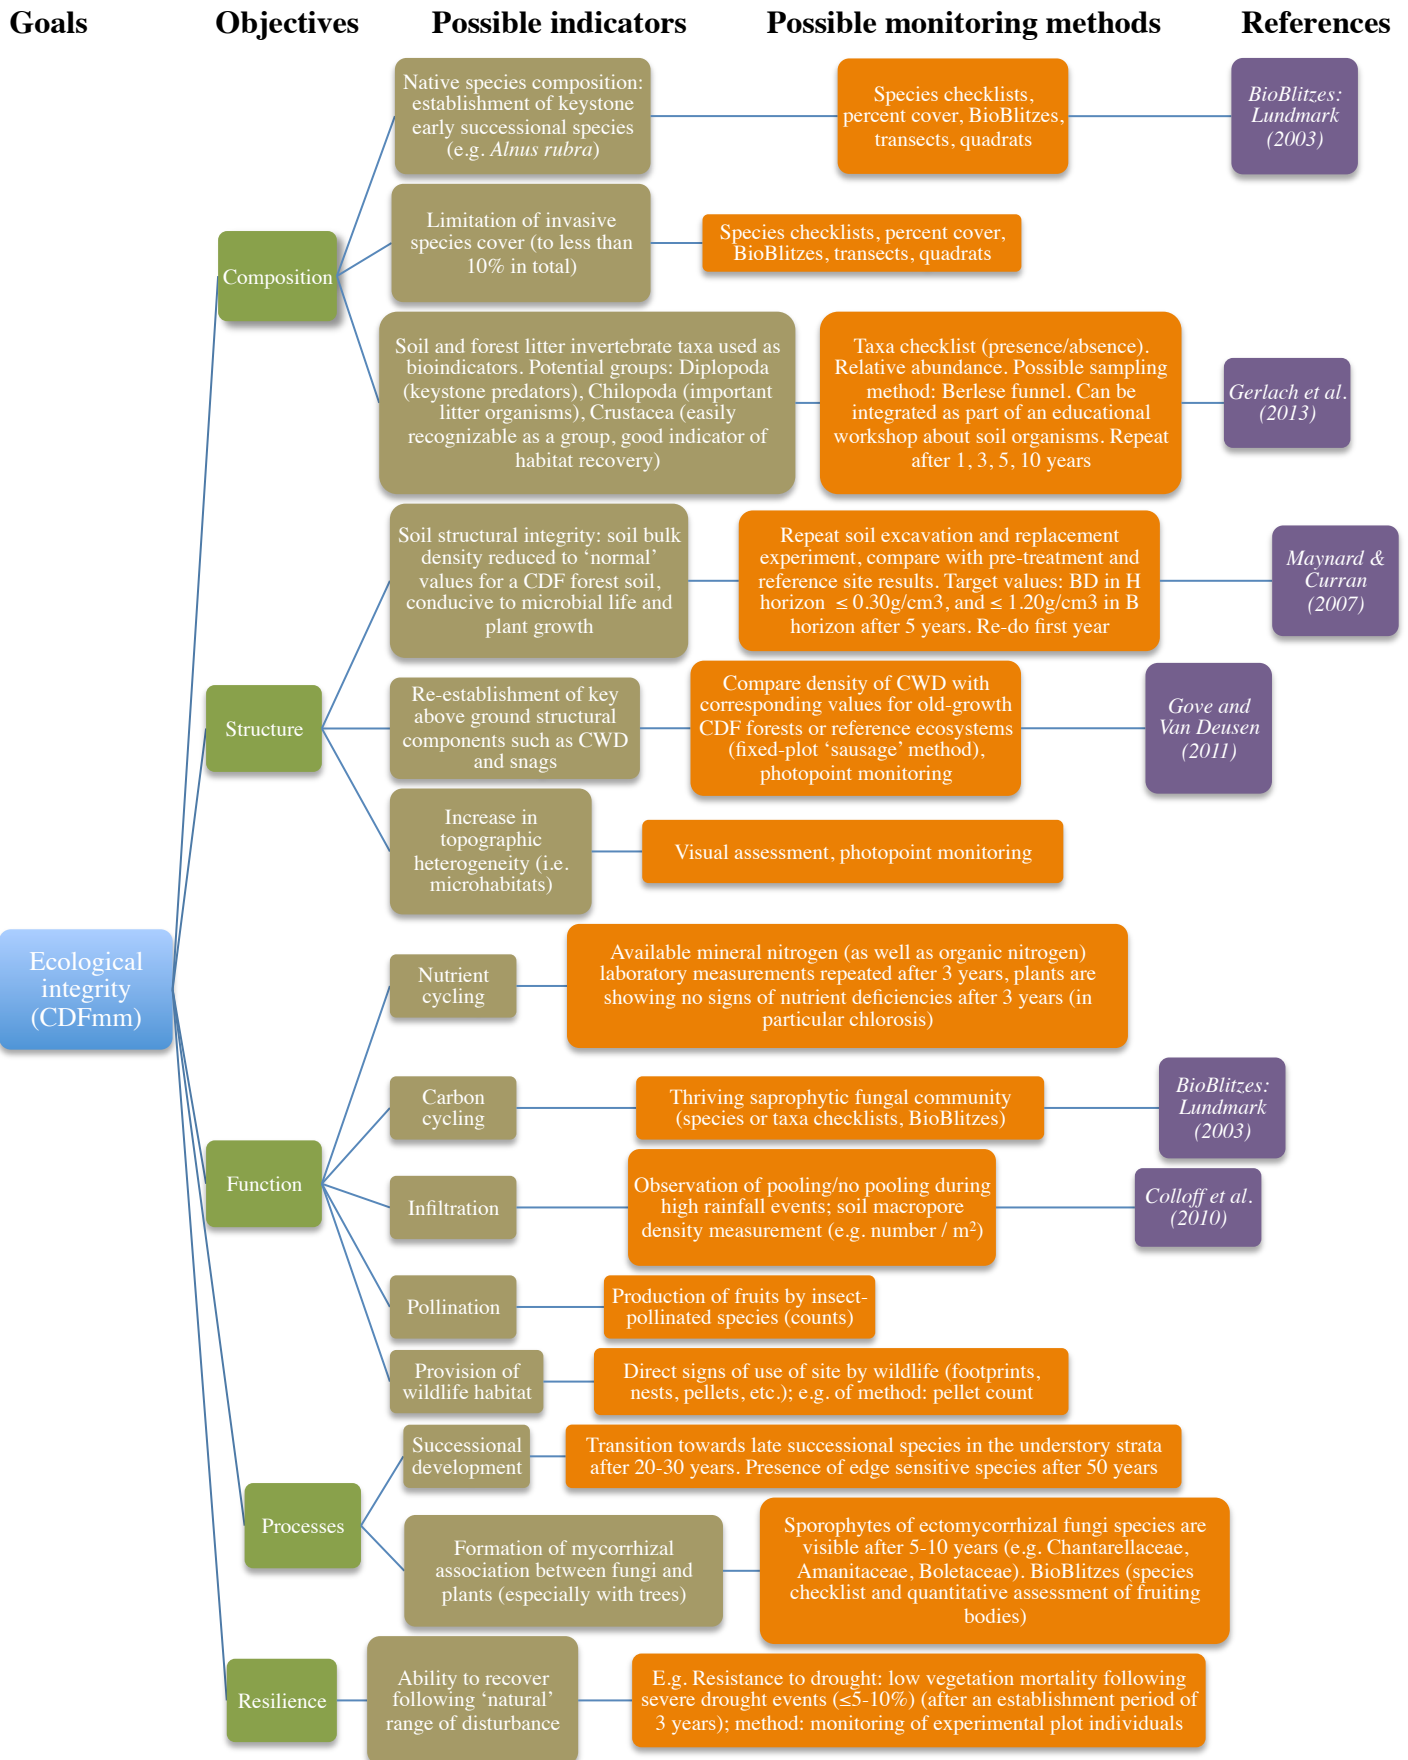
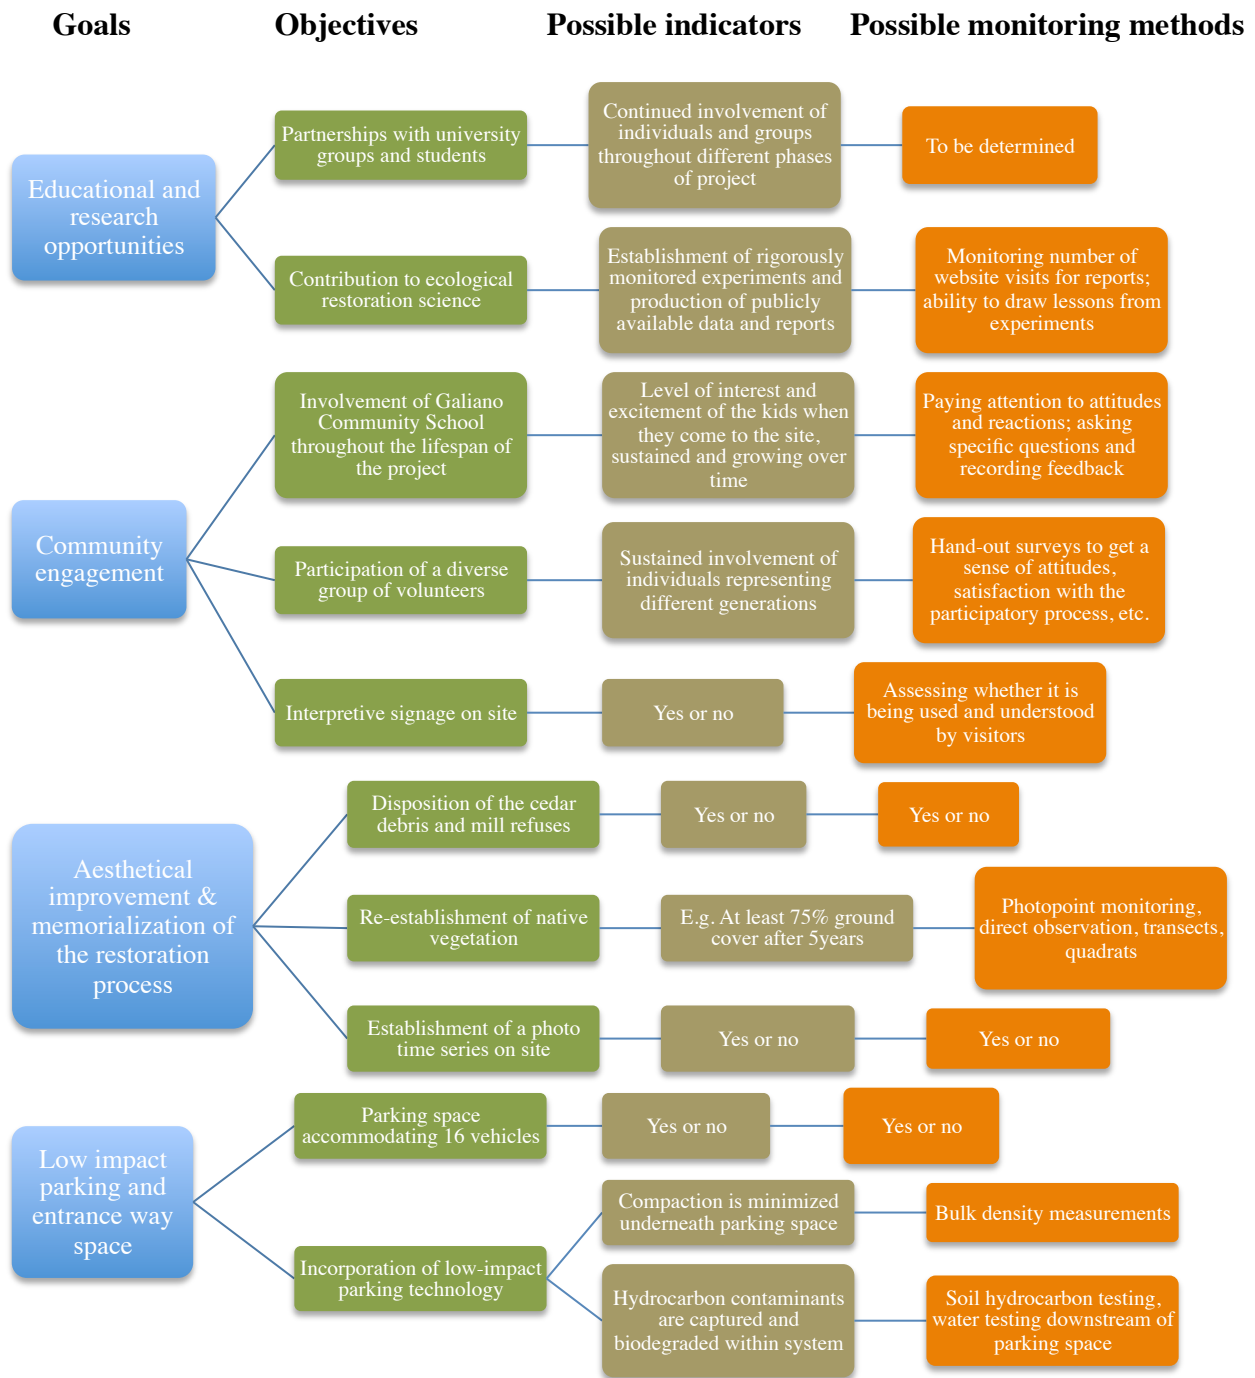
Figure 14. Conceptual framework for monitoring and evaluating the success of the restoration process

Figure 14 (continued). Conceptual framework for monitoring and evaluating the success of the restoration process

Monitoring is an extremely important, yet often overlooked phase, in any ecological restoration project. In Figure 14, I recommend a conceptual model to help guide the future monitoring of the Mill Site. I include two ecosystem functions that were not mentioned as part of the objectives, pollination and the provision of wildlife habitat, as these are critical to proper ecosystem functioning and may prove relatively easy to monitor.

Figure 14 presents the 25 proposed indicators and accompanying monitoring methods. The monitoring framework is structured in function of the goals and objectives that were initially established for the project, and I based myself on Box 24: ‘When has restoration succeeded’ in Keenleyside et al. (2012). References and a possible monitoring schedule are provided for some of these indicators.
