Seasonal Creek Mapping and Restoration Project
District Lot 57 Galiano Island

By: Marcus Messner and Christian Caillé
Galiano Island Conservancy

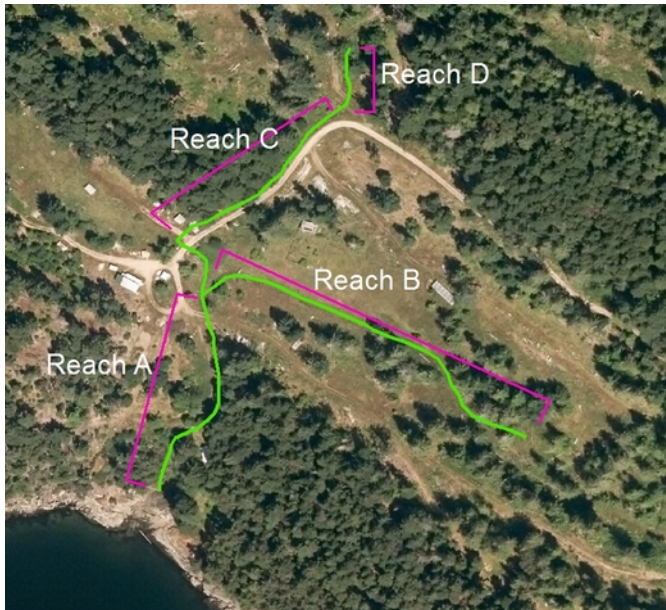
The current creek has been labeled used an alphabetical reach system, A, B,C, D. The DL 57 Baseline flora and fauna was compiled by Andrew Simon and Keith Erickson and has been referenced bellow

Figure #) Creek Reaches of DL 57 seasonal creek

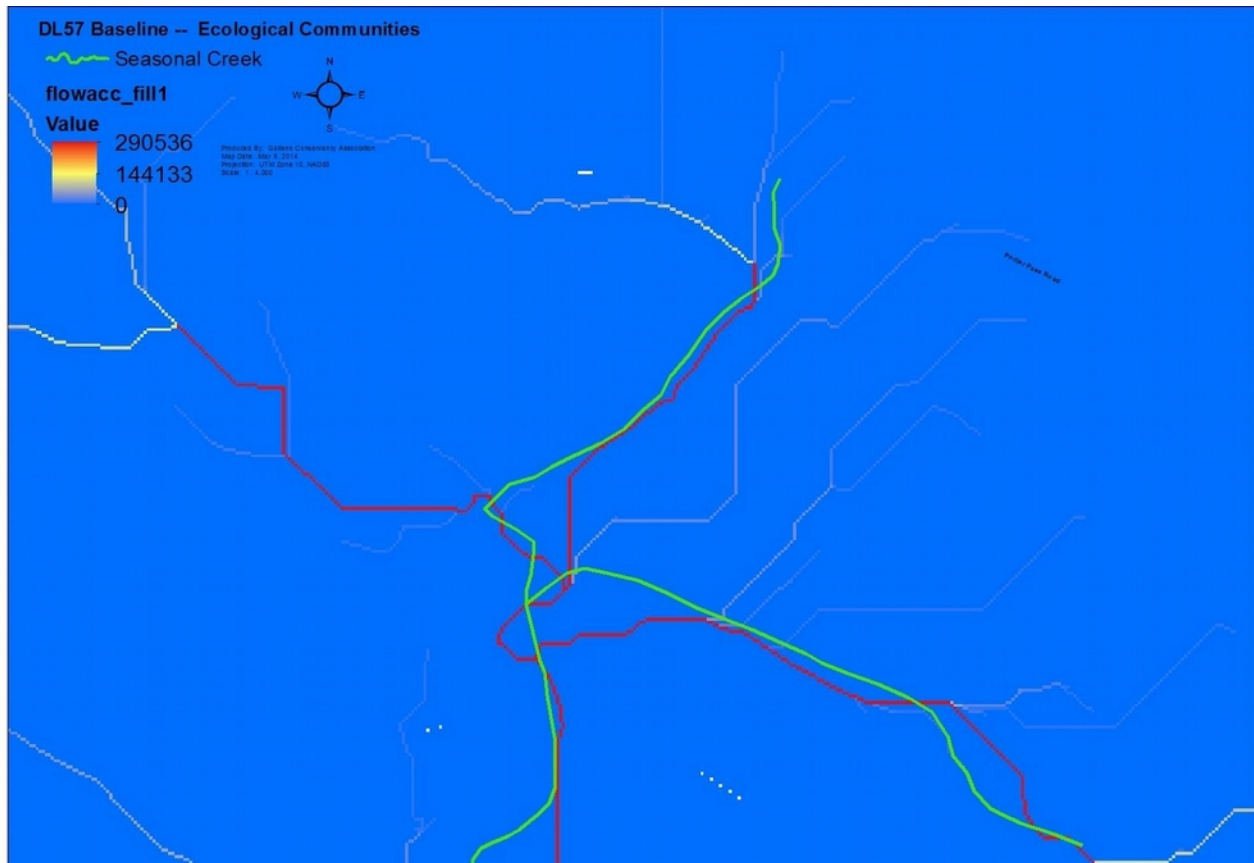
Using Arc GIS and existing data, a flow accumulation map was produced of DL 57. The map was produced in order to determine the true location of the reference creek. While the current creek is

noted in green as “Seasonal Creek” while the areas of high flow are in red. It is important to note that the existing creek is ditched, culverted, and has been drastically altered through human intervention. Additionally, the flow accumulation map is not intended to produce the true reference creek, merely a baseline for comparison purposes. This was concluded as the DEM is skewed due to human modification of the land, such as slope alteration, road infrastructure, land use modification, etc. These factors will influence how the DEM determines the slope, thus impacts for flow direction and accumulation. In order to ensure the proper orientation of the creek, we used the DEM as well as manual elevation profile.

Figure #) DEM of flow accumulation of Southern seasonal creek at DL57

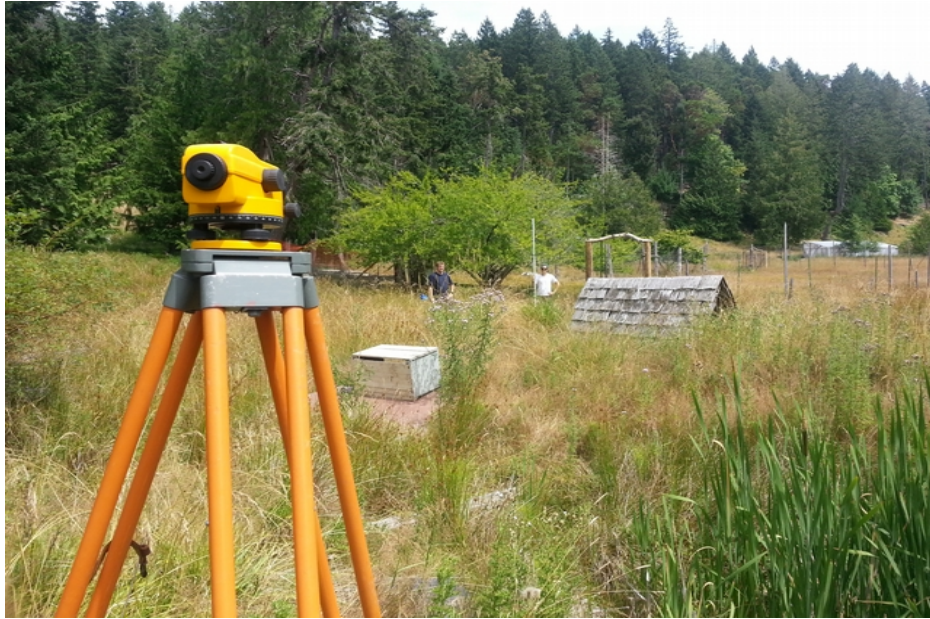
The human alteration of slope has influenced the outcome of the DEM. Therefore a manual method of surveying the landscape was used to determine the creek flow accumulation. A theodolite was positioned at a location which provided a clear vantage of the landscape. A fixed point was established, a tape measure was then used to ensure a fixed radius. Looking through the theodolite, the operator would communicate with the rod (meter stick) operator to determine the lowest slope height. When the lowest point was found on the landscape, a blue flag was put in place. The lowest point on the landscape will ensure the lowest low point as water will travel in the direction of least resistance. There are areas where the slope was approximated due to intense human modifications. In those cases, large tree stumps were used to determine slope.

Figure #) Manual surveying using theodolite and rod (determining lowest slope elevation). View from theodolite operator towards meter stick operator.

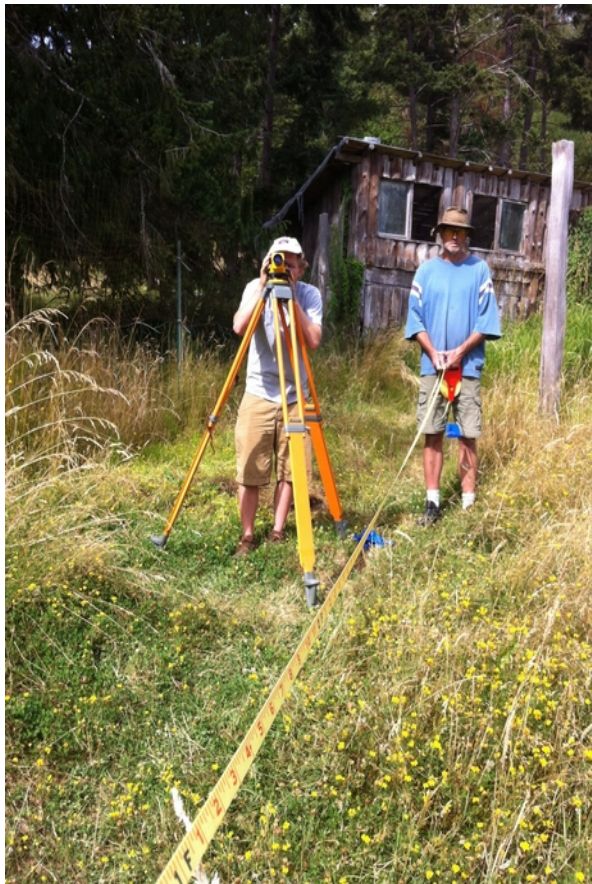
Figure #) View from meter stick operator towards theodolite and fixed tape measure point.

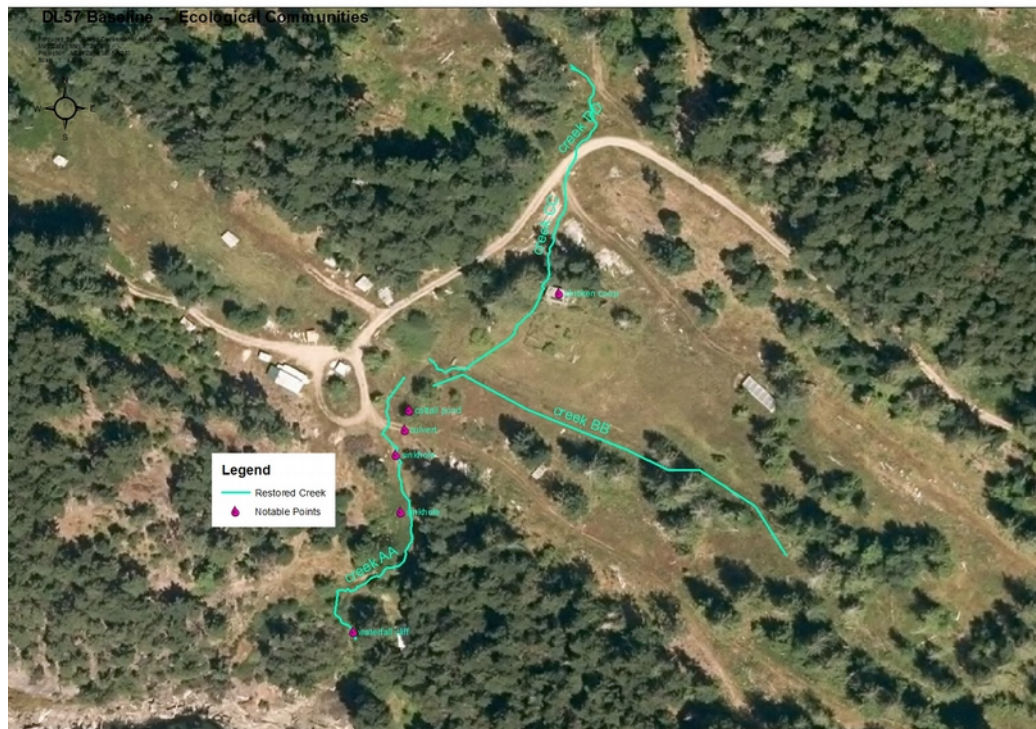
The creek reaches are labeled using an alphabetical system. The current reaches are labeled A, B, C, D, and the prescribed restoration creek reaches labeled AA, BB, CC, DD. Each reach should include the best management practices, however, we have chosen to select the best practices of highest priority for each individual reach in the interest of limitations.

Figure #) Restored creek reaches and notable points

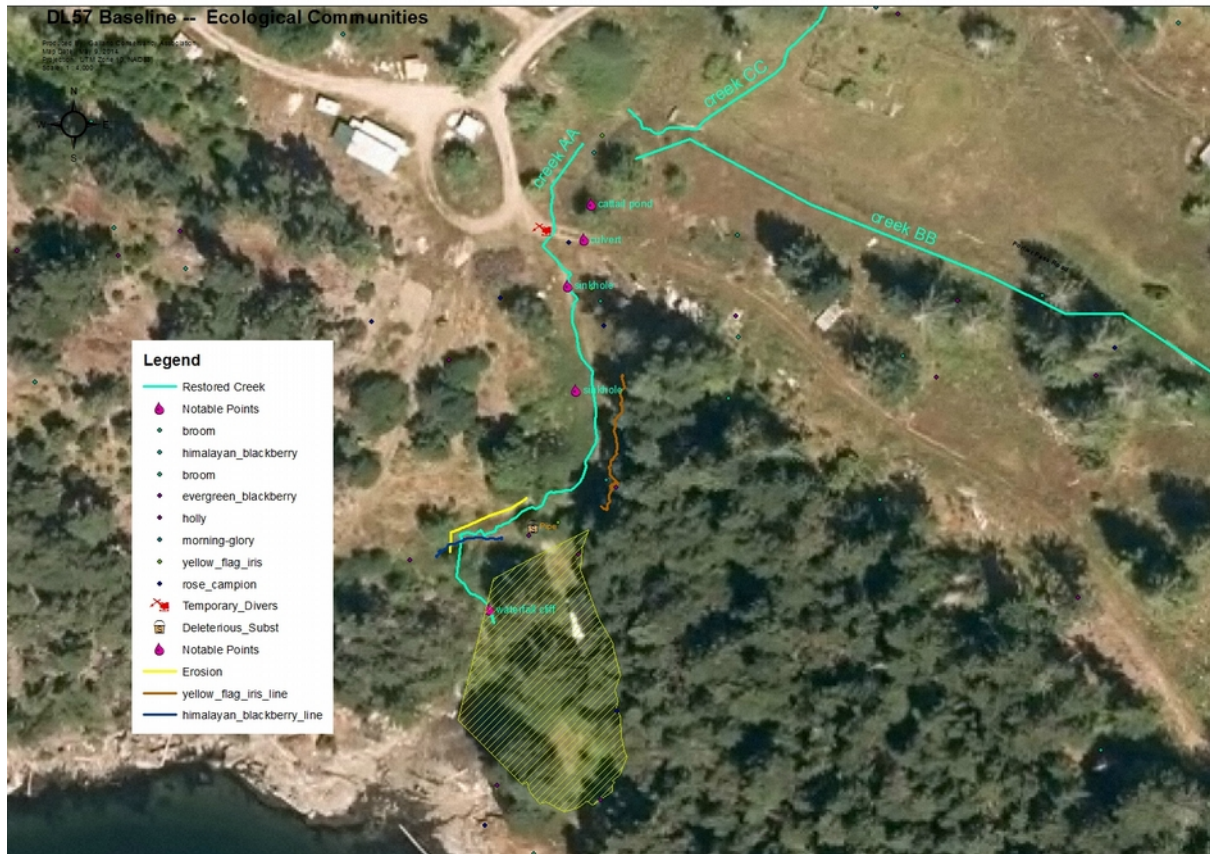
AA-Reach

Figure #) AA Reach with notable points of interest and restoration areas

Historically, the A reach of the creek was diverted in order to built a road by previous land owner. However, a portion of the creek has diverted bellow the bridges and sink holes and has begun eroding a bank. Efforts to stabilize this bank to prevent further erosion should be undertaken before restoration of reach AA occurs.

Near the conversion point of Reach B, C, lies a cattail pond, which acts as the starting point of reach A. This reach begins as a culvert under a road. The culvert will have to be repositioned in order to meet the accurate historic flow. Therefore, a temporary diversion strategy will be required to move and

construct a culvert at the Temporary_divers point on the map. The efforts will require further research to properly instal a culvert.

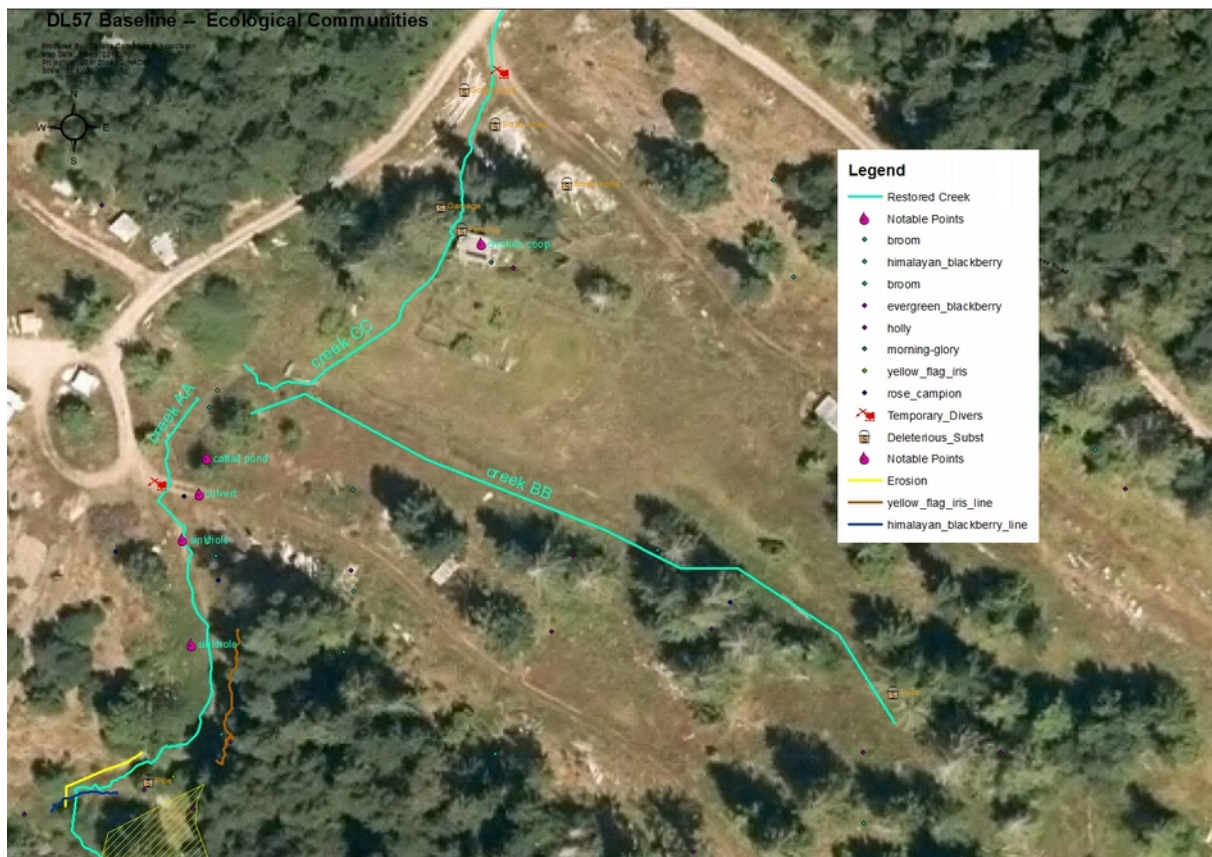
BB-Reach

Vegetation management in reach BB is the primary focus. This involves increasing biodiversity and creating a more dynamic ecosystem. Trees, shrubs, herbs, grasses, and primitive plants such as mosses and lichen form riparian or stream side vegetation. These plants tolerate occasional flooding. The riparian zone includes the immediate bank of the valley bottom or flood plain. The riparian area of influence may also include the adjacent lower slopes (see picture). Stream size and valley topography help define the width of the riparian zone. Riparian vegetation is a very important part of a stream ecosystem. Plants stabilize stream banks, reduce erosion etc. Trees provide shade, which helps control water temperatures. Logs fall into the stream, where they create diverse habitat and help dissipate erosion energy. Leaf litter provides an important source of food for stream organisms. Plants trap sediment and filter out pollutants before they reach the stream. They help the soil absorb precipitation and release it slowly during dry spells. The riparian area provides habitat and travel routes for birds and wildlife. (Streamkeepers, 1995)

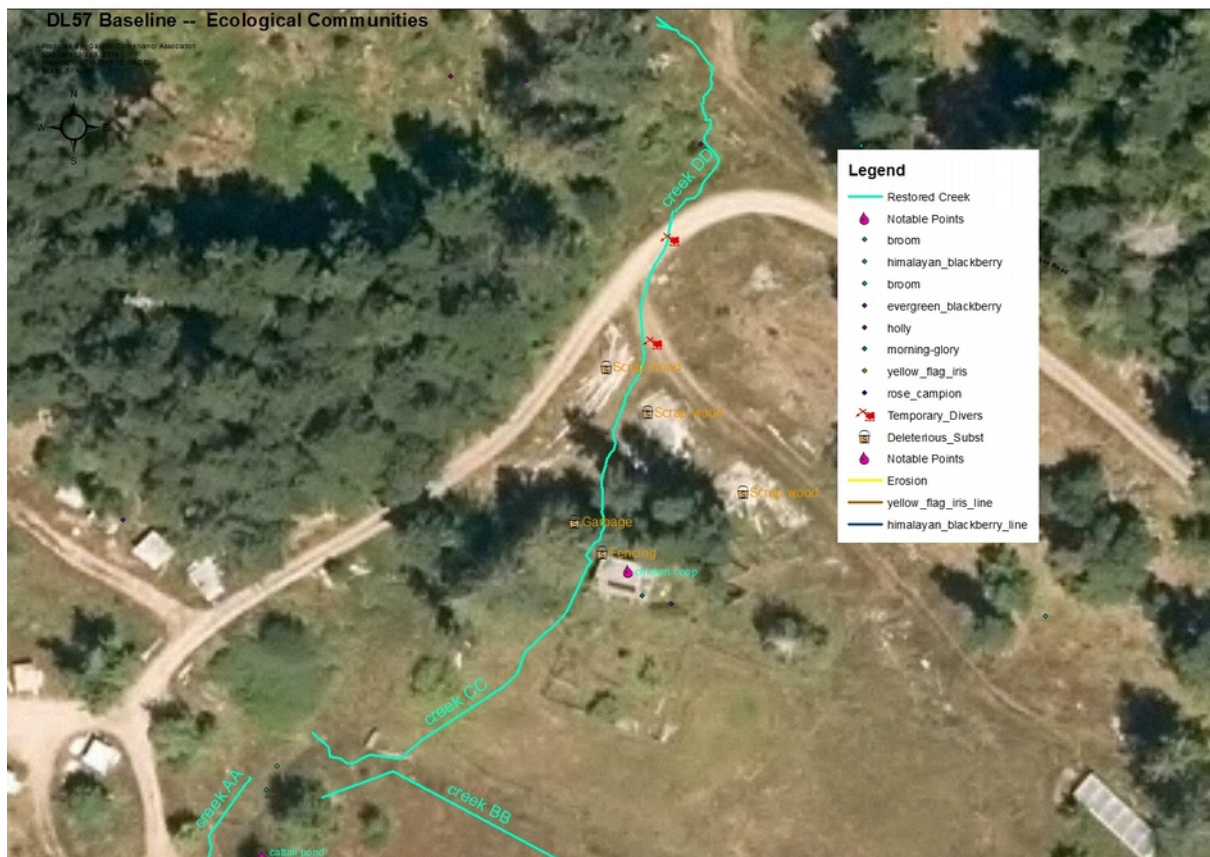
CC-Reach

Site restoration within reach CC will be quite challenging and labor/funding intensive. This involves diverting the existing reach C from the West side of the road near towards the west side of the chicken coop and through the garden. Understanding of stream benthic composition, stream flora and fauna, stream physics, will be important research components. Additionally, planning for large machinery to excavate the creek, as well as diverting the current reach C will require further planning for disturbance from machinery.

As mentioned in the site restoration heading, the creek will have to be diverted. That said, a temporary diversion strategy will be required to move construct a culvert at the Temporary_divers point on the map. This in turn will require further research to properly instal a culvert.

Throughout the years, DL 57 has had numerous occupants, who have used the property for various purposes. That said, there is an accumulation of inorganic and organic material piled and scattered throughout the restoration area. Areas of concern have been marked with a deleterious substances marker. The markers denote objects just as: large wood piles, metal fencing, garbage,

chicken coop structures. These substances should be removed and disposed of appropriately as they will likely interfere with the restoration initiatives. The effort required to remove these substances varies. For example, collecting scattered garbage will require less effort to demolish and dispose of the chicken coop. This should be taking into account for future restoration prescriptions.

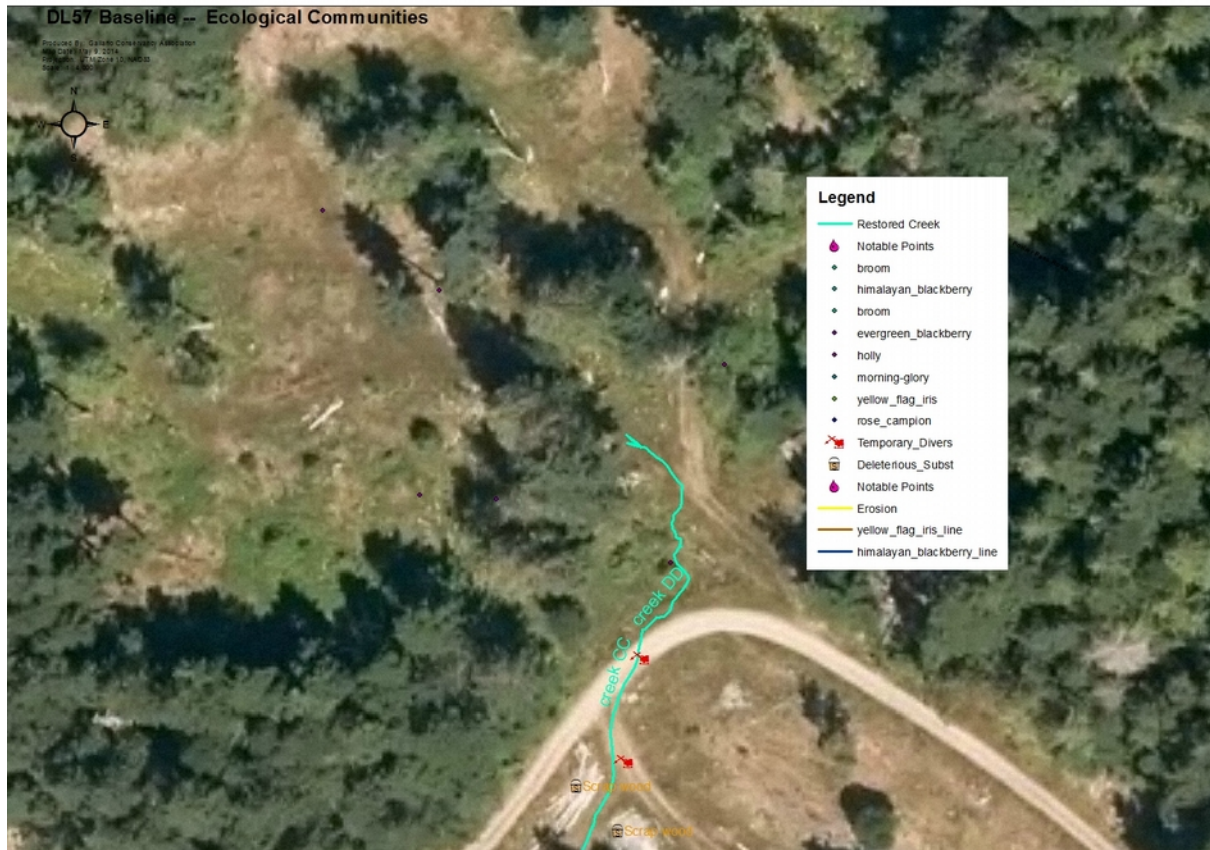
DD-Reach

In the past, several individuals have settled on DL 57, and built wells and ditches for water use. Near the intersection of reach CC and DD lies the Cable house. The house had a dug well constructed and several ditches which were intended to help fill the well. In order to returning the historic condition of the creek, these wells and ditches will have to be filled in. This will allow the surface flow to return to the historic creek.
