**Where did the Beaver Go? A Qualitative Study of Change Within the  
Beaver Creek Watershed**

Final Report

ER 412/ES 471 Galiano Island Field Study

Created for the Galiano Conservancy Association

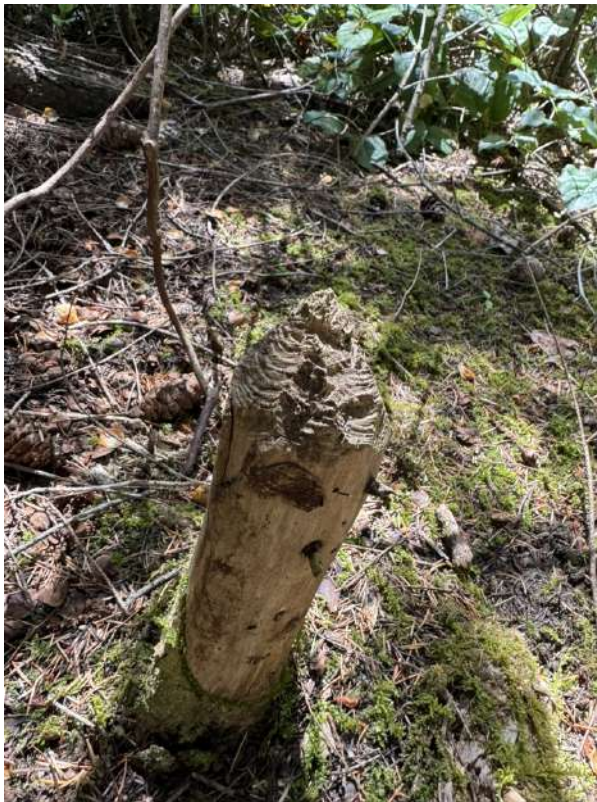
**Figure 2.** A felled tree displaying characteristic beaver chew marks along the edge of the Great Beaver Swamp.

**Note.** Beaver activity at this location was used to guide placement of the second trail camera overlooking established travel paths to suitable building materials.

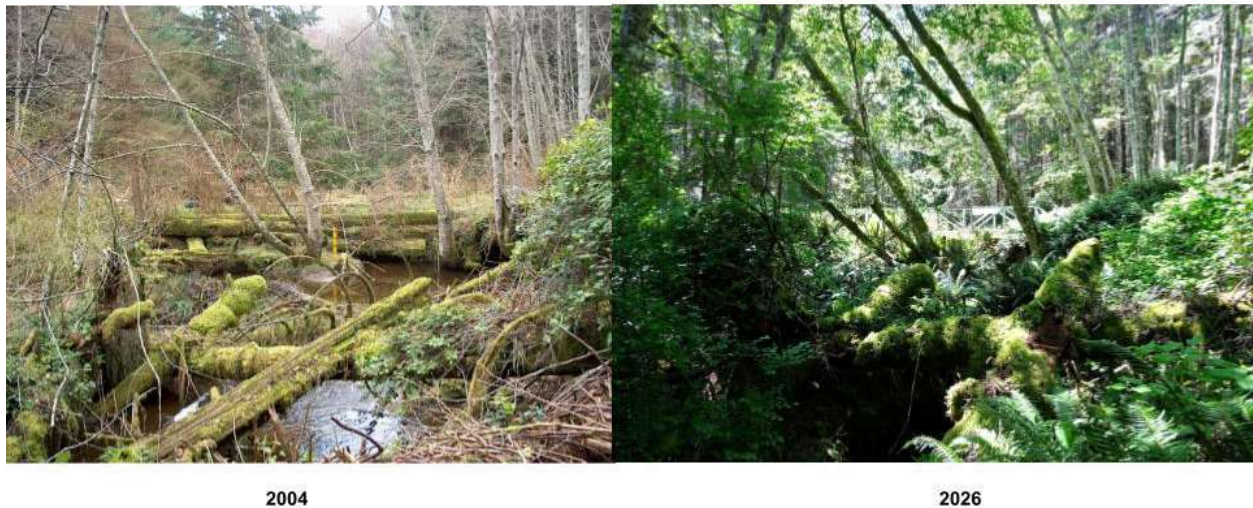
Photo Code: CR\_PBR\_P01

**Figure 4.** Repeated photograph of Photo CR\_PBR\_P01 in Reach 2 of Beaver Creek. The first photo was taken in 2004 (left) and the second photo was taken in 2026 (right).

Figures 4 to 7 demonstrate 22 years of change along Beaver Creek. Although the photos from 2004 were taken in the winter, a significant shift can be observed in the structure and composition of the vegetation. Each figure shows the extent of floodplain loss. The floodplain has been replaced by a narrow incised creek, and bracken ferns are the dominant understory plant. Figures 4 and 7 show the most dramatic changes in hydrology, as a large beaver dam has been lost along with its water reservoirs. Figure 7 also shows the conifer branches placed within the creek for BDA construction.

Our photo points on the Lower Beaver Creek will provide baseline data prior to the installation of BDA's along the stream, allowing future researchers to go back and repeat post-project to document how the stream and ecosystem have changed. By returning to the approximate location of four previous photos taken in 2004, we were also able to get a visual of how the stream has changed since then, which reinforces the significant role beavers play in shaping the creek and provides a permanent visual record of how much the landscape has changed between 2004 and 2026. By looking at the conditions in 2004, we can gather a sense of what we are aiming for post-BDA construction. Recording changes on the landscape also can build community trust in the project and show the benefits of restoration in what is a very publicly accessible location.

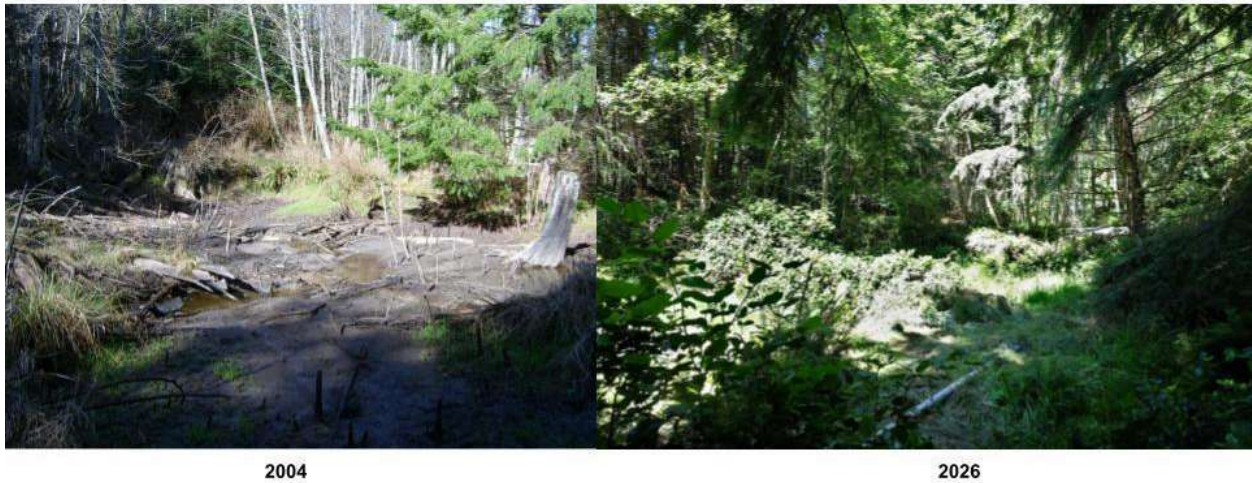
Photo Code: CR\_PBR\_P02

**Figure 5.** Repeat photograph of Photo CR\_PBR\_P02 in Reach 2 of Beaver Creek. The first photo was taken in 2004 (left) and the second photo was taken in 2026 (right).

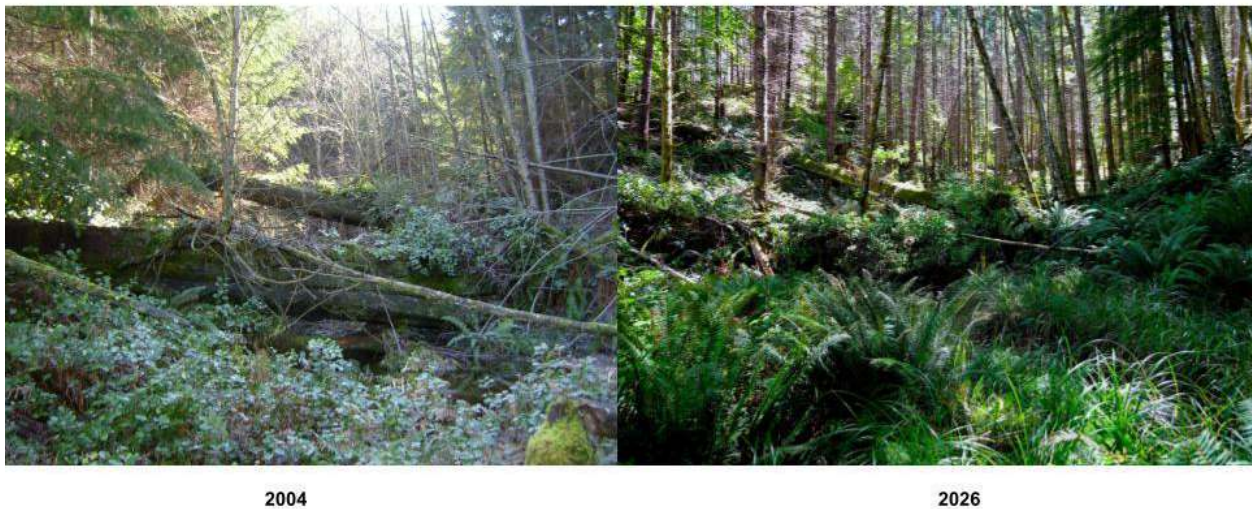
Photo Code: CR\_PBR\_P03

**Figure 6.** Repeat photograph of Photo CR\_PBR\_P03 in Reach 3 of Beaver Creek. The first photo was taken in 2004 (left) and the second photo was taken in 2026 (right).

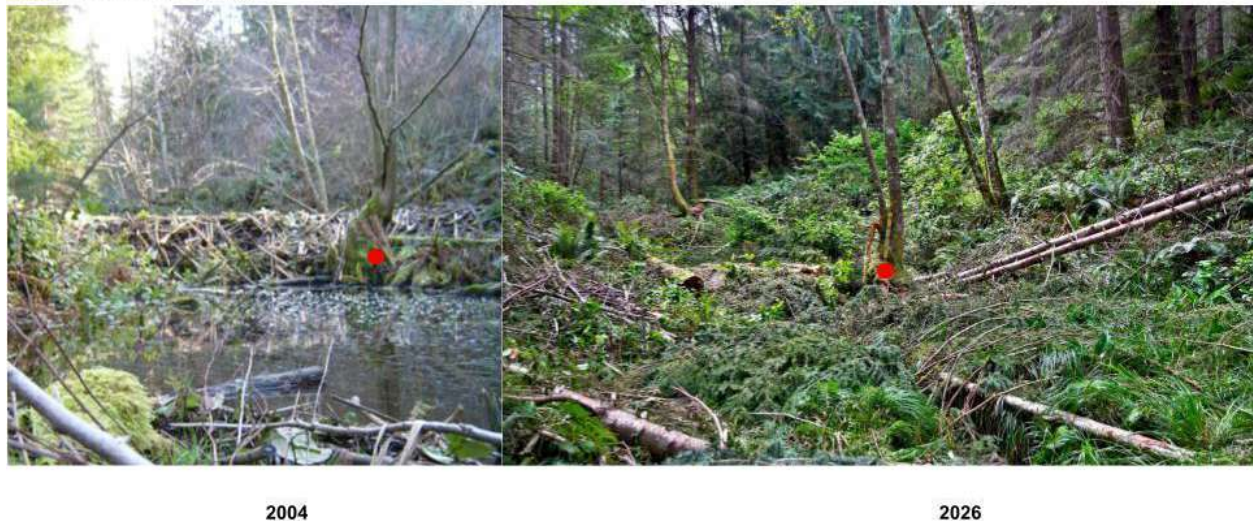
Photo Code: CR\_PBR\_P11

**Figure 7.** Repeat photograph of Photo CR\_PBR\_P11 in Reach 3 of Beaver Creek. The first photo was taken in 2004 (left) and the second photo was taken in 2026 (right). **Note.** The red dot indicates the same tree in both photos.
