Quadra Hill Wetland Restoration

Post Construction Report, October 6 - 19, 2025

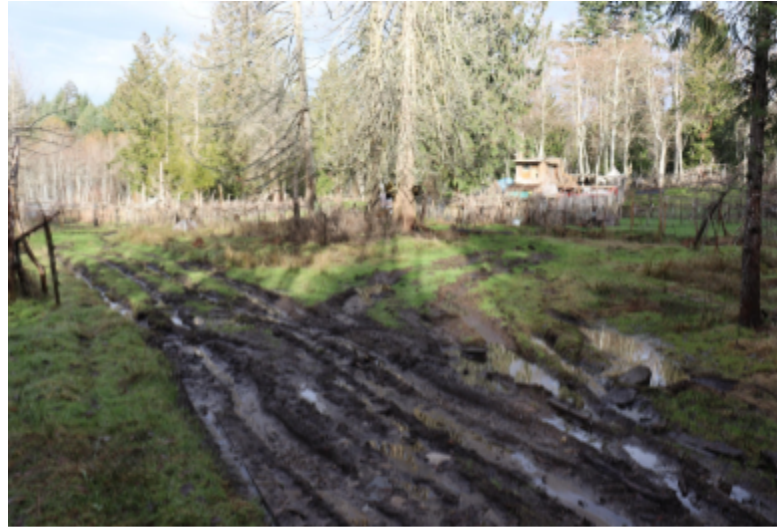
Figure A1: Quadra Hill Nature Reserve project site prior to restoration

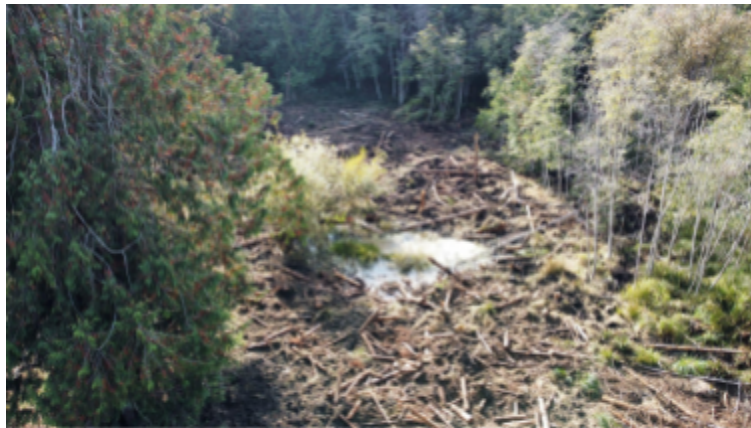
Figure A5: Site conditions immediately following primary physical restoration treatments

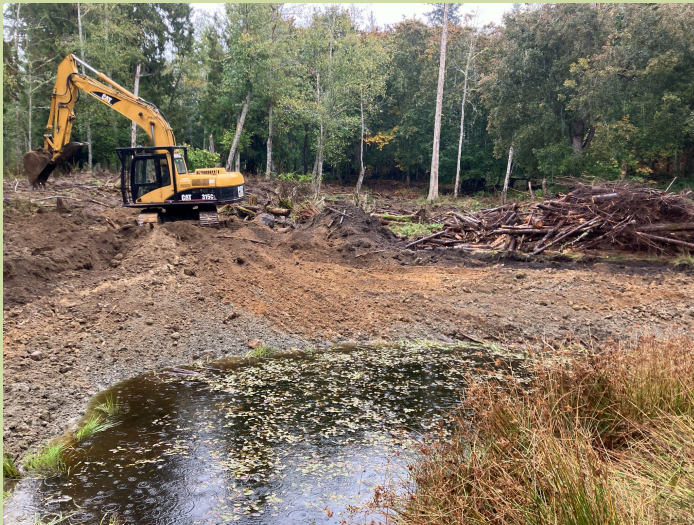
Wetland Pool - "Snaggy shack"

Site 2 is situated in the southeast portion of the field and was one of three existing dugout ponds on the site. The pond held water prior to restoration but had very steep banks. The banks were regraded to create a more gradual slope down to the water. Additionally, the low edge of the pond was raised 30 cm to prevent the formation of a headwall. All ditches surrounding the restored pool were removed. Additional materials from the regrading of the margins were used to recontour the southern portion of the ridge that runs along the eastern edge of the field. A vegetated spillway was retained through the stand of cedars on the southeastern corner of the pool. Prior to restoration a rutted road that provided access into the field ran directly beside Site 2. This road was decommissioned back to the primary access road and left rough and loose. This feature was constructed on days 5-6 of restoration, October 10 & 13, 2025.

Before restoration - January 2022

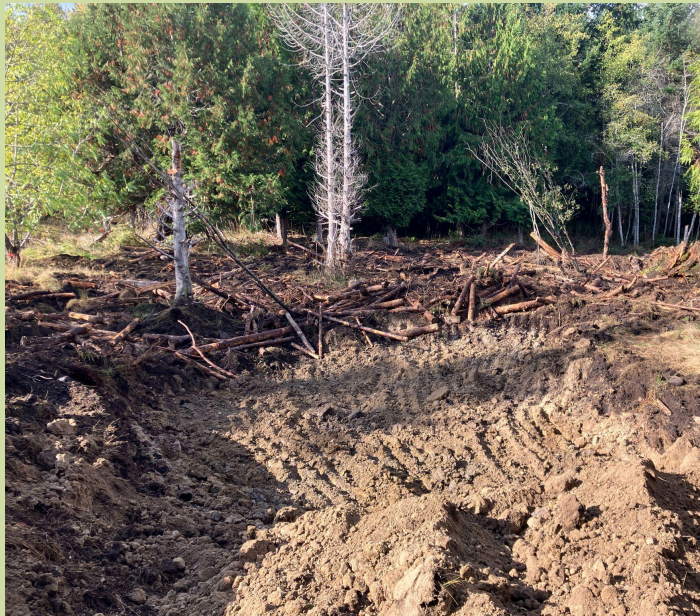
Wetland Pool - "Between two cedars"

Site 3 is located in the center of the field, upslope of Sites 4 and 5. The slope on this portion of the field was gradual, so the low edge of the pool was not raised. The pool was excavated to approximately 50 cm deep. Excavated soil was used to help recontour the ridge along the eastern edge of the site. There were several live and standing dead cedars in this area that were all retained. One standing dead cedar was transplanted into the center of the wetland. A vegetated spillway was established through the cluster of live cedars on the western side of the pool. Several ditches surrounding the pool were removed and filled. This feature was constructed on day 5 of restoration, October 10, 2025.

Before Restoration - January 2022

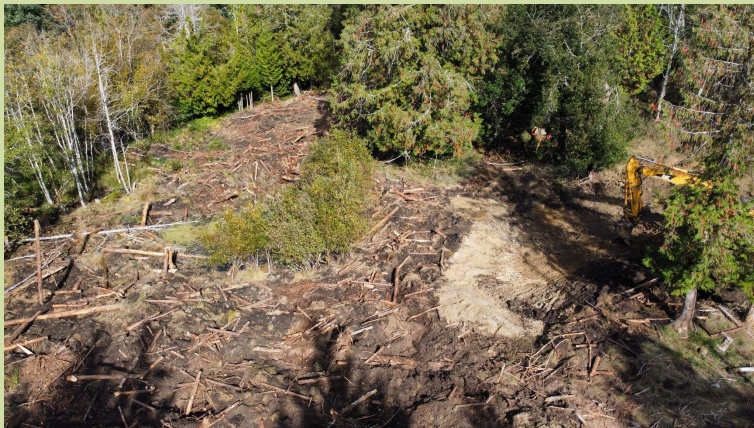
Wetland Pool - "Raindrop"

Site 5 is situated directly upslope of Site 7, to the south. Once the ditch connecting Site 7 to the upslope portion of the field was removed, a small pool was excavated. A core trench was not constructed for this pool because the mineral soil in this area was finer than other areas in the field. The lower edge of the pool was raised 30 cm to accommodate the slope of the site. The area surrounding the pool was decompacted and the excess material from excavating the pool was used to recontour the ridge along the eastern edge of the field. An additional wetland, located to the east of wetland 5, was removed from the design as it was determined that it would result in significant disruption to the root systems of mature western cedar and sitka willow (*Salix sitchensis*) on site. This feature was constructed on day 4 of restoration, October 9, 2025.

Before Restoration - January 2022

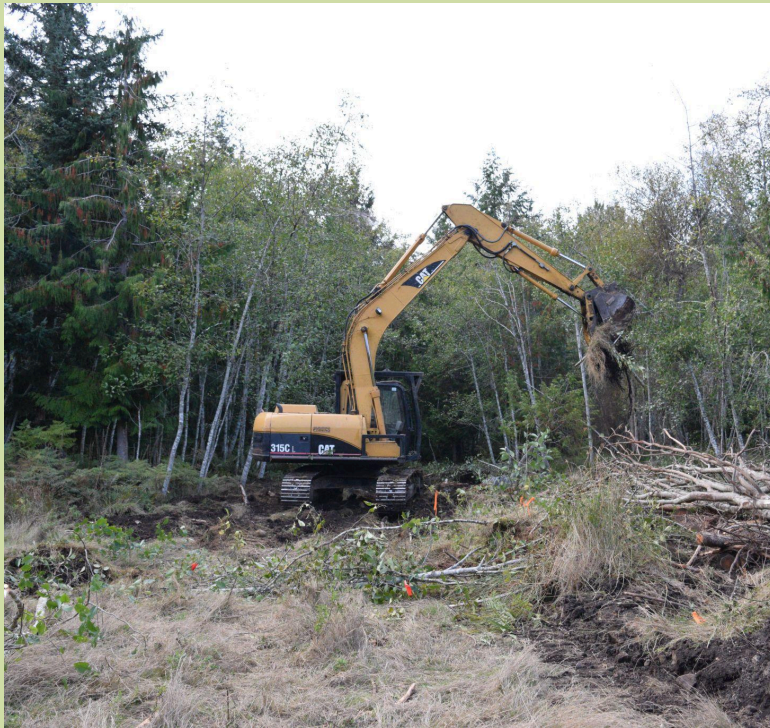
Site 6

Wetland Pool - "Above the belt"

Site 5 is located just within the fenceline, at the edge of the field on the upslope end of a bulldozer track that captured and drained surface flows into the lower alder stand. The end of the roadway was decompacted and left rough and loose. A small pool was created with a final depth of 20 cm. A ditch leading down towards the roadway was cleaned and filled. This feature was constructed on day 3 of restoration, October 8, 2025.

Before Restoration - October 2025

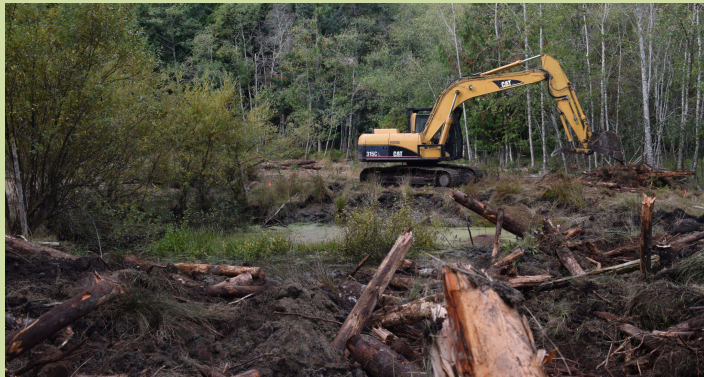
Wetland Pool - "Primordial Stu"

Situated on the northern, lower edge of the open field, Site 7 featured one of the existing dugout ponds. When surveyed prior to excavation on 6 October, 2025, this pond held 1 m of water at its deepest point. Plastic pipe had been installed to drain the pond into the disturbed marsh. Plastic pipe was also installed upslope within a ditch to drain the upper portions of the site into the pond. Both the outlet and the input pipes were removed and the ditches were cleaned and filled. The pond was improved by making the slope of the banks more gradual and excavating small 'bays'. The existing Sitka and Pacific willows were preserved, as they will provide valuable live-stake material for the site. Because the bank surrounding the willows could not be excavated backwards without disturbing the willows, it was re-graded by backfilling towards the pond. A vegetated spillway was retained draining down towards the sedge marsh. The field surrounding the pond was decompacted and left rough and loose, and woody debris was incorporated throughout the area. The unhealthy alder stand below the pool was also made rough and loose, dead alders were removed, and a pocket pool was added. This feature was constructed on days 1, 2, & 3 of restoration, October 6, 7, & 8, 2025.

Before Restoration - October 2025

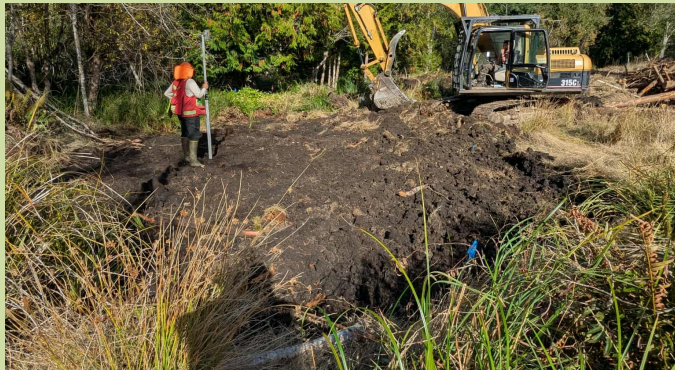
Wetland Pool - "Cabbage patch"

Site 8 is found on the southern edge of the disturbed swamp and marsh complex, to the east of Site 7. The legacy of grazing and the use of heavy machinery on the landscape had left a stark border between the sedge marsh and the open field. Site 8 was designed to extend the sedge marsh into the field and disrupt the linear border between the features. A 20 cm deep pool was dug into the field, extending back into the marsh. In the surrounding area, the slope down to the marsh was regraded to make the transition between features more gradual. The sedge wetland was made rough and loose wherever it was possible to reach through the line of cedar and alder on the southern edge of the marsh with the excavator, and a small pool was created. Several dead alders were felled to facilitate access to the marsh, and these were incorporated into the pond as woody debris. The slough sedge (*Carex obnupta*) removed during decompaction was salvaged and incorporated into Site 8 to facilitate the regeneration of wetland species within the open field. Fallen alders and woody debris from forest thinning activities were incorporated into the pool. These features were constructed on day 1 of restoration, October 6, 2025.

Before Restoration - October 2025

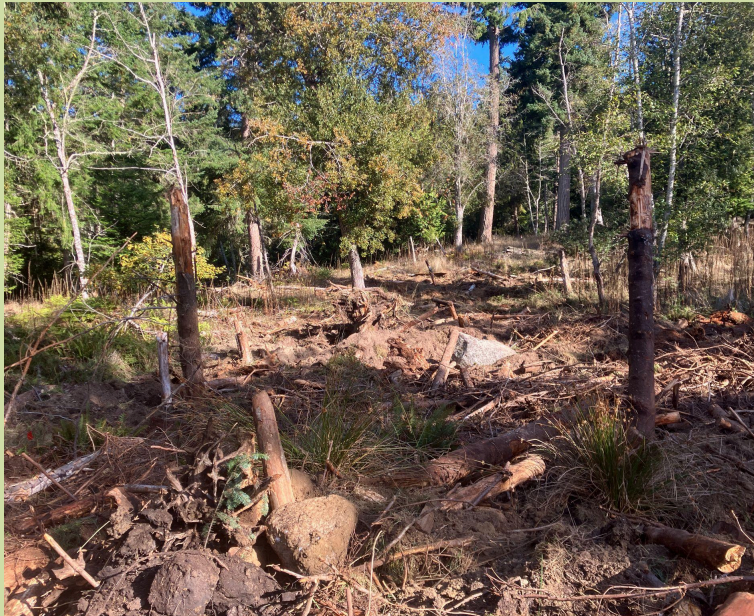
Wetland Pool - "Debutant"

Site 9 is located upslope and to the south of the sedge swamp and marsh complex, in the northeast corner of the field. A 45-cm deep pool was created at this site. Because this pool is located on a slope, the lower edge was raised approximately 15 cm. All open field areas surrounding the pool were decompacted and given a rough and loose treatment by the excavator. Sweet-briar and Scotch broom were removed by the excavator and significant woody debris was added to the site. A large spoil pile covered in thistles near the pool was recontoured. This feature was constructed on day 1 of restoration, October 6, 2025.

Before Restoration - October 2025

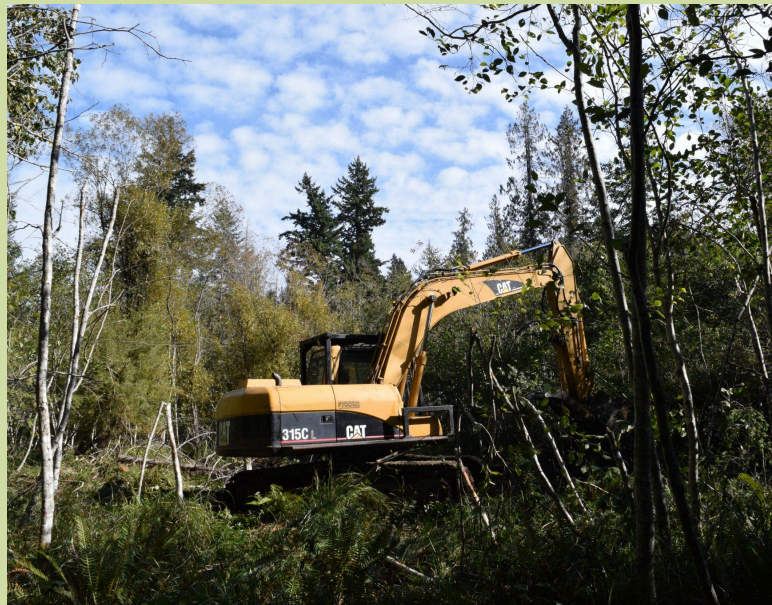
Wetland Pool - "Grow Op"

Site 13 is located in the southwest portion of the sedge marsh at the outlet of the plastic pipe that drained Site 7. This pool was expanded from the original design to further restore the microtopography of the site. Prior to restoration, a small lean-to structure was disassembled at this site. All garbage was removed but the untreated wood used in the structure was left on site and buried below the surface by the excavator. Himalayan and cutleaf blackberry on the site were removed. The final depth of the pool created at this site was 30-45 cm. Care was taken to avoid damaging the roots of a mature black cottonwood tree bordering the pool. This feature was constructed on day 3 of restoration, October 8, 2025.

Before Restoration - October 2025

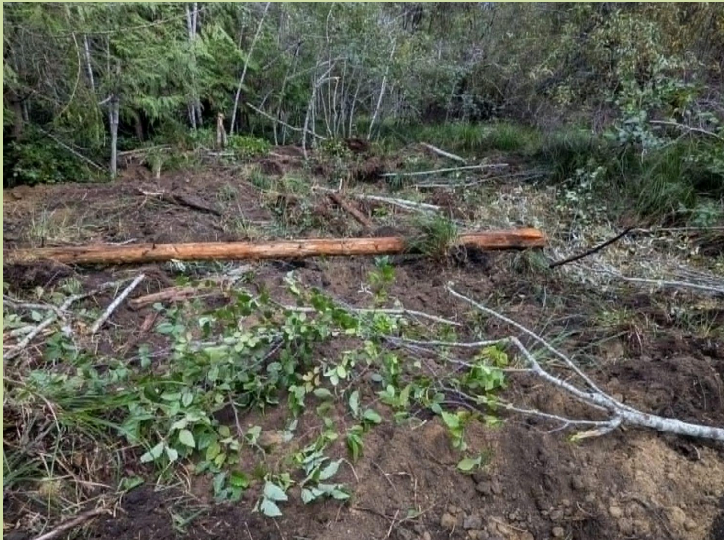
Wetland Pool - "Marsh pocket"

Site 14 is situated in the northeast portion of the sedge marsh. This area consisted of almost entirely slough sedge with one skunk cabbage (*Lysichiton americanus*) and a patch of inflated sedge (*Carex exsiccata*). This site was added to the wetland plan because access to this portion of the marsh was easier than anticipated and additional topographical diversity was desired. Prior to excavation the site was swept for wildlife, surveyed, and the boundaries were marked. Wetland boundaries were placed intentionally to preserve the skunk cabbage, inflated sedge, evergreen huckleberry (*Vaccinium ovatum*), western redcedar, and Pacific willows (*Salix lucida*) on site. Given the homogenous species composition of the marsh an emphasis was placed on preserving existing biodiversity. A compromised branch was removed from a Pacific willow bordering the pond and was placed in the wetland as a source of propagules. This feature was constructed on day 3 of restoration, October 8, 2025.

Before Restoration - October 2025

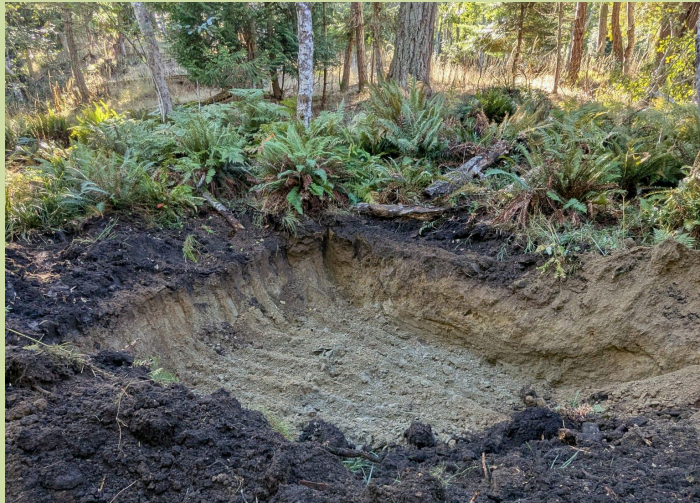
Site 16

Wetland Pool - "Fern pool"

Site 16, found just downslope of Site 15, is located on top of the same road segment at the base of a shallow valley. A soil mining pit and material piles from the construction of the road were present on the southern edge of the site. This site was used to source fine sediments for the core trench at Site 15. The pit created by mining for fine sediments was converted into a small pool, 25 cm in depth. Several dead alders were pushed down and were integrated into the wetland as coarse woody debris. The road was decompacted and given a rough and loose soil treatment by the excavator and the pits and piles created by the original road build were dispersed and filled. Road removal is intended to slow the drainage of the sedge marsh, promoting longer seasonal retention of water and preventing channelization of the flow of water down to the Great Beaver Swamp. English holly and sweet-briar rose in this area were removed by the excavator and disposed of. This feature was constructed on day 1 of restoration, October 6, 2025.

Before Restoration - October 2025

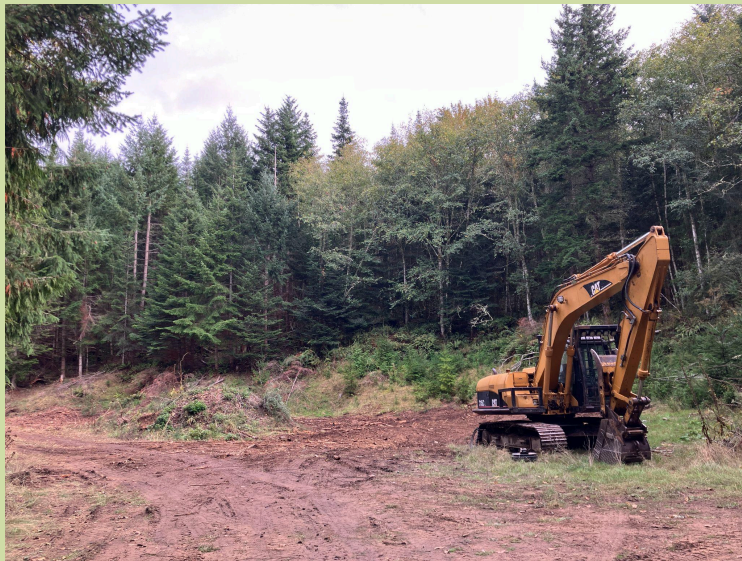
Restoration - "Gravel pit"

Site 17 is a former gravel pit located on the intersection of the primary access roads for the property. Several piles of topsoil removed prior to gravel excavation were identified along the rim of the pit; a large soil pile covered with Scotch broom and teasel had been left beside the access road. The topsoil piles were redistributed on the site and the slope was recontoured and left rough and loose to create more natural and diverse topography. Stretches of slope with significant vegetation (ferns and conifer saplings) and less severe slopes were retained, creating a series of vegetated strips along the slope. Approximately a quarter of the existing flattened area was retained to be used as parking or gathering space for events. This work was completed on

Before Restoration - January 2022

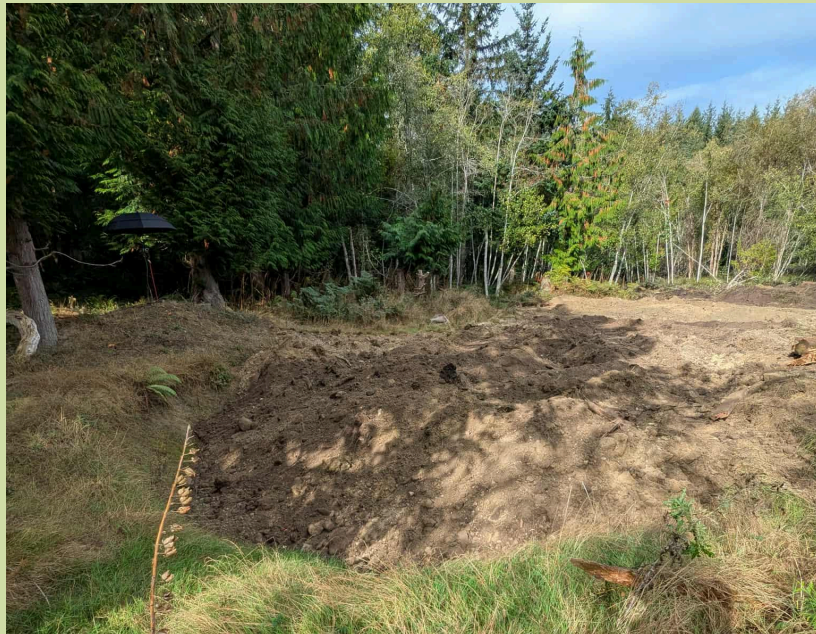
Restoration - "Failed Pond"

Site 18, located just upslope of site 4, was one of the 3 existing ponds on site. This pond was very steep and deep, and did not retain water into the summer months, likely due to underlayment by coarse sediments. The material from pond excavation had been piled on the margin. Given that this pond was not retaining water, the depression was backfilled with wood from the structures on site and additional soil from the creation of other pools throughout the field. Ditches leading into and out of Site 18 were removed. This feature was constructed on day 4 of restoration, October 9, 2025.

Before Restoration - November 2022

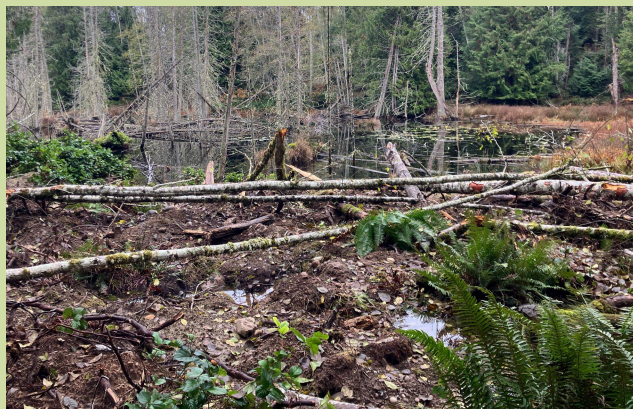
Road removal - "GBH road east branch"

Site 19 consisted of an old logging road running parallel to the margin of the Great Beaver Swamp wetland east of the intersection with the branch road from the Quadra Hill Nature Reserve. This road segment once crossed the swamp, but the crossing has since been flooded and reclaimed by the wetland. The remaining road area was swept for wildlife prior to excavation. A small disturbed clearing was present at the road terminus, and signs of significant recent beaver activity (felled red alder trees) were noted in this area.

The road surface was made rough and loose, with small ridges and pools added across the road to disrupt the previous grading. Wherever possible, the surface was blended back into the existing slope. Approximately ten small and five large pocket pools were roughed in. A large old growth log that crossed the roadway was retained as an important habitat feature and left in place. Selected alders were felled along the roadway and incorporated as woody debris. Throughout this process, all English holly plants in the area were flagged and removed. The final work on all road segments was approved by the Cultural Monitors. This road segment was decommissioned on day 8 of restoration, October 16, 2025.

Before Restoration - October 2025

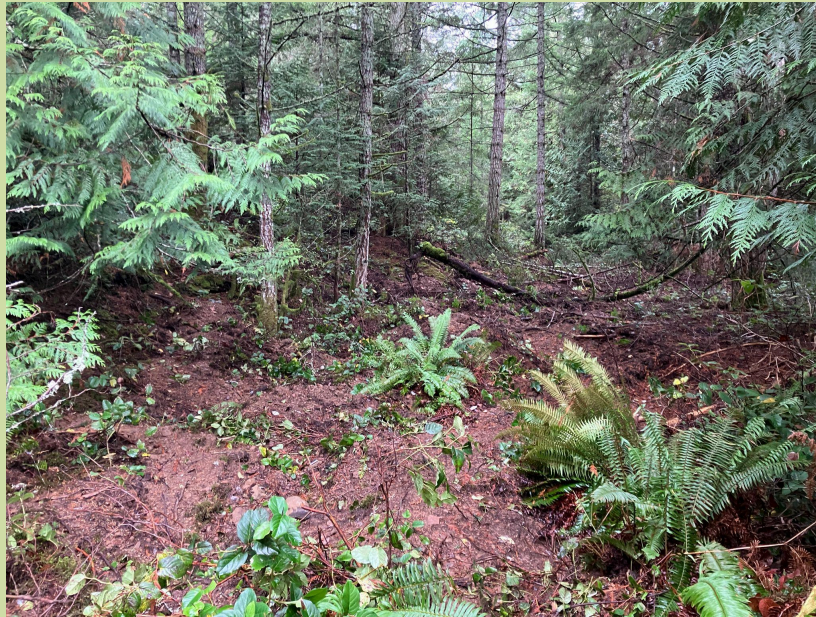
Road removal - "GBH road west branch"

Site 20 consisted of an old logging road running parallel to the margin of the Great Beaver Swamp wetland west of the intersection with the branch road from the Quadra Hill Nature Reserve. The western branch of the road was rockier and bordered in places by mature trees. As such, the regrading of the road was less extensive. The area was made rough and loose within the bounds of the existing roadway to avoid causing damage to the root systems of the trees. The pits and mounds in this area were shallower as a result of the rocky soil. Two pocket pools were added to this branch of the roadway as well as several large rock features. A live northern red-legged frog was found on the roadway while recording data the day after excavation. The road segment continued onto the neighbour's property; the restored area stops just short of the property line. This road segment was decommissioned on day 8 of restoration, October 16, 2025.

Image Before - October 2025
