# Beaver Creek Restoration Plan

Pebble Beach Reserve - Galiano Island

### • Restoration Plan - Brief •

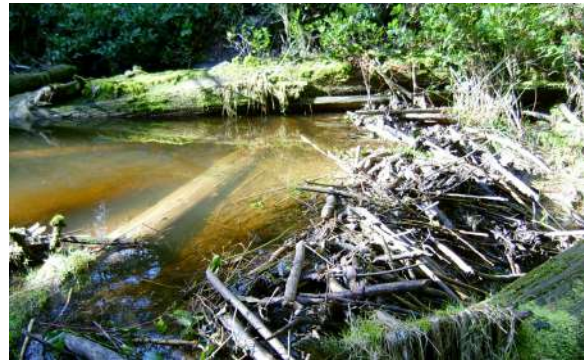
**Figure 1:** Dam on lower Beaver Creek, Feb. 2004

In the early 2000's, beaver (*Castor canadensis*) could be found up and down the length of "Beaver Creek" on Galiano Island, catalyzing the recovery of wetland and riparian ecosystems that had been degraded by decades of clear-cut logging, drainage, and road construction. In the upper watershed (upstream of the reserve), beaver were initiating the flooding of the "Great Beaver Swamp", which they continue to maintain today. In the lower watershed (within the reserve), they had established at least 10 dams, transforming the creek into a complex series of pools that accumulated sediment and supported a rich riparian ecosystem (**Fig. 1-2**).

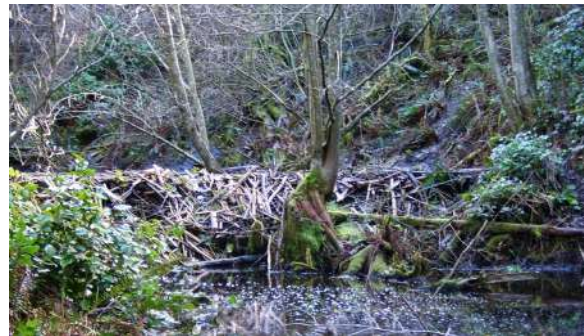
**Figure 2:** Dam on lower Beaver Creek, Feb. 2004

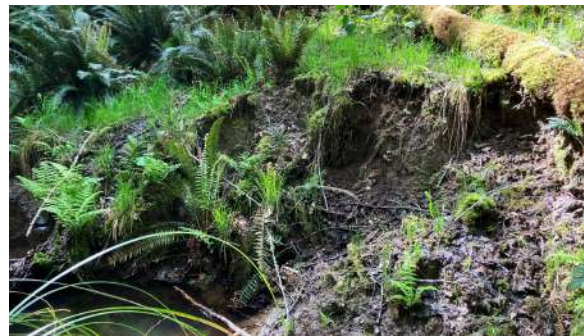
**Figure 3:** Eroding channel exposes over 1 meter of sediment on lower Beaver Creek, Apr. 2026

Around the late 2000s, beaver abandoned the lower watershed for unknown reasons. Over time, their dams were breached, and the creek channel became incised, downcutting into over a meter of rich sediment that had accumulated within the floodplain. Most of the pools have been lost and the process of erosion and incision continues to deepen the creek channel (**Fig. 3**). Today, beaver remain absent from the lower watershed, and the creek channel has become disconnected from its historic floodplain, resembling and functioning more like a ditch than a creek.

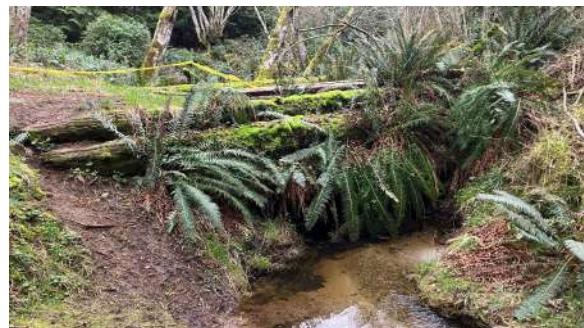
**Figure 4:** Failing earthen road crossing, Mar. 2025

Beaver are still present in the upper watershed, and the historic floodplain in the lower watershed still retains many of the key ingredients needed to support complex creek structure and function, including large woody debris and diverse vegetation. The urgent need to remove and replace a failing earthen bridge crossing (**Fig. 4**) has created an opportunity to reverse creek incision before additional damage occurs. The Galiano Conservancy Association (GCA) has purchased a bridge and secured funds to replace this crossing and initiate a restoration project.

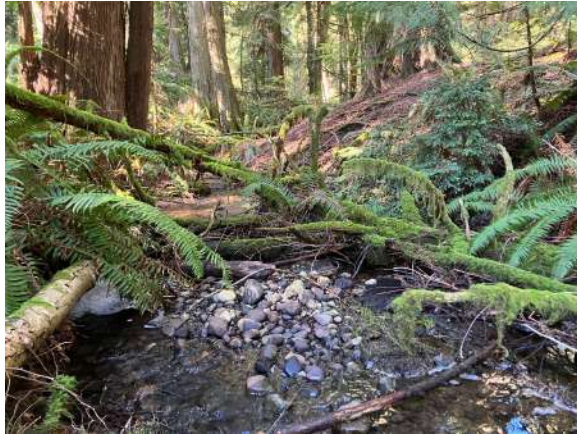
**Figure 5:** *Complex natural creek structure in lower Beaver Creek on District Lot 60, 2025*

The lower watershed consists of a perennial creek ("Beaver Creek") descending through a narrow, winding valley. The section of the creek that passes through the mature forests of DL60 exhibits healthy structure, with sufficient large woody

debris present to maintain channel complexity. Several bedrock outcrops limit incision in this upper reach.

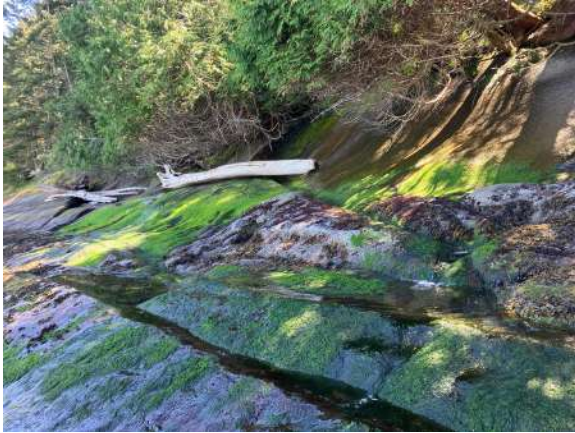
**Figure 7:** Sandstone fish barrier at outlet of Beaver Creek at Cable Bay, Galiano Island

Beaver Creek is a perennial, non-fish bearing creek that experiences high flows in the winter and very low flows during the summer drought. 916 m of Lower Beaver Creek occur within the Pebble Beach Reserve. The final 36 m of the creek occur on the neighboring Qw'xwulwis - Cable Bay Conservation Area, owned by the Nature Trust of BC and managed by the GCA. **The creek descends over a roughly 15 foot rock face into the Strait of Georgia, preventing fish passage; Beaver Creek has been surveyed many times and is not considered to be fish-bearing.**

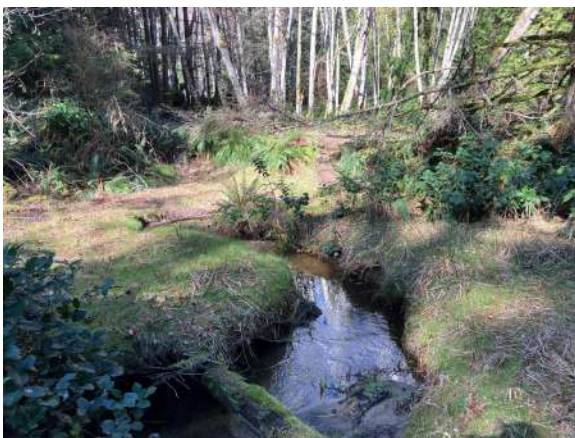
**Figure 8:** Incised channel at site of former beaver pond on lower Beaver Creek, 2025

Between 2000 and 2004, ten active beaver dams were mapped in Lower Beaver creek, and several were photographed. Despite the relatively narrow floodplain, pools formed behind these dams accumulated over a meter of sediment in many areas. At some point in the late 2000s or early 2010s, beaver abandoned the lower watershed, and their dams were breached. Without sufficient retention features in the form of logjams and beaver dams, the creek has become channelized and incised, resulting in erosion and a disconnect between the active channel and the historic floodplain. Incision ranges from 0.5m to 1.5m.

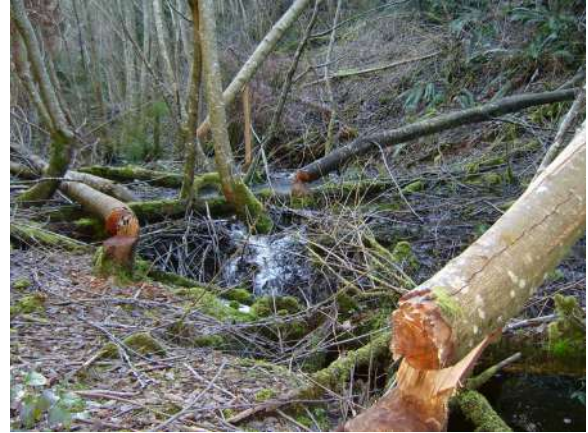
**Figure 9:** Beaver activity on lower Beaver Creek, 2004

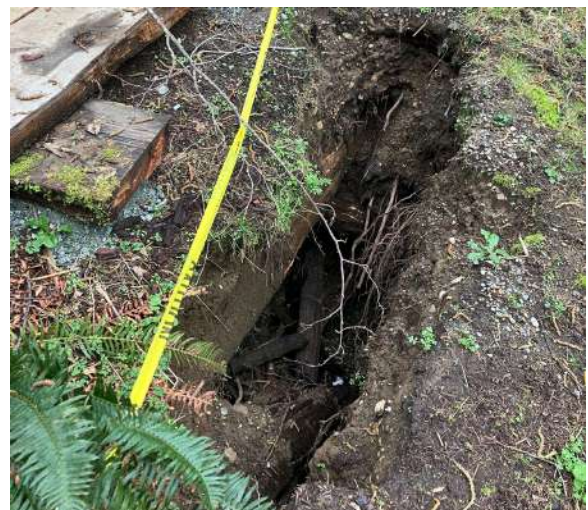
**Figure 10:** Sinkhole forming in Crossing #1, 2025

**There are no buildings or infrastructure located in, near, or downstream of the section of Beaver Creek creek on the Pebble Beach Reserve.** The creek is crossed by old logging roads at two locations. Crossing #1 is an earthen bridge supported by massive, rotting logs. This bridge doubles as the hiking trail crossing for the Cable Bay trail. Starting in 2024, sinkholes began to form in the bridge as the support structure began to fail. The GCA has purchased a locally-made clear-span bridge and placed it to span the existing crossing in order to temporarily allow safe public use of the trail until it can be permanently installed. **There is an urgent need to remove and replace Crossing #1 before it collapses into the creek.**

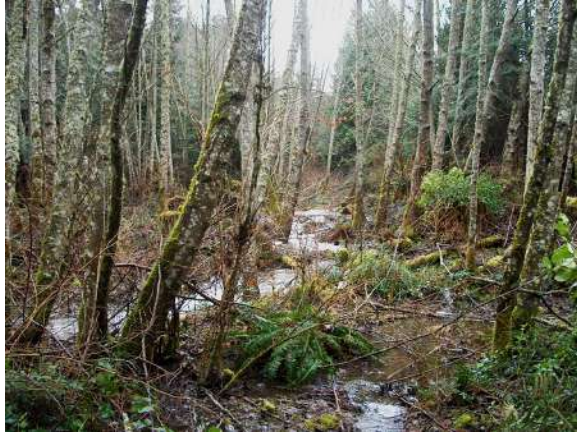
**Figure 11:** Reach 2, just above Crossing #2, in January of 2000; this area was a saturated floodplain, with water at or near the soil surface

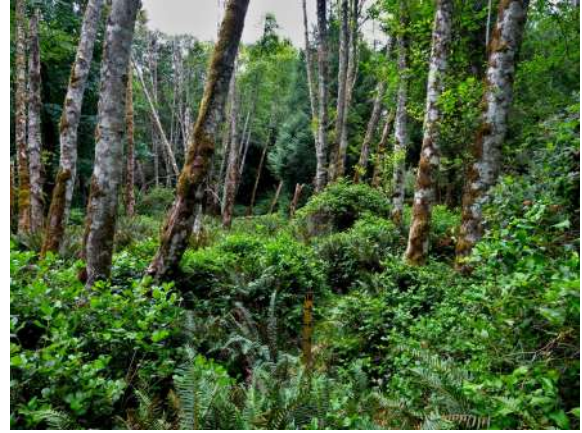
**Figure 12:** Same view as Figure 11 in July of 2026; the creek is incised ~1m, salal has encroached on the floodplain, and the red alders are all dying or dead

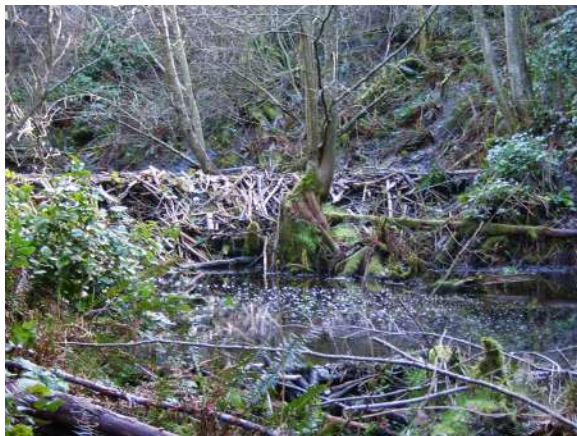
**Figure 13:** Reach 3 in February of 2004, when two large beaver dams maintained open water wetlands within the creek floodplain

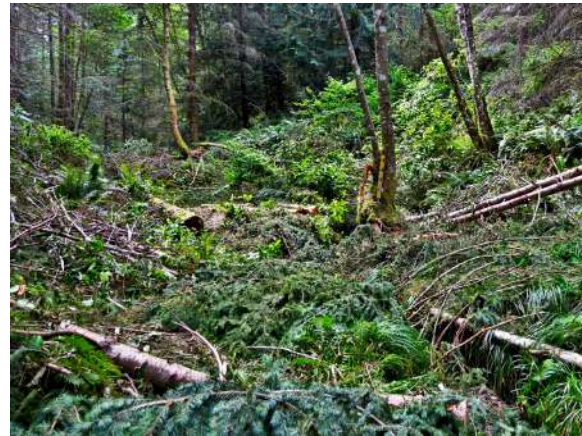
**Figure 14:** Same view as Figure 13 in July of 2026; the dams have long since washed out, and the creek has incised between 0.5 and 1m

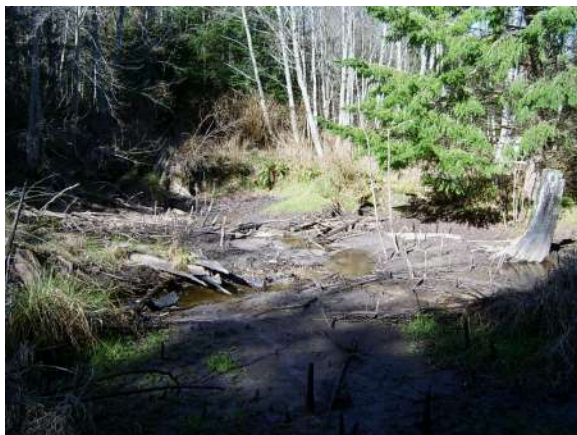
**Figure 15:** Reach 3, just above Crossing #1, in February of 2024; this area was a saturated floodplain located upstream of several beaver dams

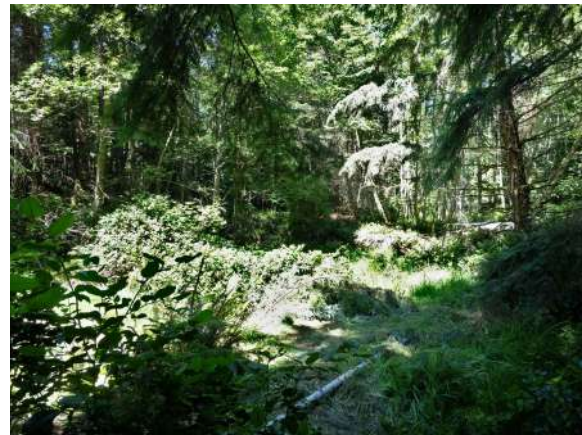
**Figure 16:** Same view as Figure 15 in July of 2026; the creek is incised between 0.5 and 1m, and flooded areas are no longer present

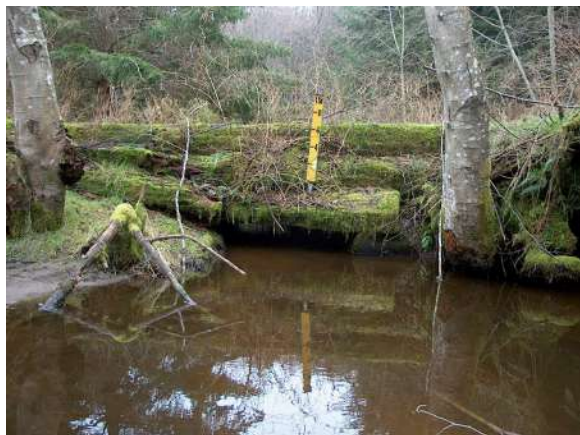
**Figure 17:** Crossing #1 in February of 2004, with beaver wetland in foreground

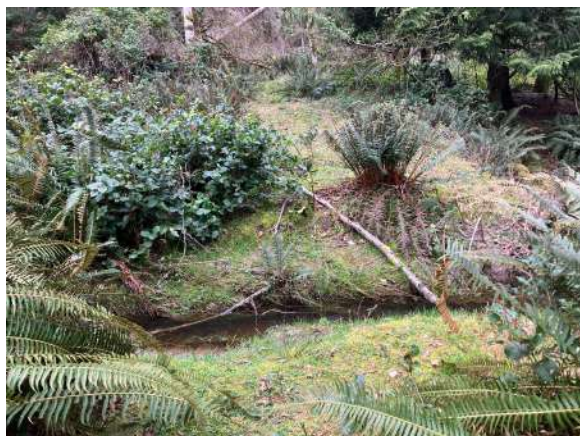
**Figure 19:** Channelized flow at Crossing #2 in 2025, following removal of steel culvert in 2000

Crossing #2 is an old road built directly through the floodplain. A corrugated steel culvert that allowed the creek to pass under the road was removed in the early 2000s and is still present on site. The creek remains channelized within the ditch left behind following culvert removal. Further incision has been prevented by several mature red alder (*Alnus rubra*) trees immediately downstream of the crossing, but washout of the road material during future high flow events is a concern.

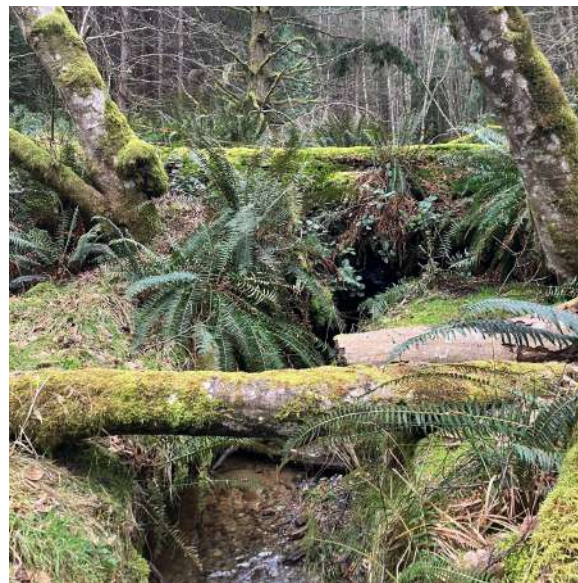
**Figure 18:** Same view as Figure 17 in March of 2025, with incised channel in foreground

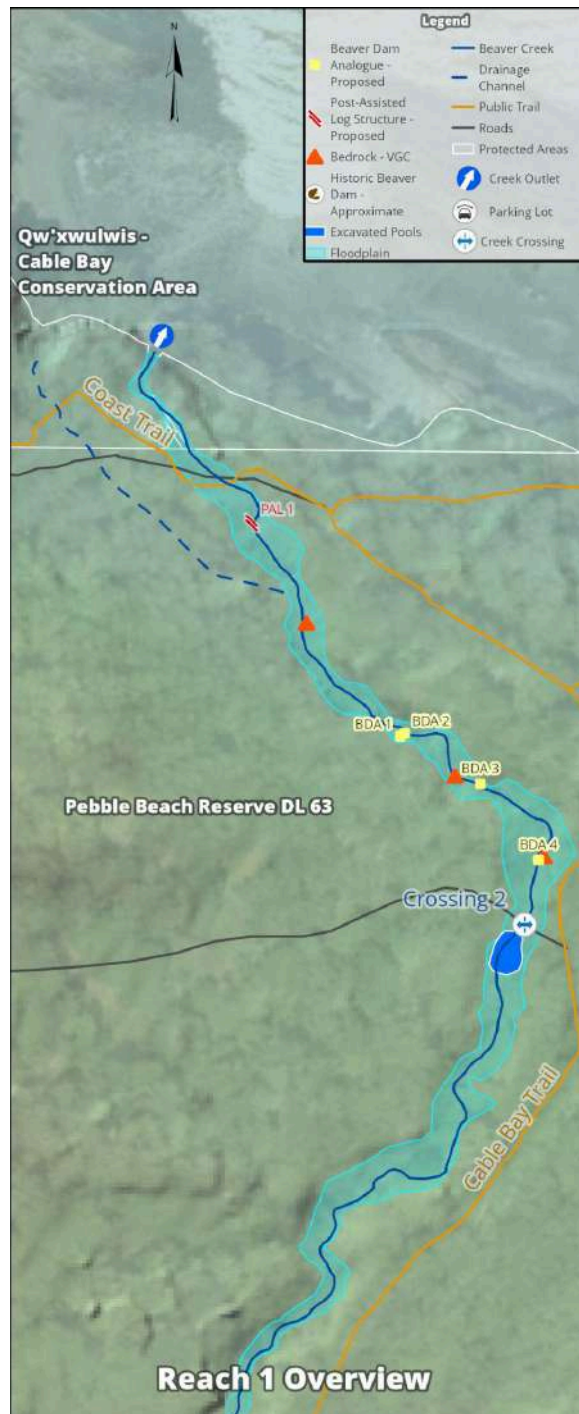
**Map 3:** Map of Reach 1 of project site, from creek outlet up to Crossing #2

The lowest reach of Beaver Creek extends from the outlet on the steep sandstone shoreline of Cable Bay up to Crossing #2. It is crossed in one location by the “Coast Trail”, over a small wooden boardwalk. No activities will take place below the trail crossing, as bedrock and well-established tree roots are currently serving to stabilize the channel.

Above the trail crossing, Reach 1 is a narrow, steeply sloping channel pressed between two low sandstone ridges running roughly parallel to the shoreline. Bedrock grade control is present in several locations, as is large woody debris in the channel. Four BDAs and one PALS are proposed for Reach 1, with the intent to recover incised channel sections and capture any suspended sediment from upstream restoration activities. Low-tech structures will be installed in Reach 1 before any other instream activities take place.

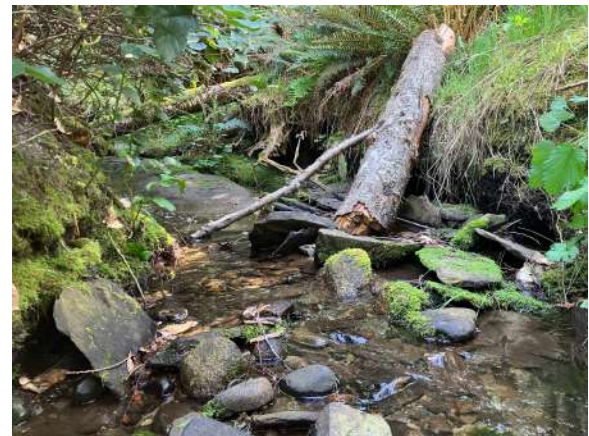
**Figure 21:** Beaver Creek, just above outlet to Cable Bay

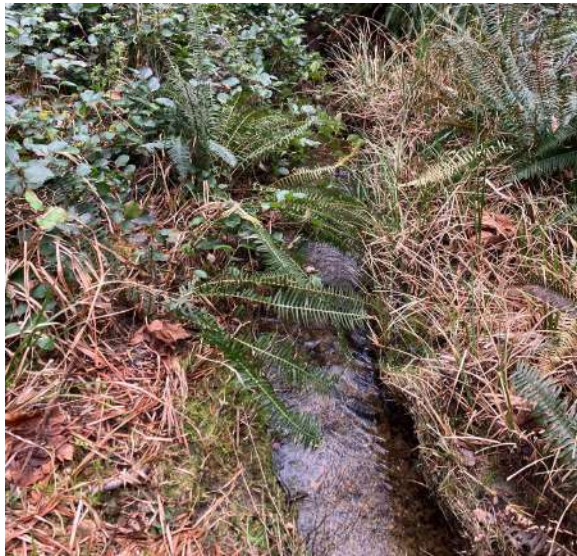
**Figure 22:** Incised channel in Reach 2

23 BDAs and two PALS are proposed for Reach 2. These low-tech structures are intended to create pools and catalyze widening of the incision trench, redistributing floodplain sediments over time and allowing the creek to aggrade sufficiently to connect with the historic floodplain.

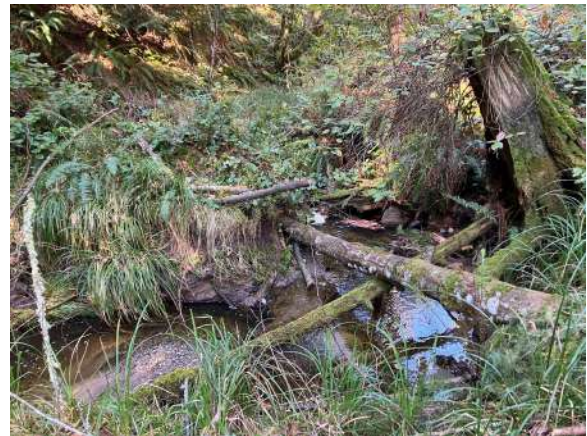
**Figure 23:** Location of breached historic beaver dam in Reach 3, with incised channel more than 1 m below historic floodplain
