# Wetland Revegetation in an Agriculturally Degraded Western Red Cedar (*Thuja plicata*) Forest on Galiano Island, B.C.

**Course Code:** ER 390

**Prepared by:** Madeleine Wong

**Prepared for:** Restoration of Natural Systems Program - Capstone Project

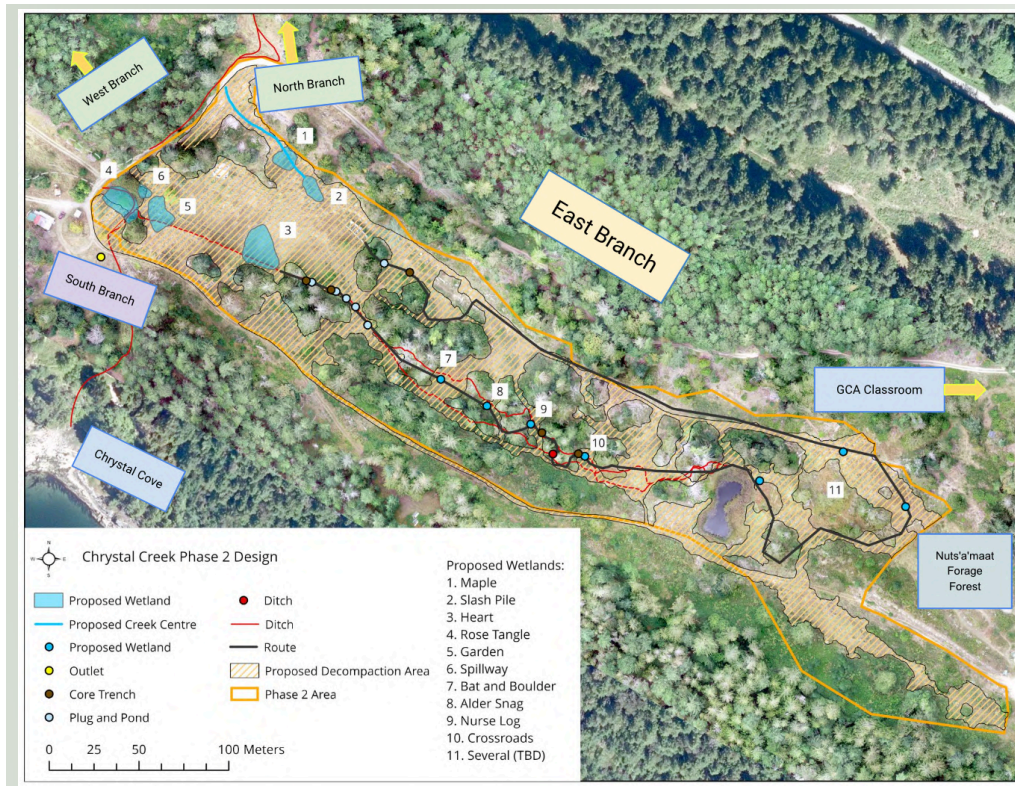
**Figure 1. Map of proposed changes to the Phase 2 Site (2020).** Developed by GCA, the map displays proposed changes in the East Branch. Of particular note are the current ditch paths and proposed wetland locations. The ditch pathways are currently draining all water that flows in the Chrystal Creek watershed.

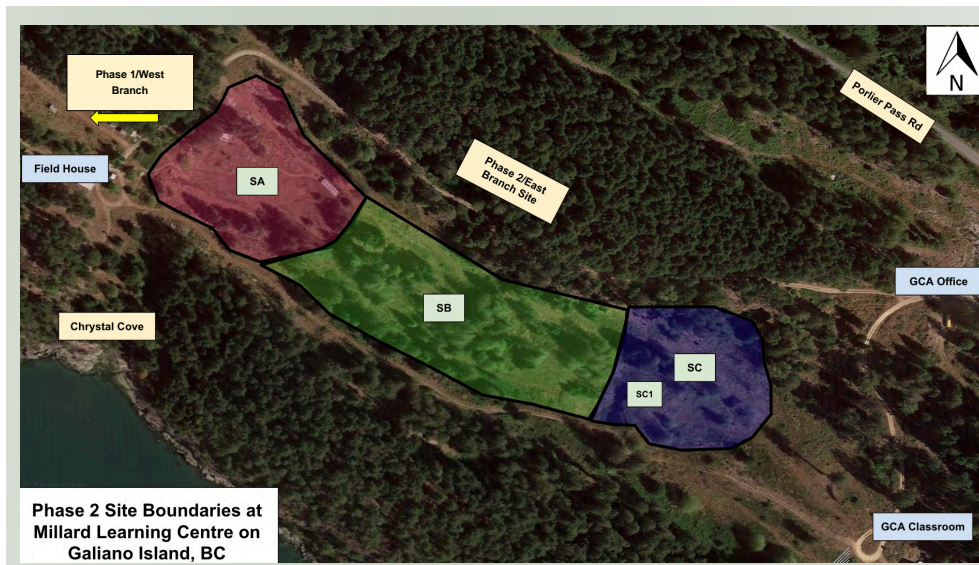
**Figure 2.** Division of the East Branch into three zones. Table 2 provides a breakdown of geographical information for each zone. The zones are divided based on observed boundaries; SA from SB through a linear border of Western red cedar trees; and SB from SC through the beginning of a heavily logged area.

**Table 2. Division of Zones in the East Branch**

Old Field (SA)	Forested Zone (SB)	Flooded Fields (SC) / Pond (SC1)
Median Coordinates	48° 55' 50" N, 123° 28' 27" W	48° 55' 47" N, 123° 28' 20" W	48° 55' 45" N, 123° 23' 18" W
Size (ha)	1.72 ha	2.37 ha	1.06 ha

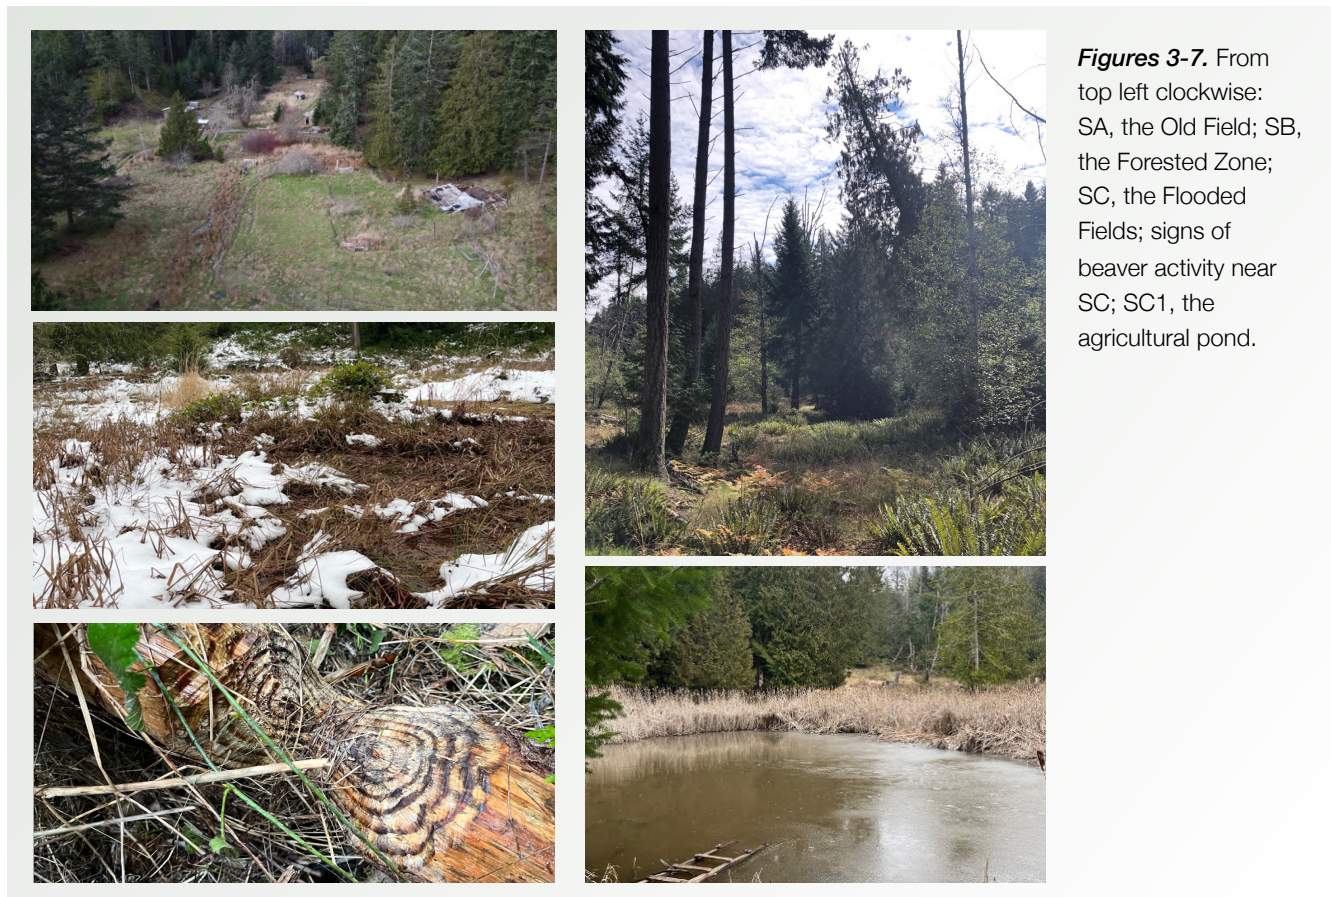
**Figures 3-7.** From top left clockwise: SA, the Old Field; SB, the Forested Zone; SC, the Flooded Fields; signs of beaver activity near SC; SC1, the agricultural pond.

The Old Field (SA) was the centre of agriculture in the East Branch (Figure 3). The site is grass and forb-dominated, consisting primarily of common rush (*Juncus effuses*) and invasive bull thistle (*Cirsium vulgare*). Remaining agricultural structures include old fences, bird boxes, and orchard trees, such as plum (*Prunus domestica*) and apple (*Malus domestica*). With poorly functioning and compacted soils, agronomic species like common velvet-grass (*Holcus lanatus*) have decreased landscape connectivity in being the only plants suitable for such conditions (Godfree et al., 2017). As such, this zone is comparatively low in species diversity to other areas of the East Branch.

The Forested Zone (SB) is the most biodiverse area in the East Branch (Figure 4). The upper slopes contain salal (*Gaultheria shallon*), big leaf maple (*Acer macrophyllum*), stinging nettle (*Urtica dioica*) and bracken fern (*Pteridium aquilinum*) alongside young stands of Douglas fir (*Pseudotsuga menzeisii*) and Grand fir (*Abies grandis*). Agronomic species, such as common vetch (*Vicia sativa*), proliferate in the valley flats. In this area, Western red cedars persist alongside riparian species such as sword fern (*Polystichum munitunum*), wild strawberry (*Fragaria vesca*), and coastal hedge nettle (*Stachys chamissonis*). Overall, the understory is a simplified composition of moisture-preferring facultative<sup>1</sup> plants typical of CDFmm1 rather than a strong association of species expected of a swamp. For example, small patches of obligate<sup>2</sup> species, such as skunk cabbage (*Lysichiton*

The Flooded Fields are almost completely cleared save for a few yellowing cedars, a sign of soil nutrient deficiency and poor moisture (BC Gov, 2015). This zone primarily contains bulrush, slough sedge (*Carex obnupta*), and horsetail (*Equisetum telmateia*), and a few patches of Oregon grape (*Mahonia aquifolium*) sit under a mature Western red cedar at the border of the Forested Zone. The site experiences seasonal flooding by a pond (SC1) used for irrigation during early agriculture (Figure 5). A key indicator of perennial moisture is a large patch of reed canary grass (*Phalaris arundinacea*) and an unidentified species of cattail (*Typha spp.*) surrounding a 10 metre buffer around the pond (Figure 6). Today, this pond provides northern red legged frog (*Rana aurora*) and Pacific chorus frog (*Pseudacris regilla*) habitat, with some evidence of North American beaver (*Castor canadensis*) (Figure 7) (Huggins, 2021b). Historic pipes connected to the pond have continuously drained water into the Old Field, highlighting how agricultural land use has caused long-term changes to the site’s natural water flow.

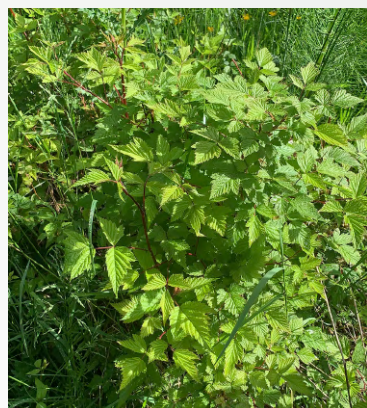
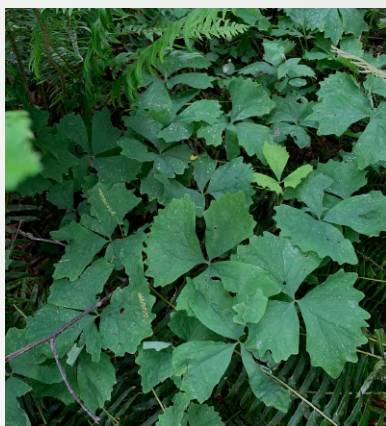
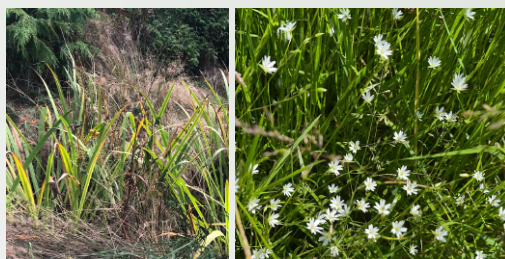
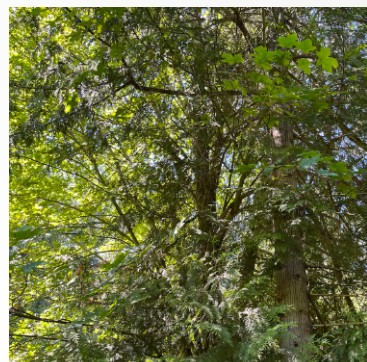
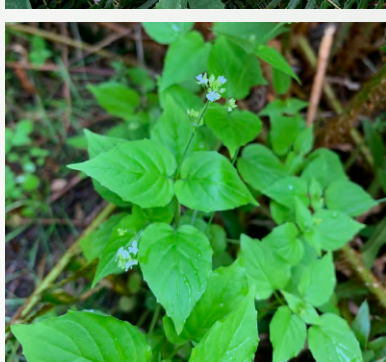
**Figures 8-13. Sample of plants in the East Branch.** From top left to bottom right:  
 Figure 8. Salmonberry (*Rubus spectabilis*) in SB Plots 1-6, surrounded by horsetail and grasses.  
 Figure 9. Vanilla leaf (*Achylys triphylla*) in SB Plot 5 surrounded by sword fern and WRC.  
 Figure 10. Bulrush (*Scirpus microcarpus*) in SB Plots 3-6, and SC Plots 9-11, surrounded by WRC, grasses, and scotch broom.  
 Figure 11. *Stellaria* spp., in SC Plot 12 surrounded by grasses and bracken fern.  
 Figure 12. Western red cedar (*Thuja plicata*) on the north-facing slope in SB Plot 2, intermixing canopies with big leaf maple.  
 Figure 13. Alpine Enchanters nightshade (*Circea alpina*) in SC Plot 9.

82 species were identified in the East Branch, with some insight from GCA's team (sample listed in Figures 8-13, full list in Appendix A). The Old Field was chosen as the priority for revegetation due to the intensity of past land use and low plant diversity compared to the Forested Zone and the Flooded Fields. Plants with the highest distribution, summarized in Table 4, were determined by calculating the proportion of total species identified to relative cover in all sample plots. The results were expected, with Western red cedar and sword fern the most commonly occurring species in their classes. Overstory cover appears low (14.3%) as the Flooded Fields and Old Field are almost completely cleared. Although common vetch had the highest cover in the herbaceous layer, this

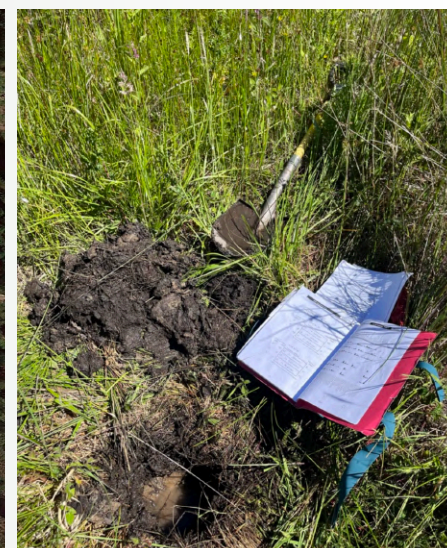
Figure 15. Soil pit in the Flooded Fields (2022)

Trimble GNSS receiver system. The Trimble mapped polygons and sample plot points on-site which were later corrected in ArcDesktop (8.1). Twelve soil pits measuring 30cm x 60cm were dug in the same sample plots as the plant inventory (Figure 14-15). The survey used a Ground Inspection Form<sup>3</sup> and analyzed soil texture, drainage and nutrient regimes, as well as site modifiers<sup>4</sup> (see Appendix B). Site series were determined using vegetation summary tables in the *Field Manual* (2010a).

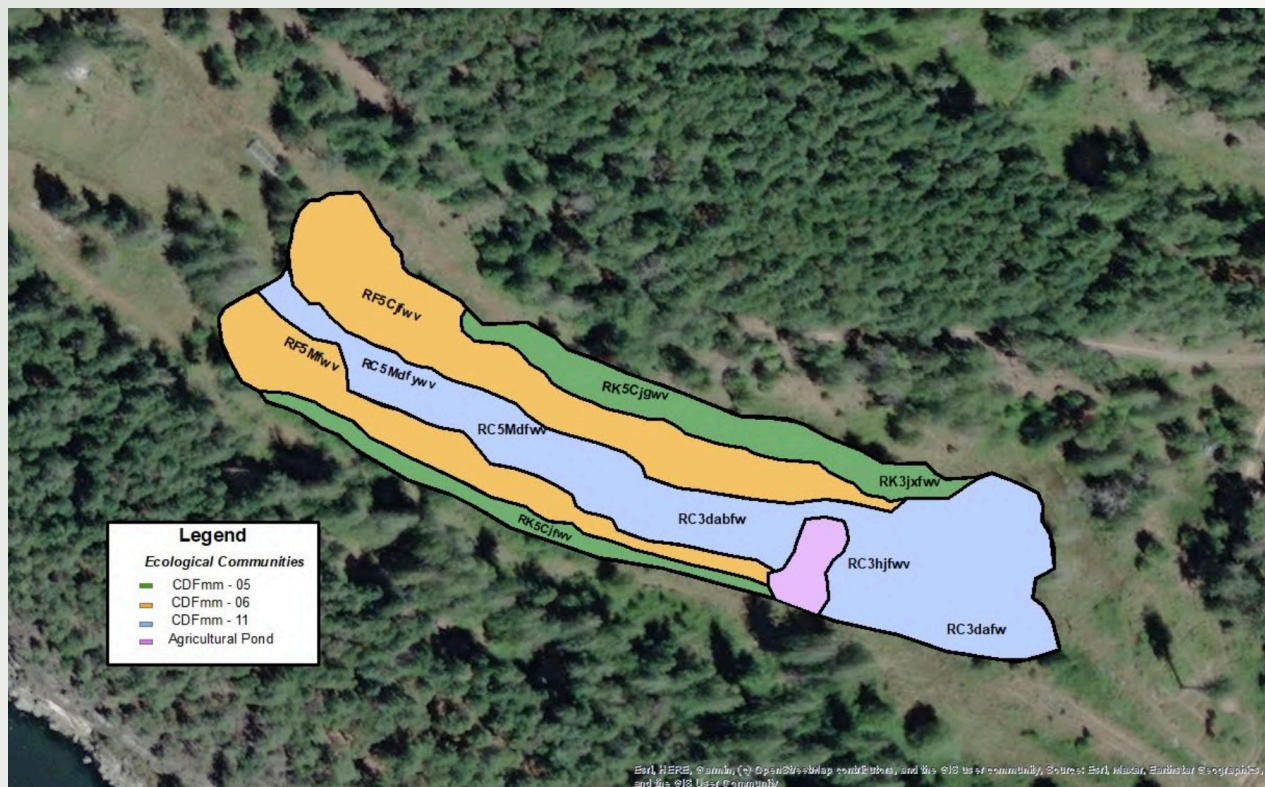
Figure 16. Completed TEM for the East Branch. Note that 06 series RF5Cjfwv is represented by 3 soil pits sharing the same TEM code. RV5Mdfwv comprises 2 soil pits.

Site series in the East Branch include 05, 06, and 11 (Table 5, Figure 16). The nutrient regime is *Rich/Very Rich* and the drainage regime varies from *Poor* in the the valley flats to *Moderate* in the upper slopes. Surficial soil type also varies from sandy loam (SL) to clay loam (CL) based on topographical position.

The 05 zone contains light and red sandy loam soils (SL). Decomposing cedar bark indicates a lower pH typical of Western red cedar forests. There was no seepage, and streaks of oxidation and sharper pebbles suggest moderate drainage in the free movement of air and water. The sites contained some mesic species with patches of open canopy supporting subxeric species in SP12, such as *Stellaria* spp. (potentially *S. pallida* or *S. graminea*). This moisture change reflects a fluctuating water table in the transition between 05 and 06 site series.

The 06 zone dominates the low slopes of the East Branch. The Ah horizon contains silty loam (SiL) and silty clay loam (SCL) soils. Mottling and seepage were present in each sample plot by 30 cm, with SP1 containing charcoal at 25 cm that may be the result of past fire and/or occupation. The south-facing slopes experience more sun and were comparatively drier to the north-facing slopes, supporting submesic soils suitable for species such as bracken fern and Douglas fir. Vanilla leaf (*Achlys triphylla*) on the north-facing slopes point to a mesic moisture regime, likely due to shade from Western red cedars and big leaf maples. Rounded pebbles indicate a fluctuating water table.

The 11 zone is dominated by Western red cedar and red alder trees with an understory of bulrush, hedge nettles, horsetail, and a large patch of slough sedge in SP9, which also contained evidence of beaver cutting. These species indicate the site supports a hygric-subhydryc moisture regime and experiences year-round wet conditions. Seepage was immediate at the 15 cm mark and soils contain both gleying and mottling, indicating poor drainage and anaerobic conditions (Ministry of Forests, 2010b). SP11 unknowingly took place on an old soil pile leftover from digging the pond, reflecting the *Imperfect* drainage regime. High seepage made analysis challenging, although it was evident the soil texture was sandy clay (SC) at SP11, an 05 transition point, and clay loam (CL) in the valley flats as strong casts were easily formed.

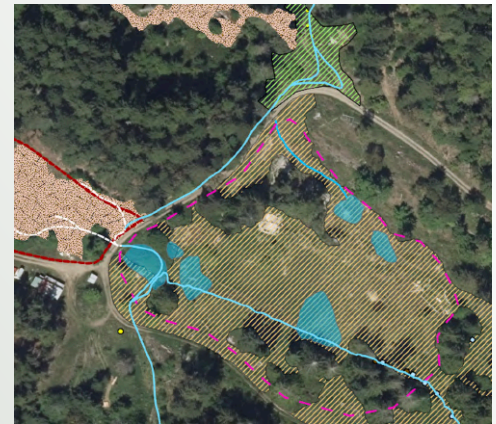
**Figure 17.** Map of the fenced area in pink dashed lines around the Old Field.

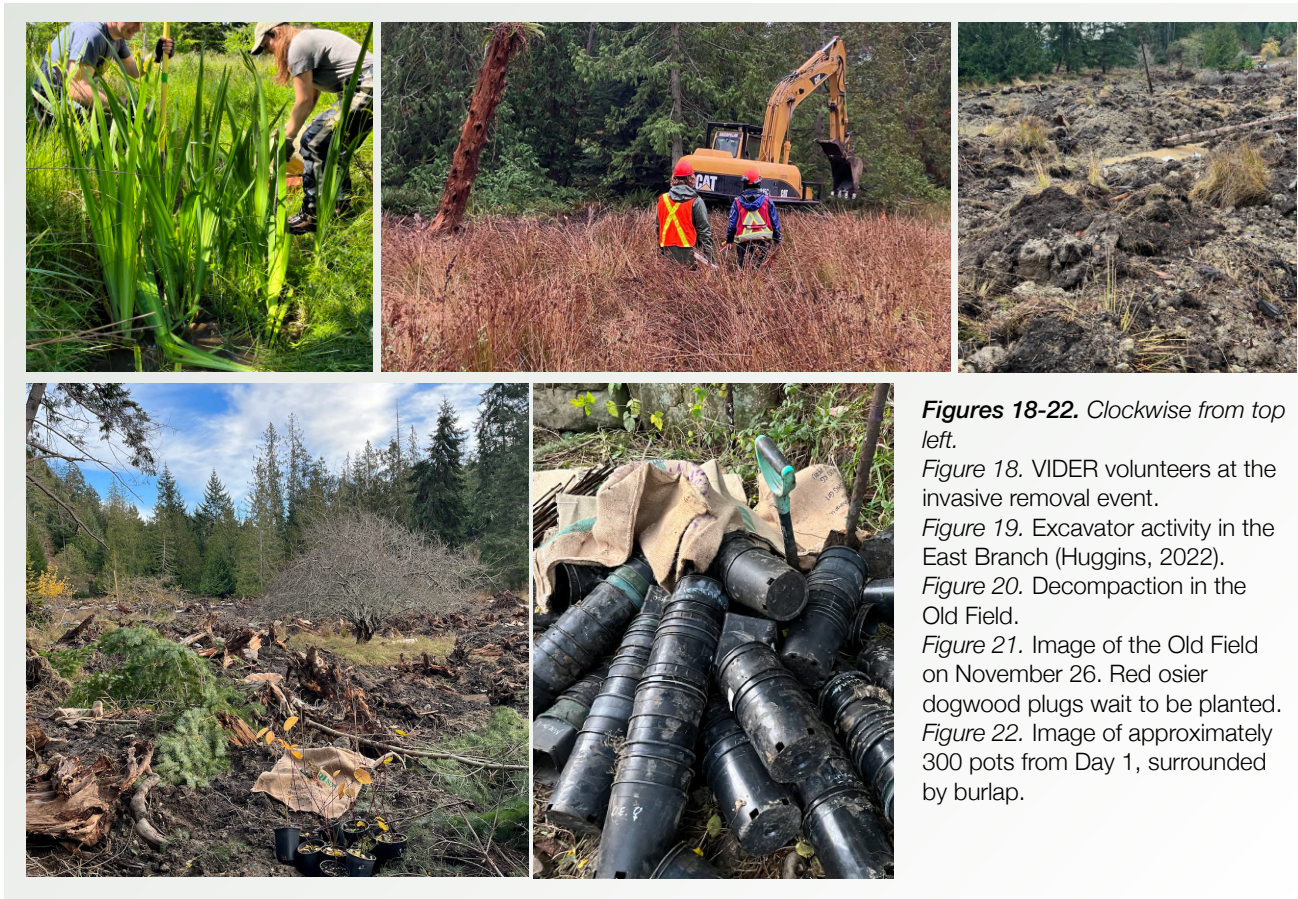
**Figures 18-22.** Clockwise from top left.

Figure 19. Excavator activity in the East Branch (Huggins, 2022).

Figure 20. Decompaction in the Old Field.

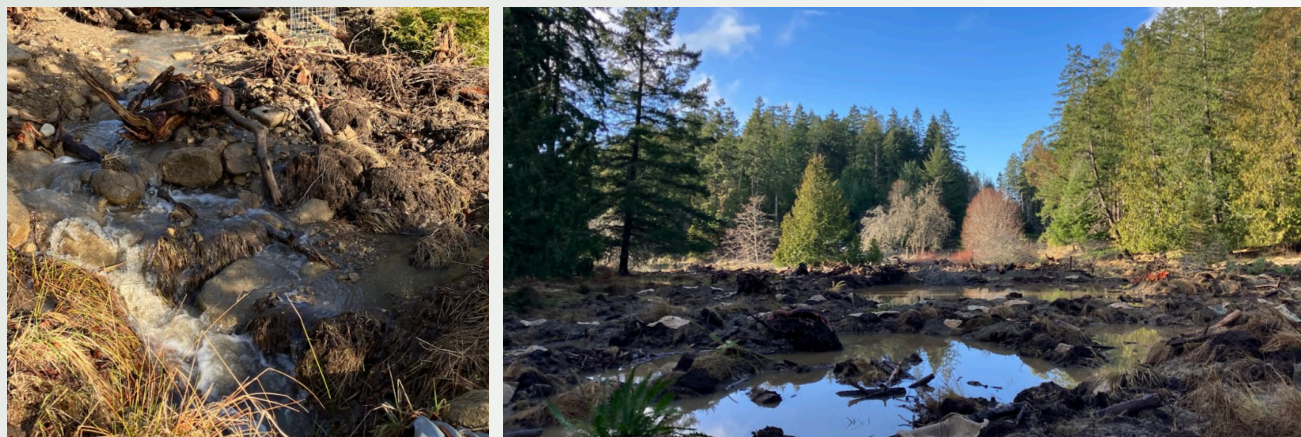
**Figures 23-24.** Restored wetland landscape in the Old Field (February 2023, Huggins). Active spillways channeled through a new culvert; west-facing view.

By January 2023, water was actively flowing in the East Branch and the new wetlands readily captured winter precipitation. The new hydrological infrastructure connected surface water flows from the North Branch and West Branch to the East Branch, bringing *Cedars for the Next Century* a step closer in the goal to restore the Chrystal Creek watershed. A 2019 test pit in the Old Field held water year-round, and considering the 11 site series in the low valley, it is likely that the wetlands in the East Branch will be perennial and smaller pools may experience ephemerality in the summer.
